Richard W. Veyna
ASSOCIATES
Horticultural Consultants

February 21, 2024

Ping Wei
2907 Rio Lempa Dr.
Hacienda Heights, CA 91745

On 2/16/24 we inspected the property at the above address. The lot slopes down from south to north. We surveyed the property for the presence of Coast Live Oaks (*Quercus agrifolia*). We found four trees, one of which had been reduced to two feet in height, and three others which had not been pruned at all.

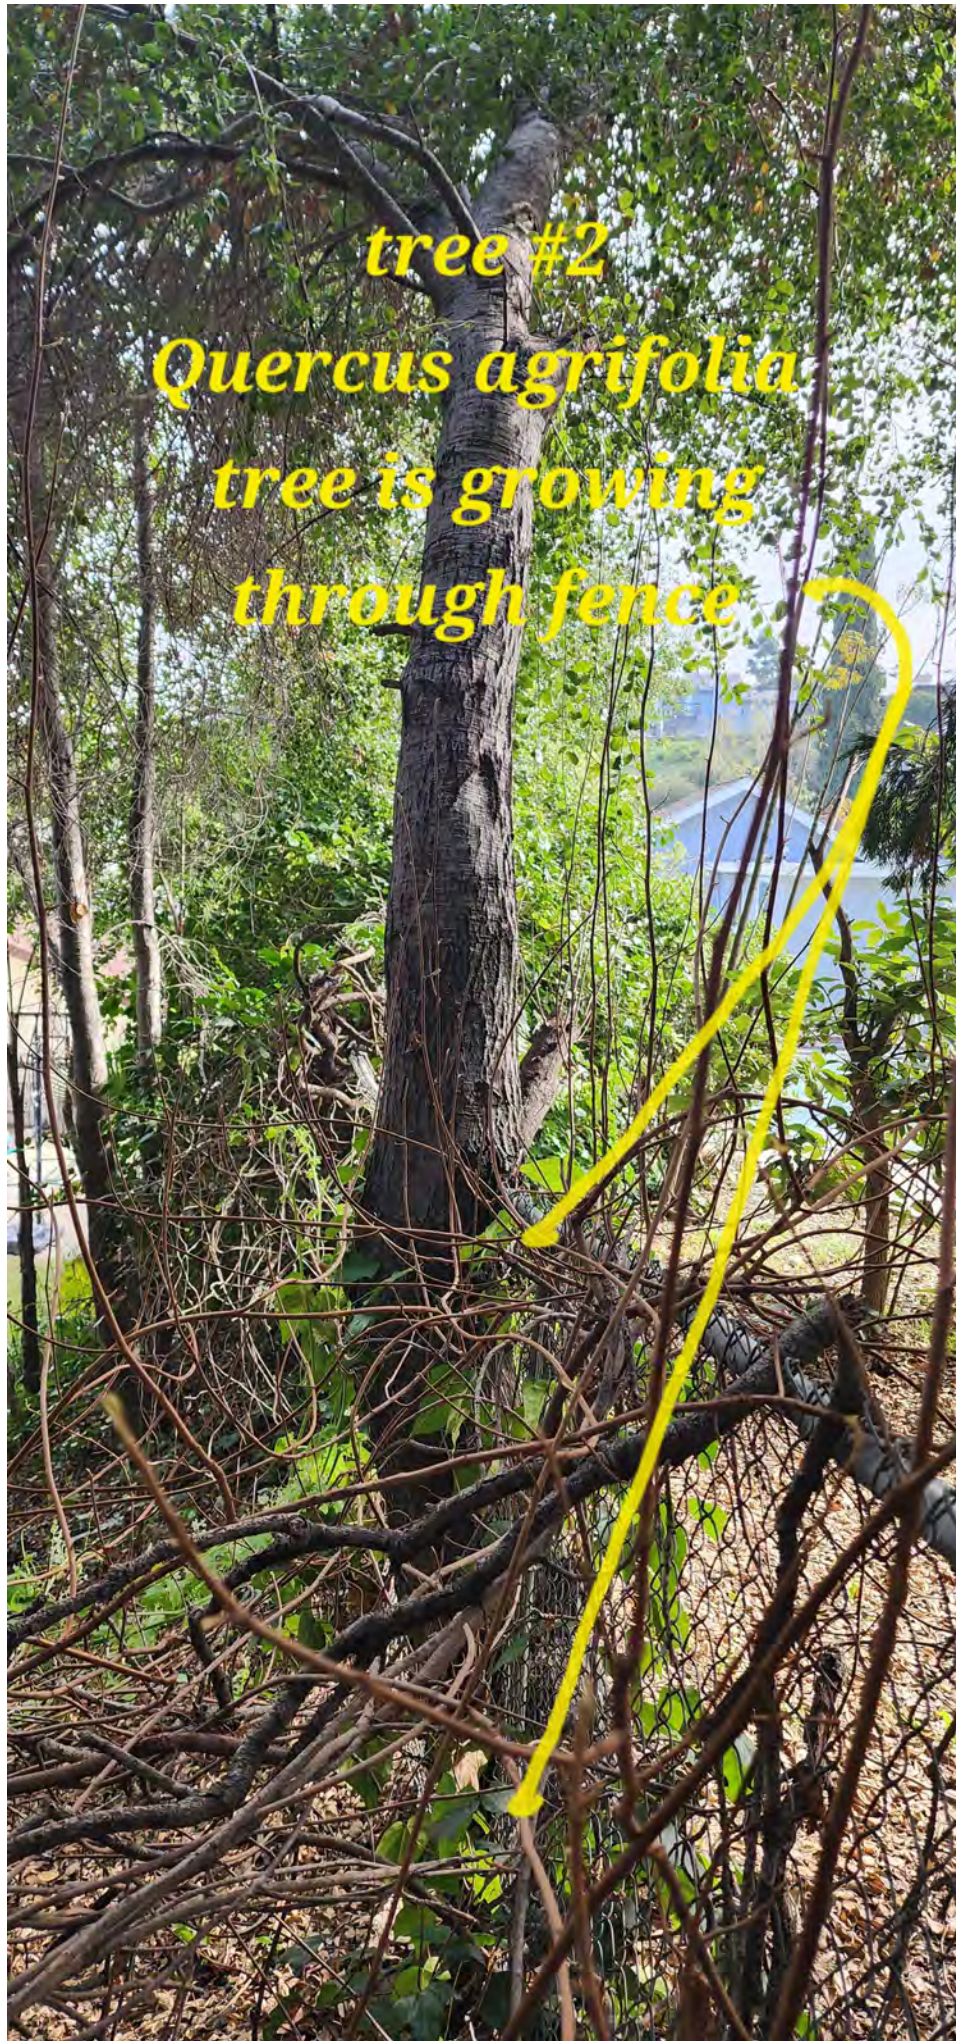
tree #2

Tree #2, Coast Live Oak, (*Quercus agrifolia*). This tree is located WITHIN the eastern fence line. Apparently, an acorn must have germinated some years ago and literally grew through the existing chain link fence on the property line. The tree measures approximately thirty-seven feet high, twenty-two feet wide, with a twelve-inch dbh. This tree is in very good health, with little signs of insect invasion or disease. The tree has a pronounced lean to the north. Although the tree is well rooted, we recommend it be monitored over the next few years to ensure it does not succumb to invasion by insects due to the fact the top bar of the fence is embedded in the trunk and could negatively affect the flow of nutrients and water within the tree. The TPZ on this tree is a radius of fifteen feet from the trunk.

Quercus agrifolia

tree is growing

through fence

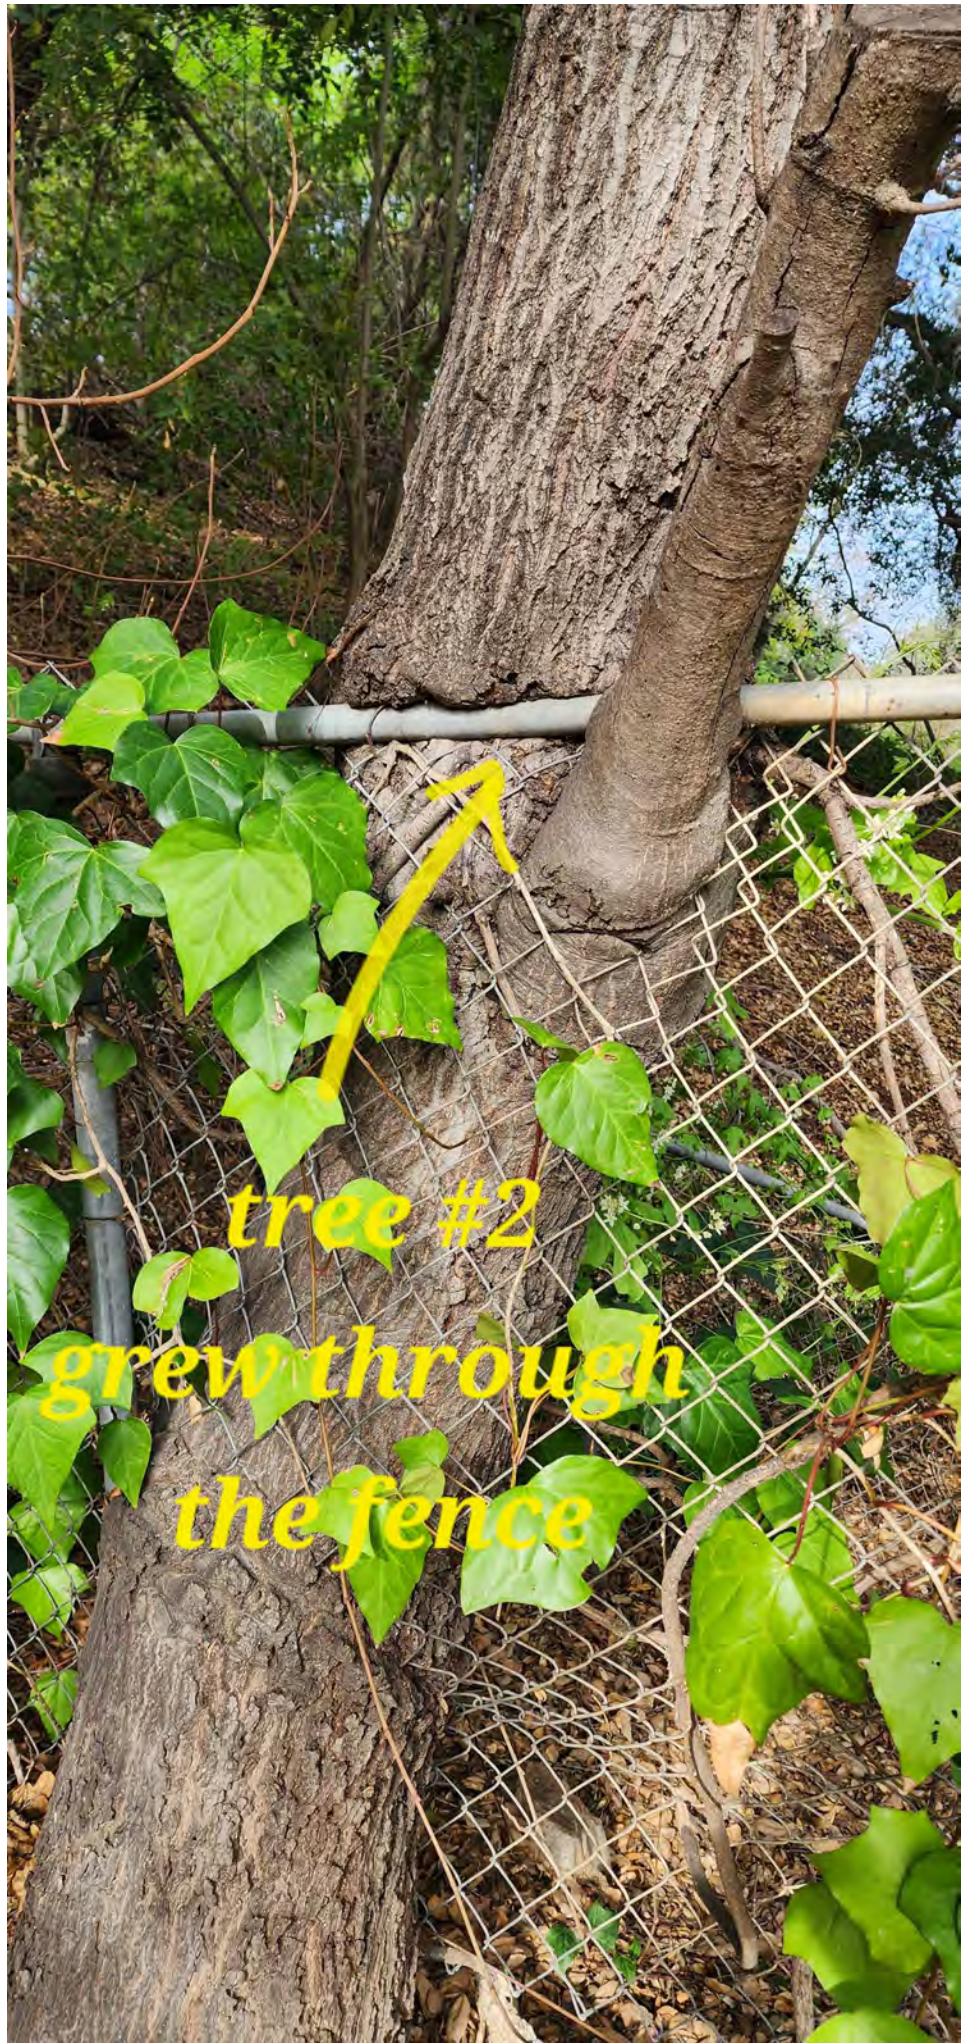
*tree #2
grew through
the fence*

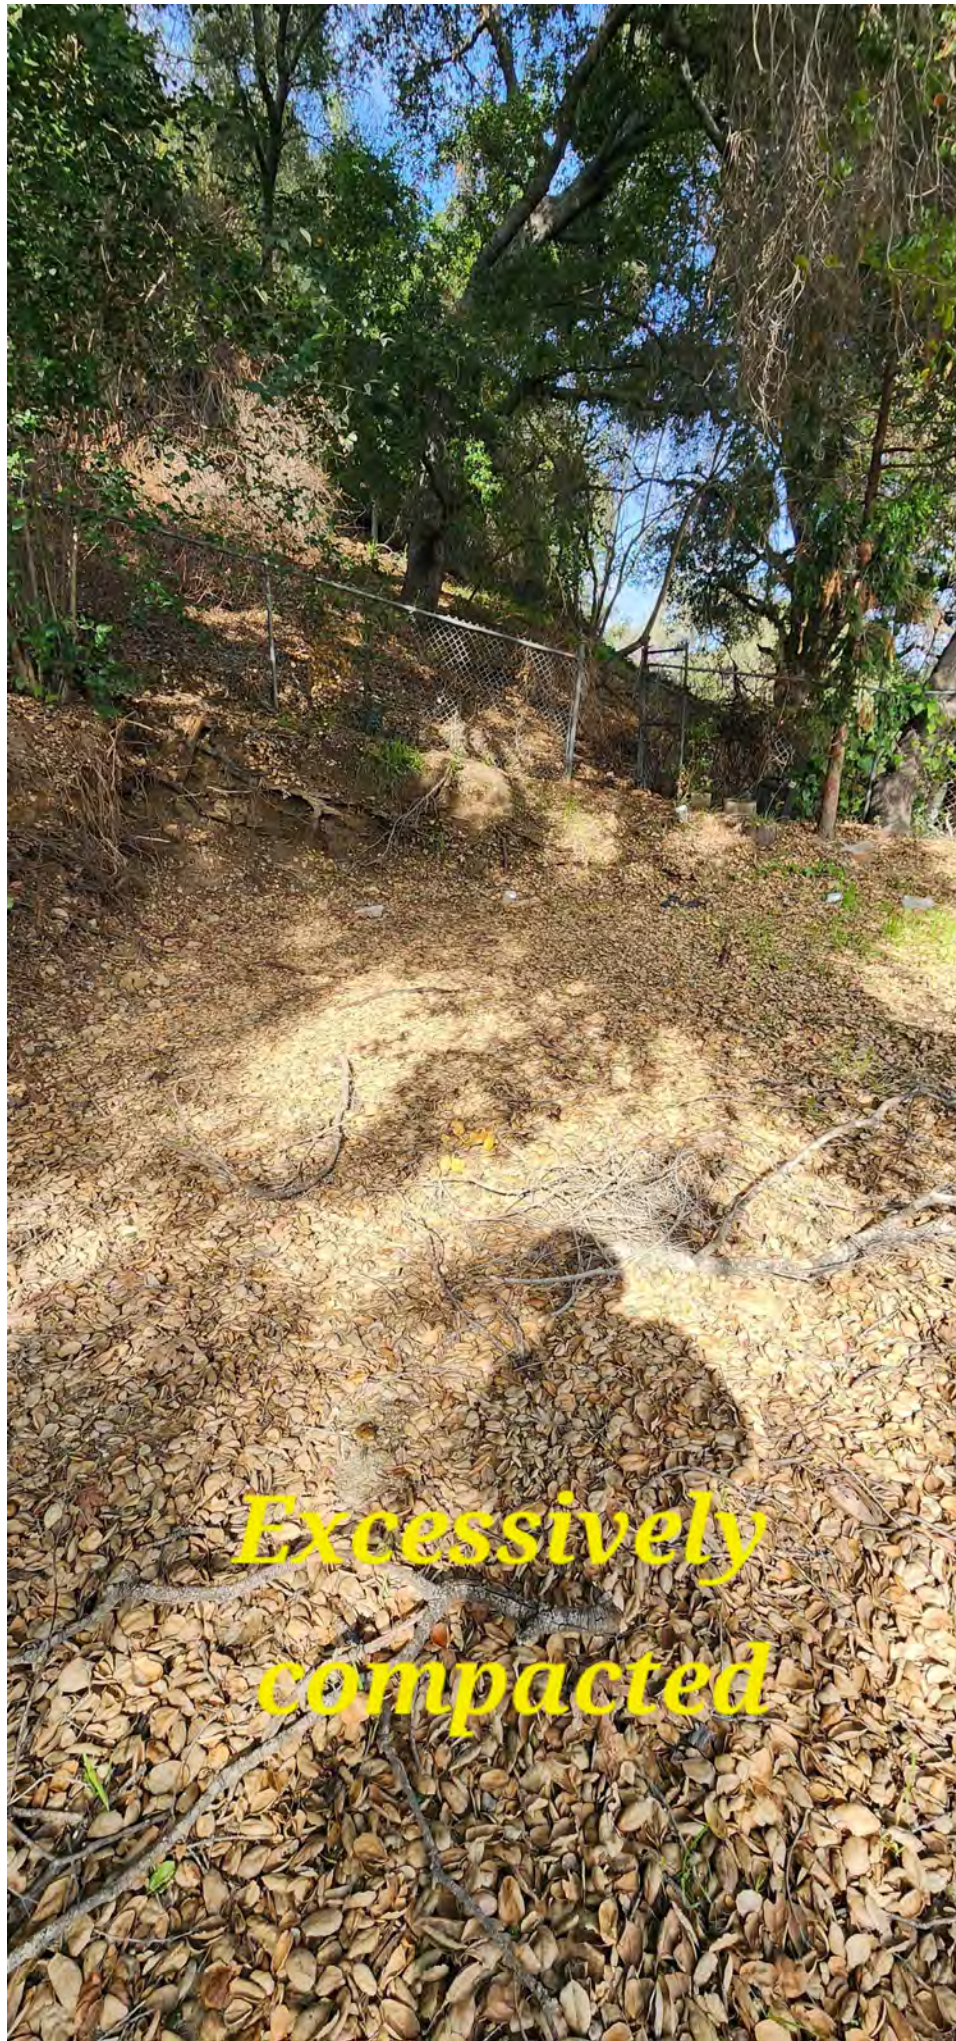
The area encroached upon constitutes approximately thirty percent of the root zone. For reference we will refer to it as the "affected area." The area under the dripline of an Oak should never be compacted. In this case the native soil is predominantly CLAY. The characteristics of this soil type have a natural tendency on its own to be compact. In the affected area the soil was compacted with heavy equipment possibly crushing the roots below it. Measures will need to be taken to reduce the compaction so as not to "lock up" the soil preventing the free flow of water and nutrients. Prior to backfilling, we suggest two-inch-wide holes be bored to a depth of twelve inches, three feet on center, within the "affected area," thus allowing the soil to have some form of oxygen exchange. We suggest all the soil removed from the "affected area" be replaced with native soil mixed with 25% oak mulch. The backfill mix should not be compacted beyond 15%. This may need to be done by hand as no equipment should enter the TPZ from this point on. We recommend a retainer wall be constructed to hold the new backfill. This wall should go from the existing height of the unaltered slope under this tree to a height of no more than thirty inches on the north side. The engineering of this wall is outside of our purview. Any footing should be dug **OUTSIDE OF THE TPZ.** If any roots are encountered in the process of creating footing, they need to be protected with a plastic barrier to prevent harmful chemicals from entering the vascular system of the subject "Heritage" Oak. Prior to backfilling the area, all exposed roots should be cut **UNDER THE SUPERVISION OF A CERTIFIED ARBORIST.**

*Excessively
compacted*

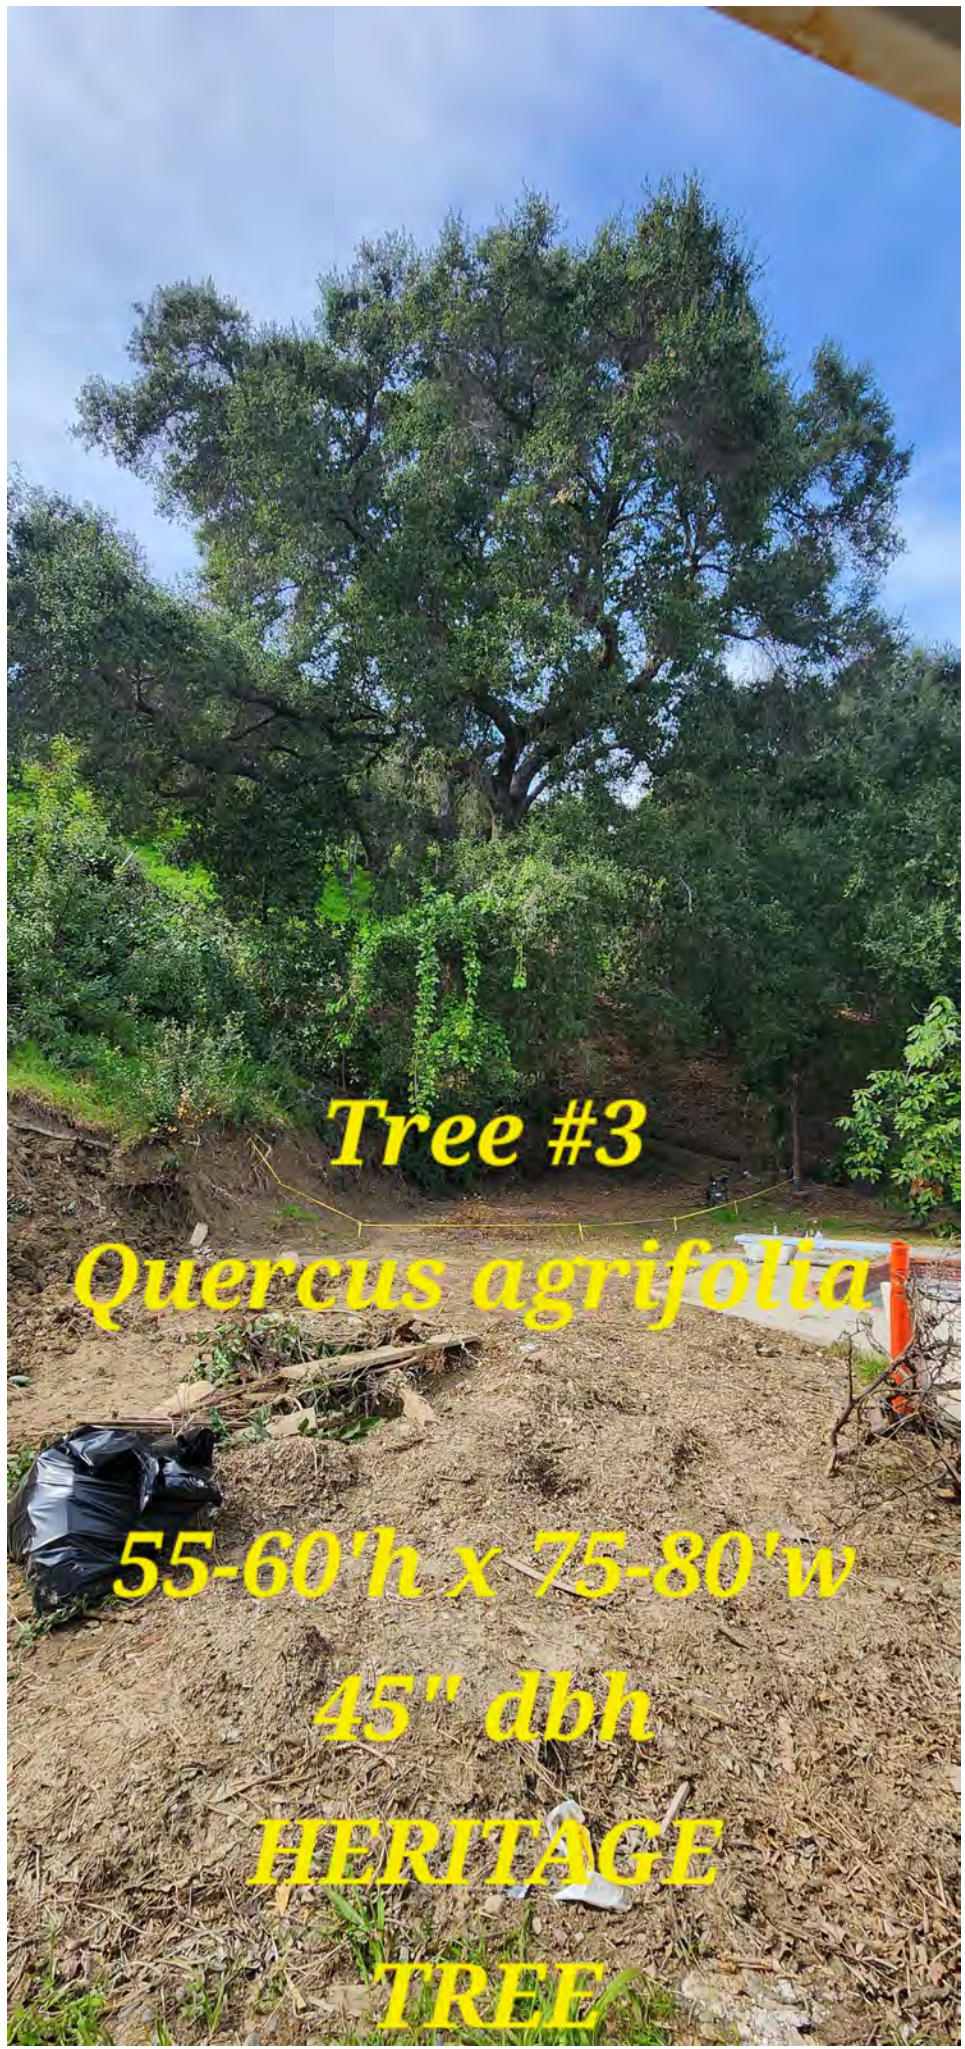
Tree #3

Tree #3, Coast Live Oak, (*Quercus agrifolia*). This tree is very prominent in the area as it measures approximately sixty feet high, seventy-five to eighty feet wide, with a forty-four-inch dbh. This tree would be classified as a "Heritage Tree." This tree is in excellent condition. We saw no apparent signs of insect damage or disease. It could benefit from pruning to remove deadwood. The form on this tree is free of any noticeable "cross branching." Of major concern to us is the root system on the north side of the tree. Grading has been done in preparation for construction of a retaining wall on the south side of the property. Encroachment has occurred and a portion of the root system was removed in the process. A radical slope cut was made approximately six feet from the trunk of this tree on the north side. The south side of the root system remains intact and undisturbed. Approximately thirty percent of the root system was either removed or compacted on the north side of this tree.

Quercus agrifolia which grow in a steep hillside generally have anchoring roots on the uphill side and most of their feeder roots on the downhill side. At present, this tree seems to show little signs of stress as it is currently dormant. We are very concerned that this tree may suffer a loss of foliage if the summer temperatures rise to the level they have in the recent past. Should the tree not be able to draw up enough water due to the loss of a portion of its feeder roots, it may go into stress and will likely defoliate. Should this occur, the dehydration of the tree will be accelerated, and the tree could slowly succumb to insects and disease. Should the tree fail, the residence at 2907 Rio Lempa Drive would likely be one of its potential targets. To prevent this, we suggest remedial measures be taken as soon as possible. These measures include but are not limited to replacing the soil removed from the root zone on the north side of the tree. We placed an *informal* Tree Protection Zone around the tree while we were on site. This area of the root zone needs to be repaired. Until a plan is put in place to save this tree, **NO ONE SHOULD ENTER THAT ZONE.** The actual Tree Protection Zone on this tree is a radius of forty-five feet from the trunk.

Quercus agrifolia

55-60'h x 75-80'w

45" dbh

HERITAGE

TREE

We suggest the tree be irrigated as needed for a period of two to five years between March and October of each year. The water content within the backfill should be monitored monthly, by a **CERTIFIED ARBORIST.** The affected area should contain a drainage system created from a three-inch perforated pipe to drain any excess moisture away from the root system. The design of these drainage and irrigation systems is not covered by our agreement. The installation of the drainage system should be done by a licensed landscape contractor. The aim of the retaining wall along with the drainage and irrigation system is to establish **NEW** roots in the area where soil was removed in the affected area.

We recommend a Mycorrhizal treatment be applied in the affected area to encourage the establishment of new roots. Once the tree has put out a new roots system in the affected area, irrigation may be halted, and monitoring can be reduced to once per year.

Bore 2 inch holes, 12 inches deep, 3 feet on center

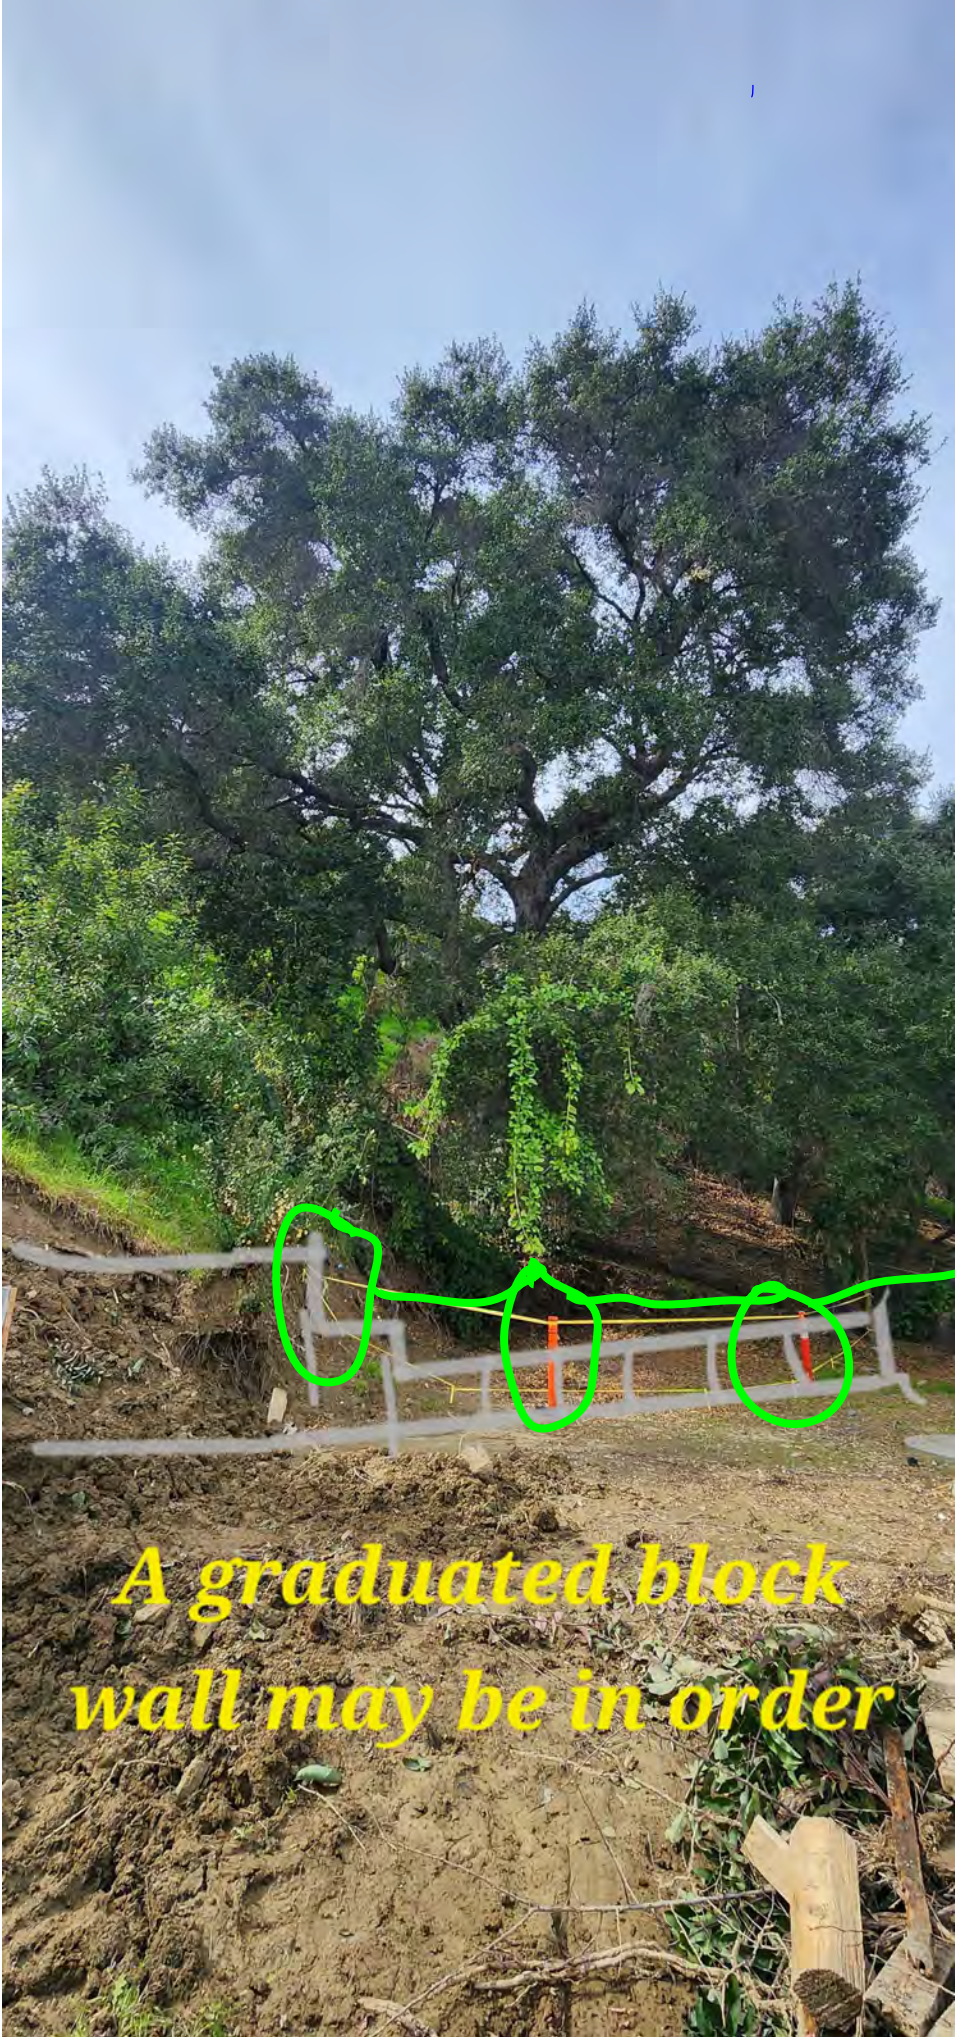
This "barrier" was not in place when I conducted my site visit.

A graduated block wall may be in order

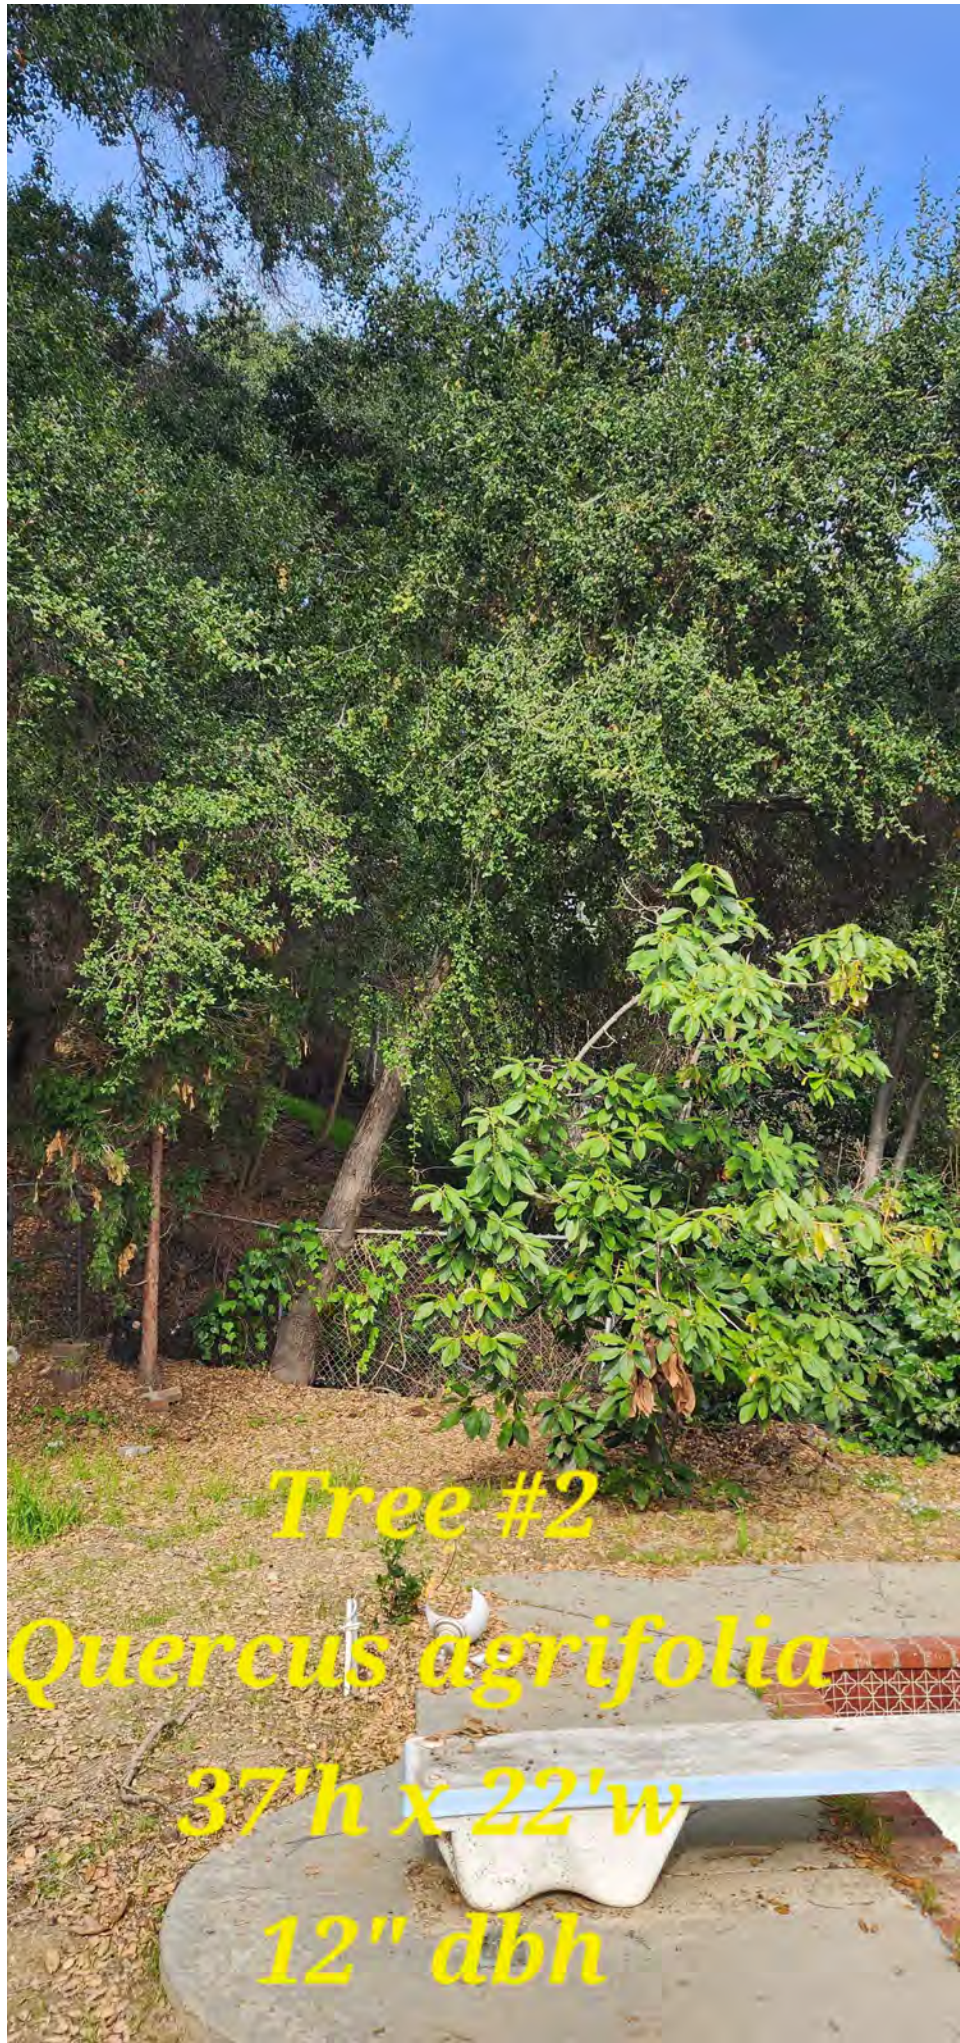
Tree #2

Quercus agrifolia

37'h x 22'w

12" dbh

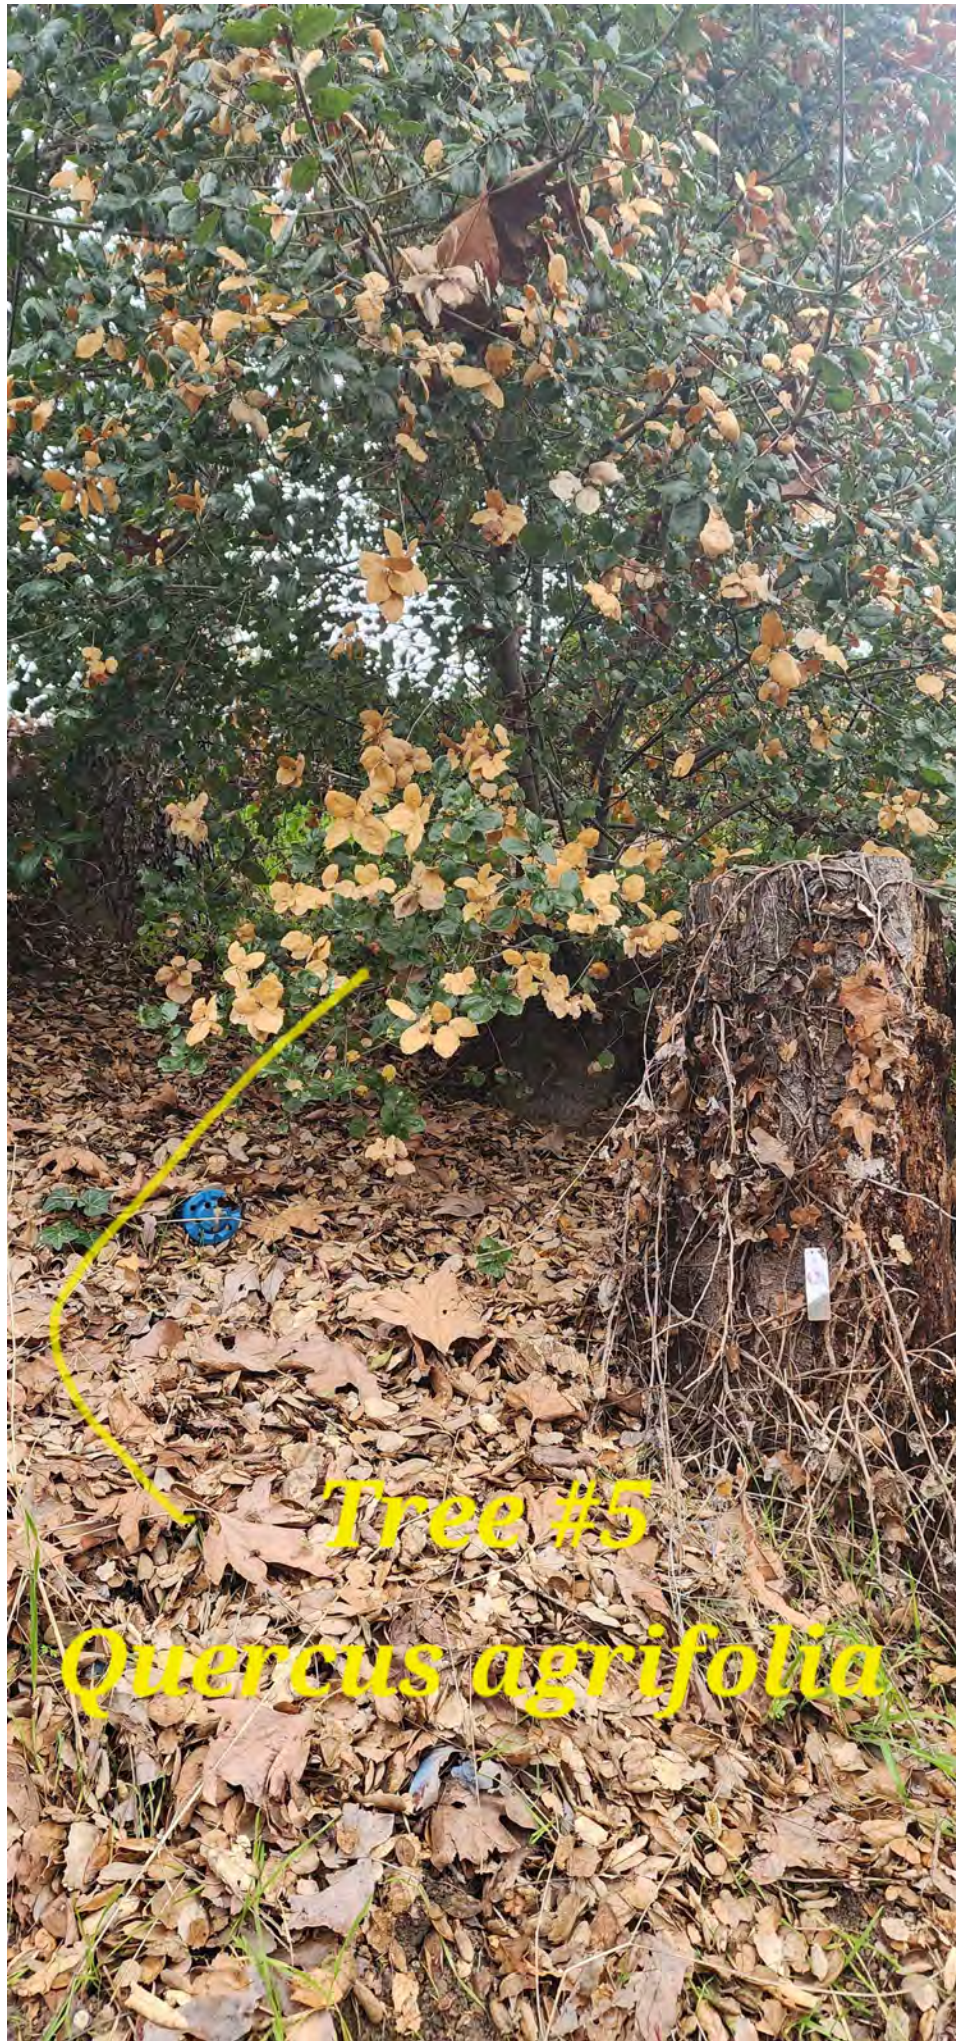
Tree #5
Quercus agrifolia

Diameter? How old is the cut? Tree #5 Coast Live Oak, (*Quercus agrifolia*). This is a stump approximately two feet high. Undisturbed it will grow into a large bush. It appears to be in poor condition. It lies within the TPZ of tree #1.

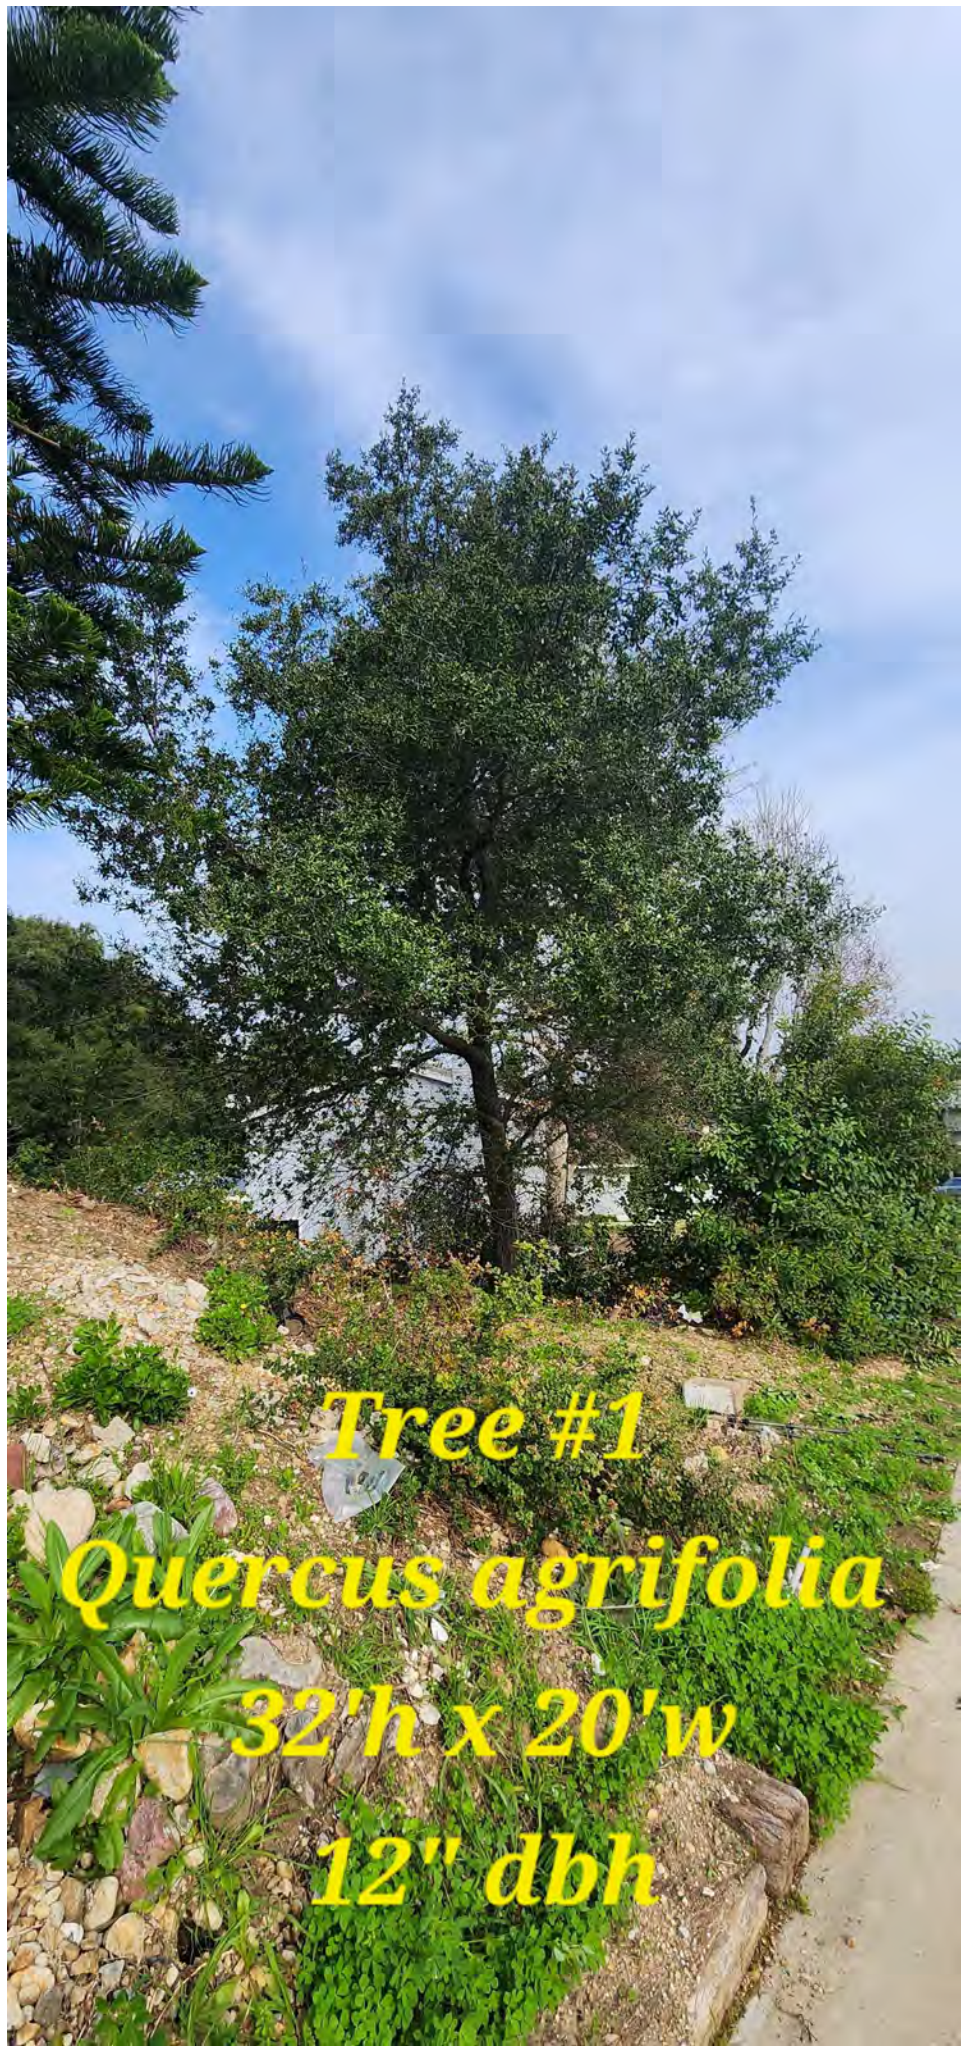
Tree #1

Tree #1, Coast Live Oak, (*Quercus agrifolia*). This tree is located just within the property on the west side. The tree measures approximately thirty-two feet high, twenty feet wide with a twelve-inch dbh. This tree is in very good condition. We saw no signs of insect invasion or disease. The tree could use some thinning out to remove deadwood. It has no noticeable "cross branching." We recommend the ground cover surrounding this tree be cleared three feet away from the trunk to minimize competition for water in the summer months. Any oak leaf litter that falls should be left in place to maintain moisture in the root zone. The Tree Protection Zone (hereto referred to as the TPZ), on this tree is a radius of fifteen feet from the trunk.

Quercus agrifolia

32'h x 20'w

12" dbh

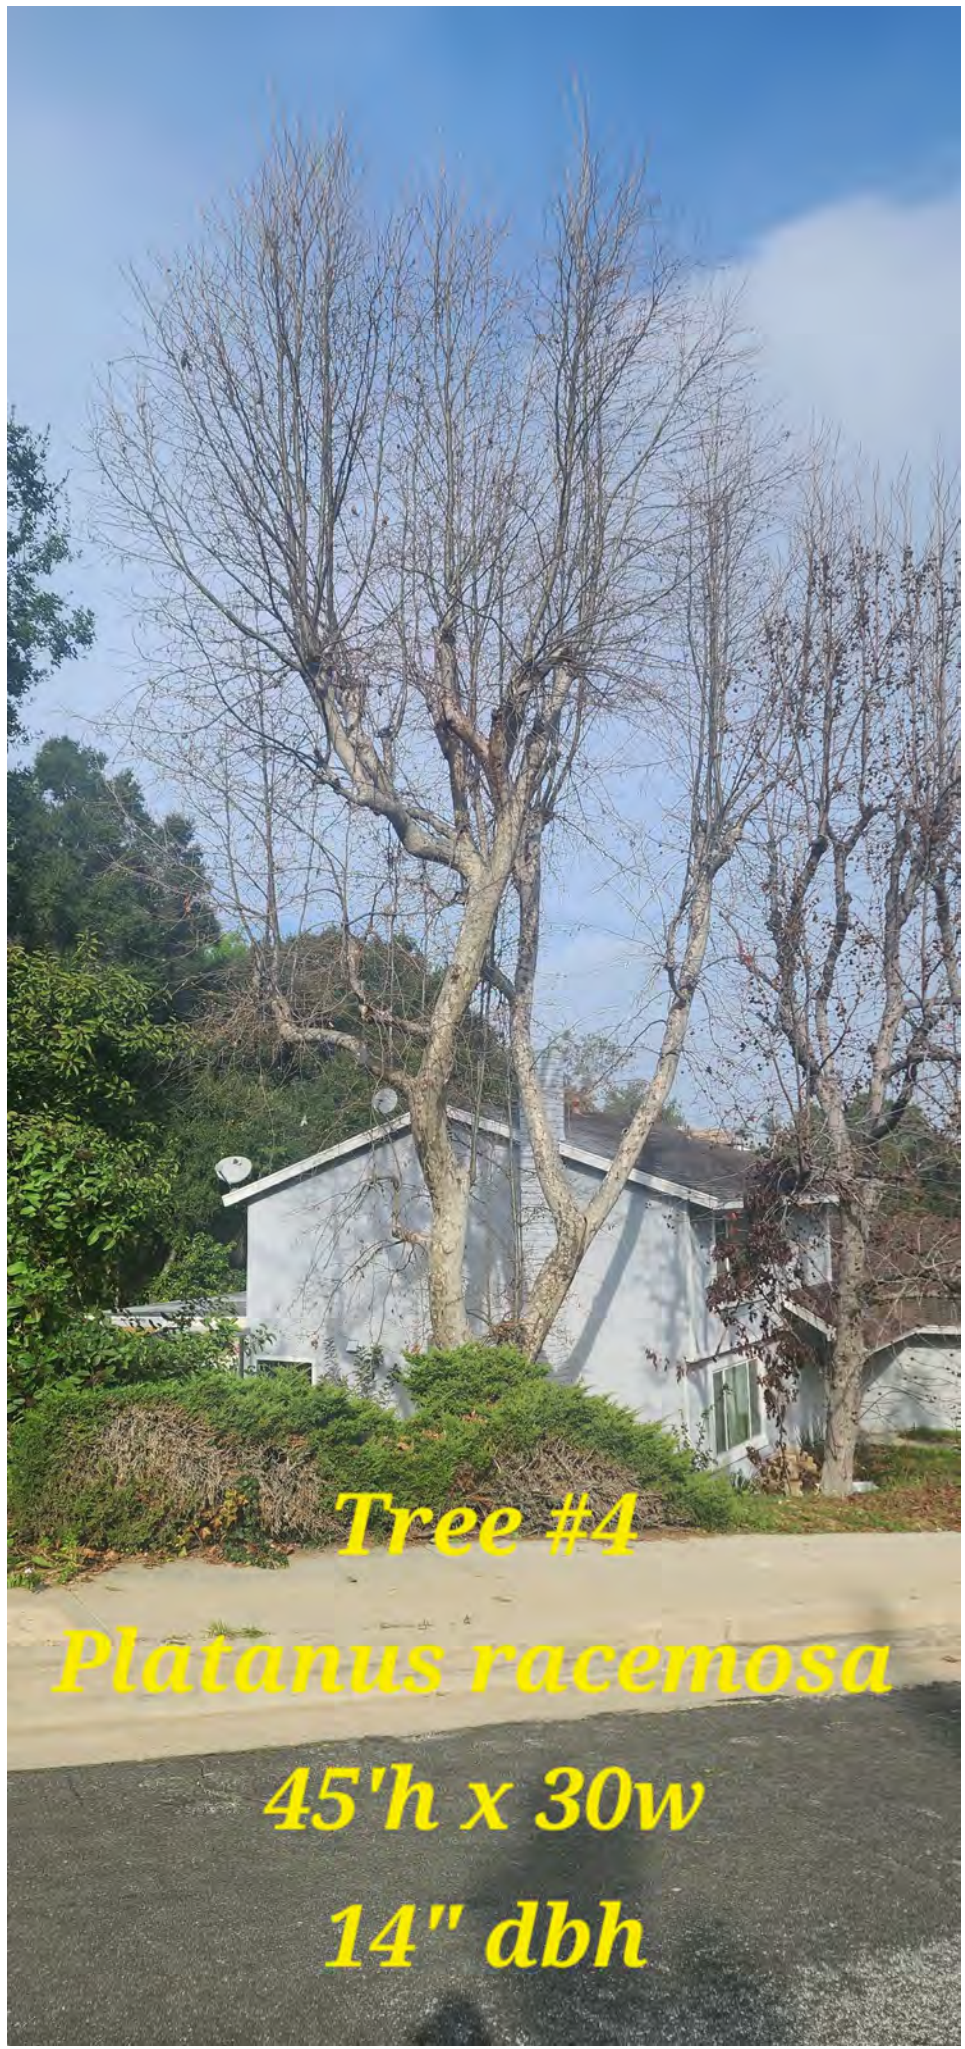
Tree #4 California Native Sycamore, (*Platanus racemosa*). This tree is not part of an Oak Tree Report but is considered a California native and is protected in some jurisdictions. This tree measures approximately fifty-five feet high, thirty-two feet wide, with a nineteen-inch dbh. It appears to be in good health with no apparent insect damage. Any signs of disease cannot be accurately determined while the tree is dormant. The tree has been “topped” previously. The off shoots resulting from this practice should be selectively pruned to prevent “lion’s tails.” The TPZ should be sixteen feet from the trunk of this tree.

Platanus racemosa

45'h x 30w

14" dbh
