## NATIVE TREE AND OAK TREE REPORT

### TOPANGA ELEMENTARY SCHOOL

Revised 1 June 2023

Revised 27 October 2025

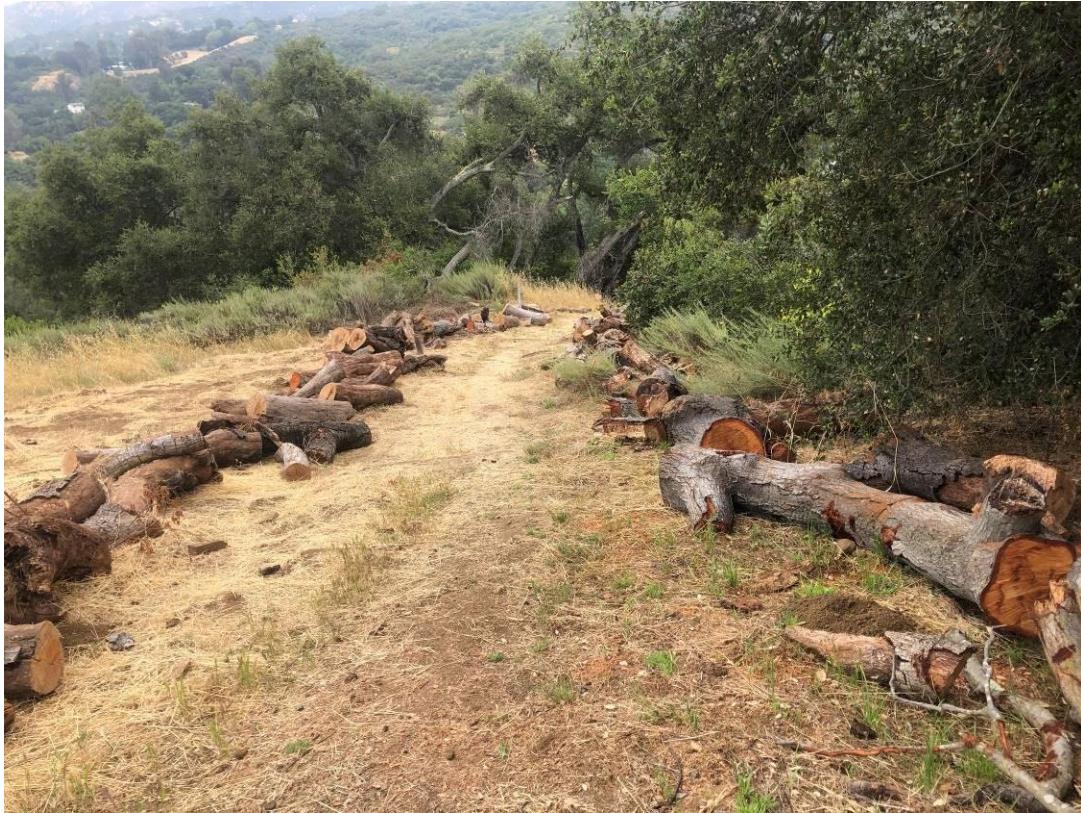
**Figure 2a. Backbone Trail lined with recently cut Coast Live Oaks. Photo taken 29 May 2020.**

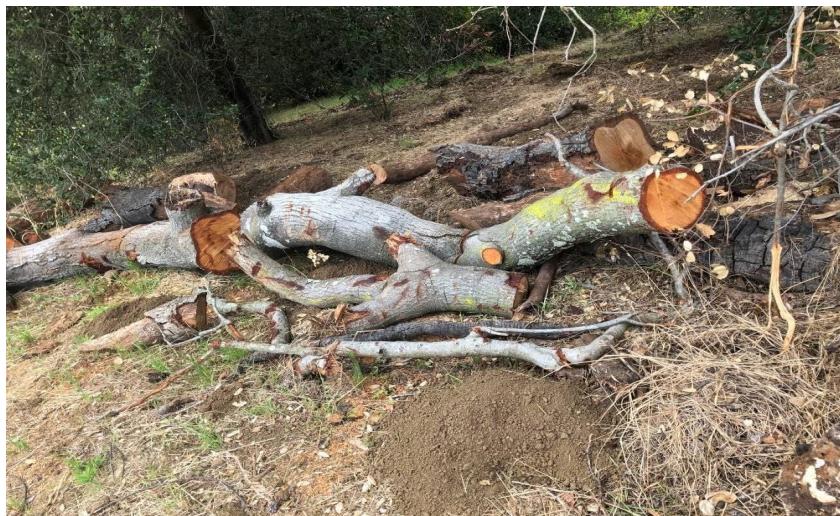
**Figure 2b. Photo of section of Coast Live Oak still oozing sap taken 29 May 2020.**

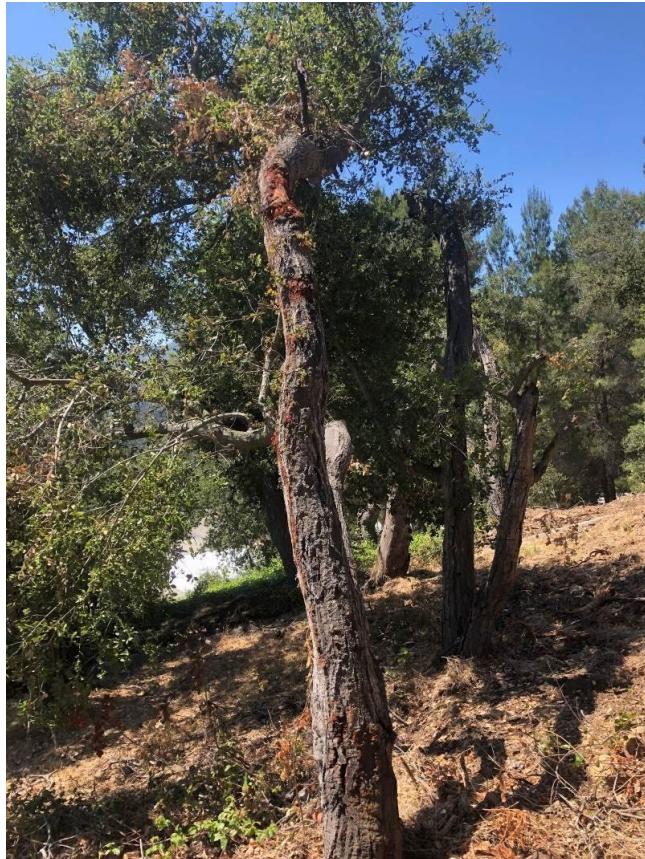
Additionally, our review of remaining (tagged) tree conditions indicates that at least *14 coast live oaks and one western sycamore* were mechanically damaged by equipment ripping into the trunks (**Figure 2c**).

**Figure 2c. Photo of Coast Live Oak mechanical damage taken 29 May 2020.**

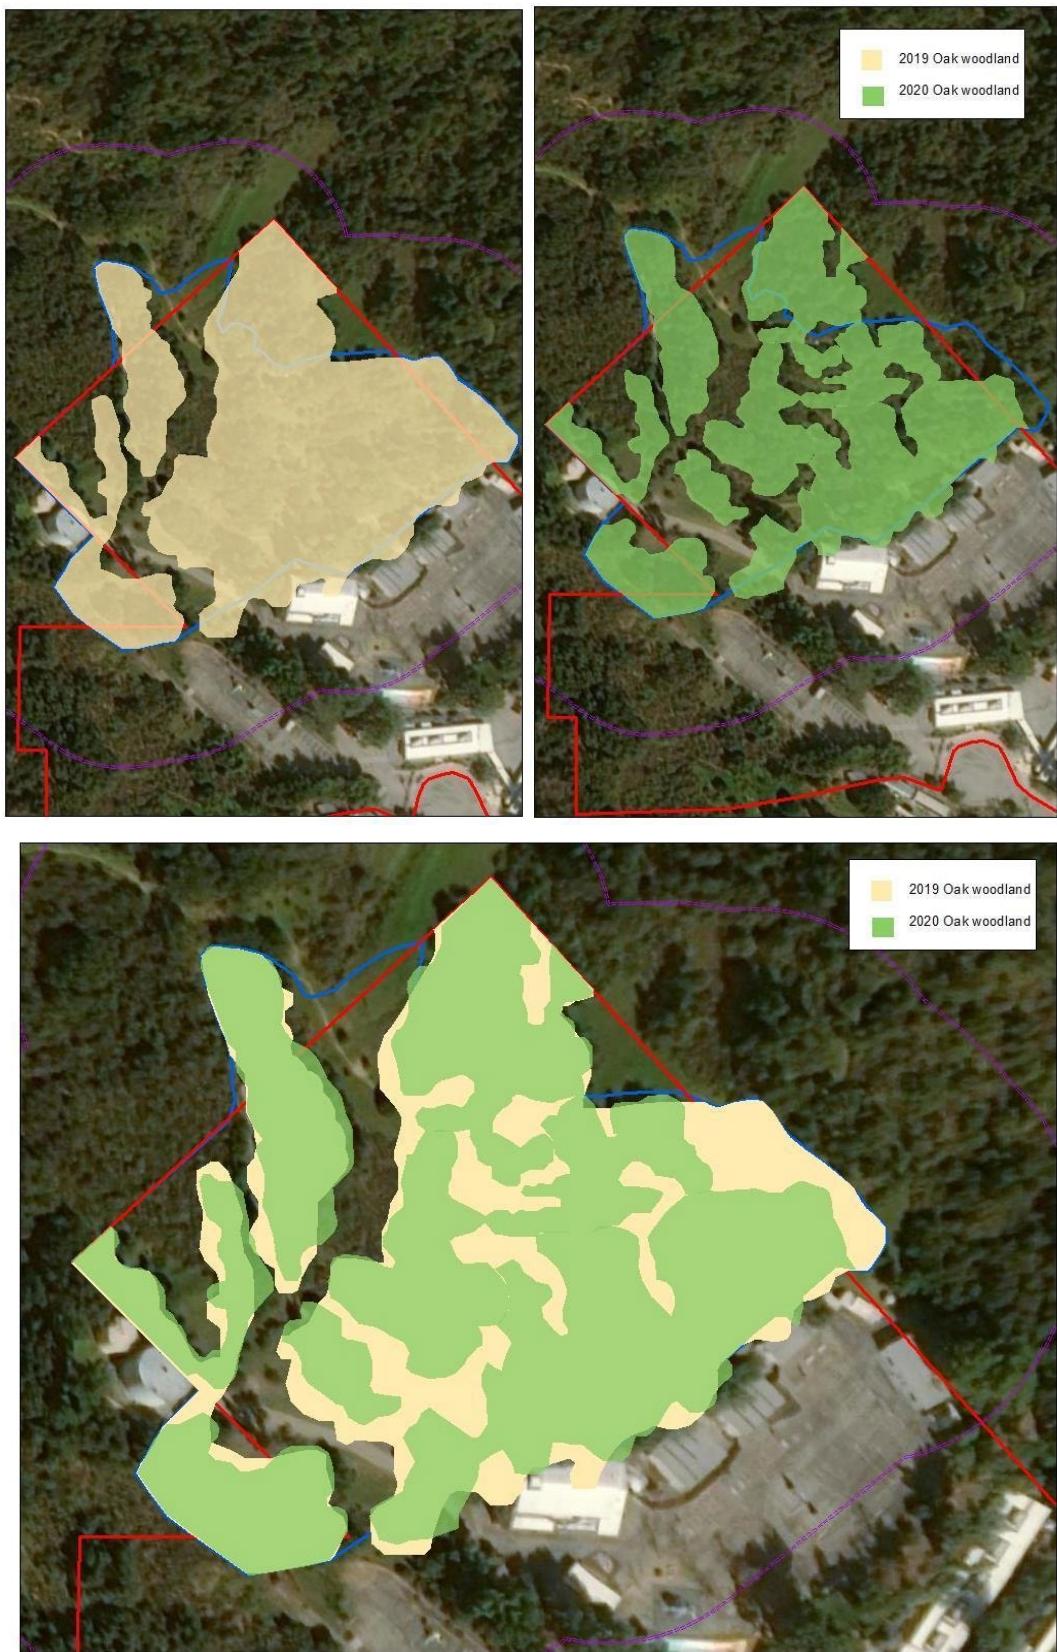
**Figure 6. Changes to oak woodland canopy cover, 2019 to 2020.**

**Based on our analysis of the canopy changes between 2019 and 2020, we calculated at least 0.7 acres of impact (including outright loss of trees, canopy loss, and encroachment) to the oak woodland occurred as a result of the 2020 violation.**

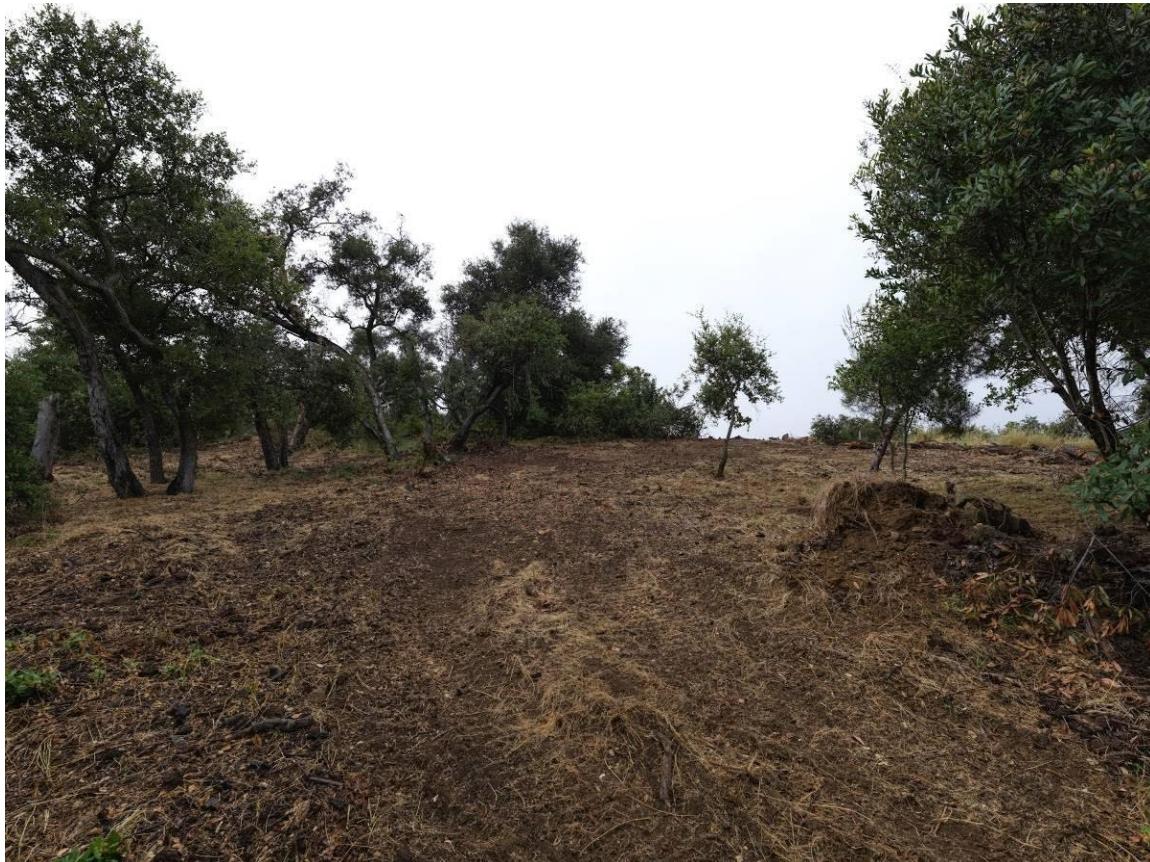
We observed a diverse range of tree size within the approximately 4.75-acre impact area (**Figure 9**); specifically, we found 37 mature living trees (21-36" DSH size range), 9 declining trees that were over 36", and 134 young trees (5-10" DSH). This site has been stewarded by the school students who have planted many seedlings over the years, which

**Figure 9. Photo taken on 18 May 2020 showing the demographic range of the trees on the site.**
