# Native Tree Report

# Saddle Peak Road

APN# 4438-039-001

**August 2022**  
Revised March 2023

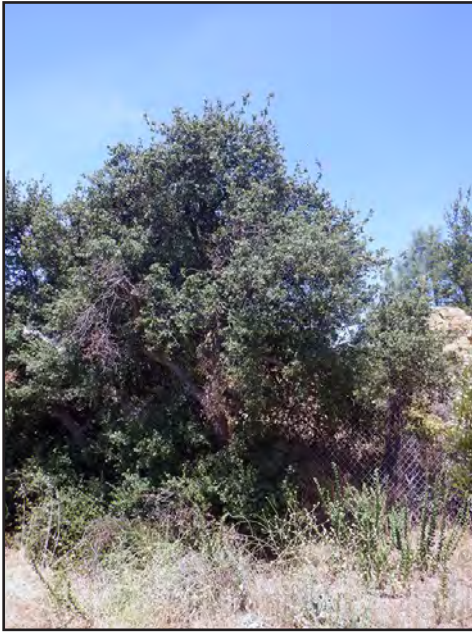
Tree #	Species	Trunk Diameter (inches)*	Heritage Tree	Health Rating	Notes
1	Scrub Oak	6.5, 8.3	No	B	Confirmed by digging to be a multi-stemmed tree rather than two separate trees. There is a chain link fence beneath tree canopy. “B” rating aesthetics and conformity (aesthetics and conformity ratings provided for oak trees).
2	Scrub Oak	6.3	No	A	Chain link fence beneath tree canopy. “B” rating aesthetics and conformity.
3	Scrub Oak	6.2, 2.8	No	B	Lower, smaller mainstem shaded and possibly dying, and appears to have been cut previously. Chain link fence beneath tree canopy. “B” rating aesthetics and conformity.
4	Scrub Oak	6.4	No	A	“B” rating aesthetics and conformity. There is a chain link fence within the Protected Zone.

Tree #	Species	Presumed Impact of Fill Placement	Impact of Proposed Restoration Activities
1	Scrub Oak ( <i>Quercus berberidifolia</i> )	No Impact. This protected tree is not located where the fill was placed.	Potential Impact. The canopy and Protected Zone of Tree #1 would be encroached upon to remove the chain link fencing. This would affect less than 10% of the Protected Zone. Except for weed removals and spreading native seed no habitat restoration activities would be conducted within the canopy or Protected Zone of this tree.
2	Scrub Oak ( <i>Quercus berberidifolia</i> )	No impact. This protected tree is not located where the fill was placed.	Potential Impact. The canopy and Protected Zone of Tree #2 would be encroached upon to remove the chain link fencing. This would affect less than 10% of the Protected Zone. Except for weed removals and spreading native seed no habitat restoration activities would be conducted within the canopy or Protected Zone of this tree.

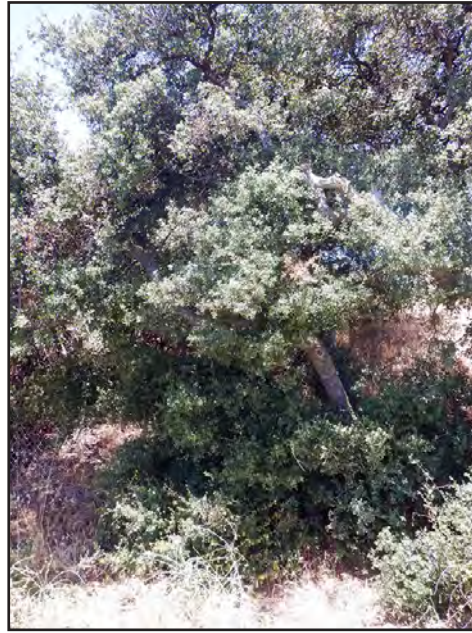
Tree #2

TREE NUMBER	# 2				
SPECIES		<i>Quercus agrifolia</i>		NOTES: Tree is part of small stand of scrub oaks. Numerous woodpecker holes. Exposure - full sun			
		<i>Quercus lobata</i>					
		<i>Quercus berberidifolia</i>	✓				
		Other					
FORM		TREE HEIGHT (~ FEET)	15				
		LEAN	S				
		TRUNK DIAMETER / CIRCUMFERENCE (INCHES)	6.3				
PHYSICAL CONDITION		TRUNK CAVITY	✓				
		TRUNK EXUDATION					
		TRUNK DAMAGE	✓				
		BURIED ROOT COLLAR					
		EXPOSED ROOTS					
		WEAK CROTCH					
		FUNGAL DISEASE					
		INSECT DAMAGE					
		FIRE DAMAGE (NEW/OLD)					
		BRANCH CAVITIES	✓				
		MAINSTEM DIEBACK					
		TWIG/BRANCH DIEBACK	✓				
		EPICORMIC GROWTH	✓				
		THIN FOLIAGE					
		DROUGHT STRESSED					
		UNBALANCED CROWN	✓				
		EXC. HORIZONTAL BRANCH.					
		VIGOR (GOOD/MOD/POOR)	MOD				
	TERRAIN (SLOPE/LEVEL)	SLOPE					
TREATMENT		REMOVE DEADWOOD					
		INSECT TREATMENT					
		DISEASE TREATMENT					
		SAFETY PRUNE					
RATING		HERITAGE

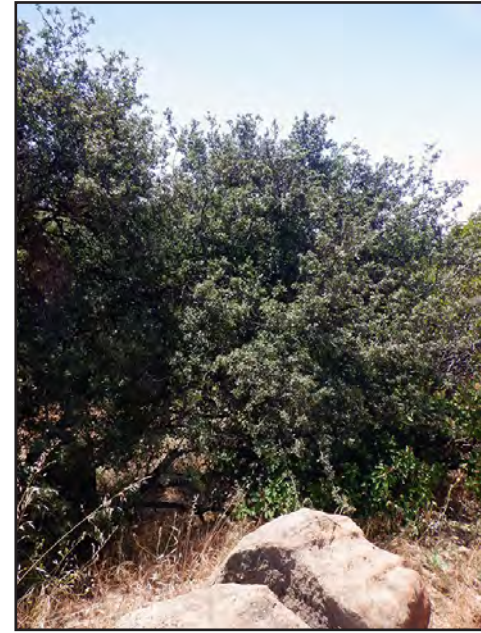
3	Scrub Oak ( <i>Quercus berberidifolia</i> )	No impact. This protected tree is not located where the fill was placed.	Potential Impact. The canopy and Protected Zone of Tree #3 would be encroached upon to remove the chain link fencing. This would affect less than 10% of the Protected Zone. Except for weed removals and spreading native seed no habitat restoration activities would be conducted within the canopy or Protected Zone of this tree.

TREE NUMBER	#3
SPECIES		<i>Quercus agrifolia</i>	
		<i>Quercus lobata</i>	
		<i>Quercus berberidifolia</i>	✓
		Other	
FORM	TREE HEIGHT (~ FEET)	18	
	LEAN	SW	
	TRUNK DIAMETER / CIRCUMFERENCE (INCHES)	6.2 2.8	
	multistem total:	9.0	
PHYSICAL CONDITION	TRUNK CAVITY		
	TRUNK EXUDATION		
	TRUNK DAMAGE	✓	
	BURIED ROOT COLLAR		
	EXPOSED ROOTS		
	WEAK CROTCH		
	FUNGAL DISEASE		
	INSECT DAMAGE	✓	
	FIRE DAMAGE (NEW/OLD)		
	BRANCH CAVITIES		
	MAINSTEM DIEBACK	✓	
	TWIG/BRANCH DIEBACK	✓	
	EPICORMIC GROWTH		
	THIN FOLIAGE		
	DROUGHT STRESSED		
	UNBALANCED CROWN		
EXC. HORIZONTAL BRANCH.			
VIGOR (GOOD/MOD/POOR)	MOD		
TERRAIN (SLOPE/LEVEL)	SLOPE		
TREATMENT	REMOVE DEADWOOD	✓	
	INSECT TREATMENT <i>Remove stem</i>	✓	
	DISEASE TREATMENT		
	SAFETY PRUNE		
RATING	HERITAGE		
	HEALTH	B	
	AESTHETICS & CONFORMITY	B	
<p>NOTES: Lower, small mainstem is heavily shaded and dying, and appears to have been cut. Woodpecker activity - numerous holes in dying stem from exposure - full sun. Tree is part of small stand of scrub oaks. Wood boring insects.</p>

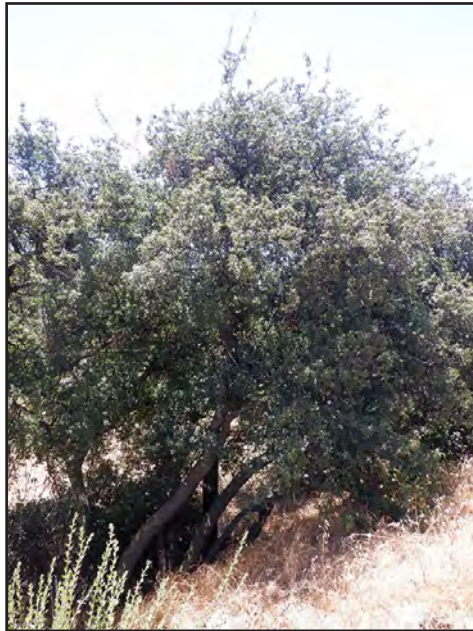
Tree #	Species	Presumed Impact of Fill Placement	Impact of Proposed Restoration Activities
4	Scrub Oak ( <i>Quercus berberidifolia</i> )	No impact. This protected tree is not located where the fill was placed.	Potential Impact. The Protected Zone of Tree #4 would be encroached upon to remove the chain link fencing. This would affect less than 10% of the Protected Zone. Except for weed removals and spreading native seed no habitat restoration activities would be conducted within the canopy or Protected Zone of this tree.
5	Laurel Sumac ( <i>Malosma laurina</i> )	Potential Impact. The canopy and Protected Zone of Tree #5 was encroached upon by the placement of fill at the slope near the south entrance to the property. The fill placement impacted 23% of the Protected Zone of this tree. The tree does not appear to have been adversely impacted by the fill.	Potential Impact. The canopy and Protected Zone of Tree #5 would be encroached upon to remove the fill from the slope near the south entrance to the property. This would affect 23% of the Protected Zone. Except for weed removals and spreading native seed no other habitat restoration activities would be conducted within the canopy or Protected Zone of this tree.

TREE NUMBER	#4				
SPECIES	Quercus agrifolia					
	Quercus lobata					
	Quercus berberidifolia	✓				
	Other					
FORM	TREE HEIGHT (~ FEET)	17				
	LEAN	SW				
	TRUNK DIAMETER / CIRCUMFERENCE (INCHES)	6.4				
PHYSICAL CONDITION	TRUNK CAVITY					
	TRUNK EXUDATION					
	TRUNK DAMAGE					
	BURIED ROOT COLLAR					
	EXPOSED ROOTS					
	WEAK CROTCH					
	FUNGAL DISEASE					
	INSECT DAMAGE					
	FIRE DAMAGE (NEW/OLD)					
	BRANCH CAVITIES					
	MAINSTEM DIEBACK					
	TWIG/BRANCH DIEBACK	✓				
	EPICORMIC GROWTH					
	THIN FOLIAGE					
	DROUGHT STRESSED					
	UNBALANCED CROWN					
	EXC. HORIZONTAL BRANCH.					
	TREATMENT	REMOVE DEADWOOD				
INSECT TREATMENT						
DISEASE TREATMENT						
SAFETY PRUNE						
RATING	HERITAGE					
	HEALTH	A				
	AESTHETICS & CONFORMITY	B

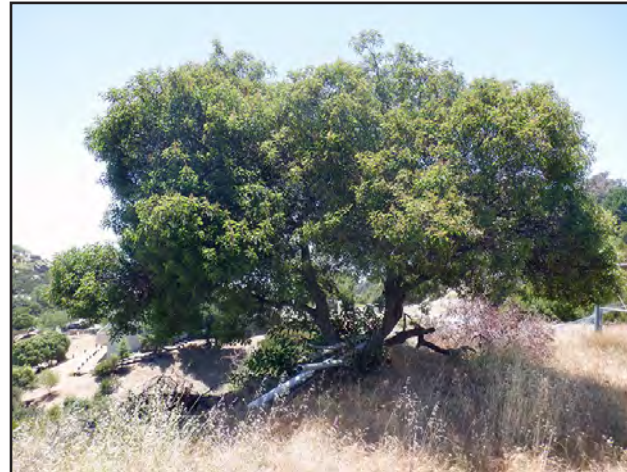
Tree #	Species	Trunk Diameter (inches)*	Heritage Tree	Health Rating	Notes
5	Laurel Sumac	7.9, 6.3	No	B	Significant sap exudation along main stems but canopy in good condition. Some of the lower branches have been removed, although not recently. There is some debris piled near the base of the tree.
6	Scrub Oak	6.2	No	B	“B” rating aesthetics and conformity. There is another scrub oak trunk close to this tree, but since the diameter at breast height of this trunk is 4.9” it is not a LA County oak woodland.
7	Scrub Oak	4.1, 4.1	No	A	“A” rating aesthetics and conformity.
8	Laurel Sumac	5.0, 3.6	No	C	Significant dieback of branches and twigs.
9	Toyon	5.5, 4.8	No	A	Relatively wide canopy extent and in excellent condition. Chain link fence outside canopy but within Protected Zone.

No protected trees have been removed or will be removed by the project. Tree #5 was encroached upon by placement of fill, which was deposited within 23% of its Protected Zone. Tree #5 is located at the northern margin of the entrance slope. Tree #5 would also be encroached to remove the fill from its Protected Zone, which would be accomplished using hand tools. No protected trees other than Tree #5 were encroached by the placement of fill dirt, and no other protected trees would be encroached during removal of fill. Removal of the debris within the understory of Tree #5 can be accomplished by hand and would not impact this tree.

The placement of fill as well as the removal of the fill would encroach upon 23% of the Protected Zone of Tree #5, a laurel sumac. The removal of fill within the Protected Zone of Tree #5 shall be conducted using

hand tools. The LIP requires a 5:1 mitigation ratio for encroachments impacting 10% to 30% of the Protected Zone. To compensate for the encroachment into 23% of the Protected Zone of Tree #5, five (5) laurel sumac shrubs shall be provided onsite in accordance with the planting, monitoring, and reporting requirements specified in subsection K of Section 22.44.1920 of the LIP. **Table 3, Tree Mitigation** identifies the mitigation offset for the tree that would be impacted.

Tree #	Species	Trunk Diameter (inches)	Mitigation Offsets
5	Laurel Sumac	7.9, 6.3	5:1

The five (5) laurel sumac trees required to compensate for the encroachment impact to Tree #5 will be incorporated into the restoration plan prepared for the project, which shall include a native tree replacement planting program. The native tree replacement planting program shall specify replacement tree locations, tree or seedling size, planting specifications, and a monitoring program to ensure that the replacement planting program is successful, including performance standards and procedures for periodic monitoring and implementation of corrective measures in the event that the health of replacement trees declines.

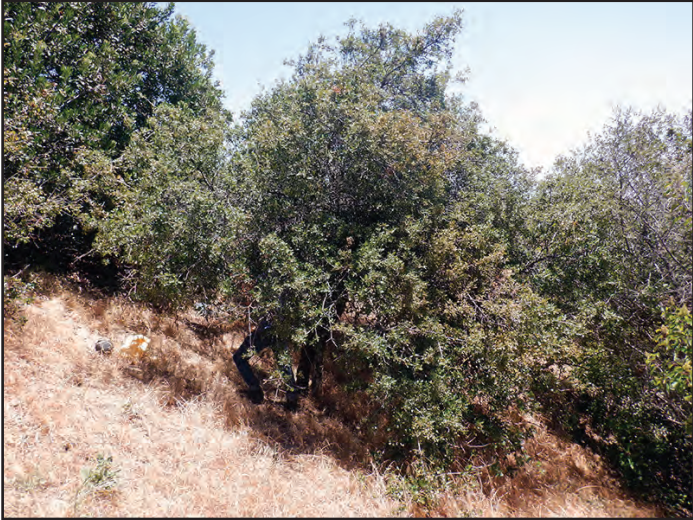
Tree #6

6	Scrub Oak ( <i>Quercus berberidifolia</i> )	No impact. This protected tree is not located where the fill was placed.	No Impact. This protected native tree would not be impacted. Except for weed removals and spreading native seed no habitat restoration activities would be conducted within the canopy or Protected Zone of this tree.
7	Scrub Oak ( <i>Quercus berberidifolia</i> )	No impact. This protected tree is not located where the fill was placed.	No Impact. This protected native tree would not be impacted. Except for weed removals and spreading native seed no habitat restoration activities would be conducted within the canopy or Protected Zone of this tree.
8	Laurel Sumac ( <i>Malosma laurina</i> )	No impact. This protected tree is not located where the fill was placed.	No Impact. This protected native tree would not be impacted. Except for weed removals and spreading native seed no habitat restoration activities would be conducted within the canopy or Protected Zone of this tree.

TREE NUMBER		#6
SPECIES	Quercus agrifolia	
	Quercus lobata	
	Quercus berberidifolia	✓
	Other	
FORM	TREE HEIGHT (~ FEET)	13
	LEAN	F
	TRUNK DIAMETER / CIRCUMFERENCE (INCHES)	6.2
PHYSICAL CONDITION	TRUNK CAVITY	
	TRUNK EXUDATION	
	TRUNK DAMAGE	
	BURIED ROOT COLLAR	
	EXPOSED ROOTS	
	WEAK CROTCH	
	FUNGAL DISEASE	
	INSECT DAMAGE	
	FIRE DAMAGE (NEW/OLD)	
	BRANCH CAVITIES	
	MAINSTEM DIEBACK	
	TWIG/BRANCH DIEBACK	✓
	EPICORMIC GROWTH	✓
	THIN FOLIAGE	
	DROUGHT STRESSED	
	UNBALANCED CROWN	
	EXC. HORIZONTAL BRANCH.	
	VIGOR (GOOD/MOD/POOR)	MOD
TERRAIN (SLOPE/LEVEL)	SLOPE	
TREATMENT	REMOVE DEADWOOD	
	INSECT TREATMENT	
	DISEASE TREATMENT	
	SAFETY PRUNE	
RATING	HERITAGE	
	HEALTH	B
	AESTHETICS & CONFORMITY	B
NOTES: Another stem close to this tree treated as separate tree <del>but</del> and dbh of next tree is 6.9" so not a scrub oak woodland, exposure: full sun		
NOTES:		
NOTES:

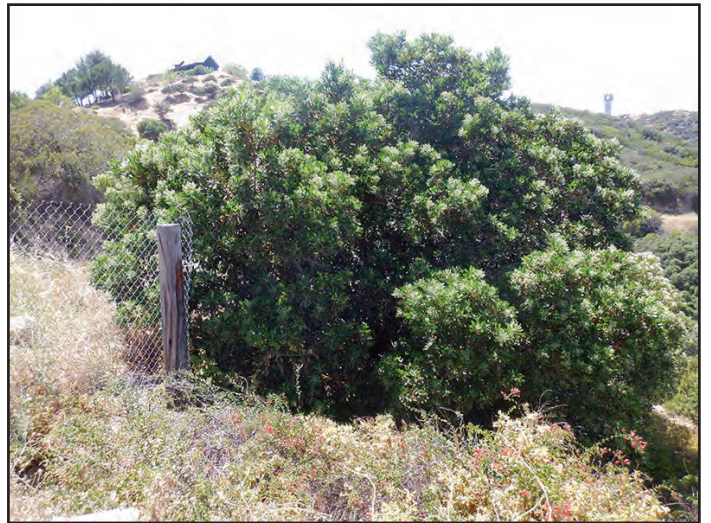
9	Toyon ( <i>Heteromeles arbutifolia</i> )	No impact. This protected tree is not located where the fill was placed.	Potential Impact. The Protected Zone of Tree #9 would be encroached upon to remove the chain link fencing. This would affect less than 10% of the Protected Zone. Except for weed removals and spreading native seed no habitat restoration activities would be conducted within the canopy or Protected Zone of this tree.
