# Oak Tree Survey Report

## Hope Gardens Sequoia Building Project

**September 2020 (Updated December 2022)**

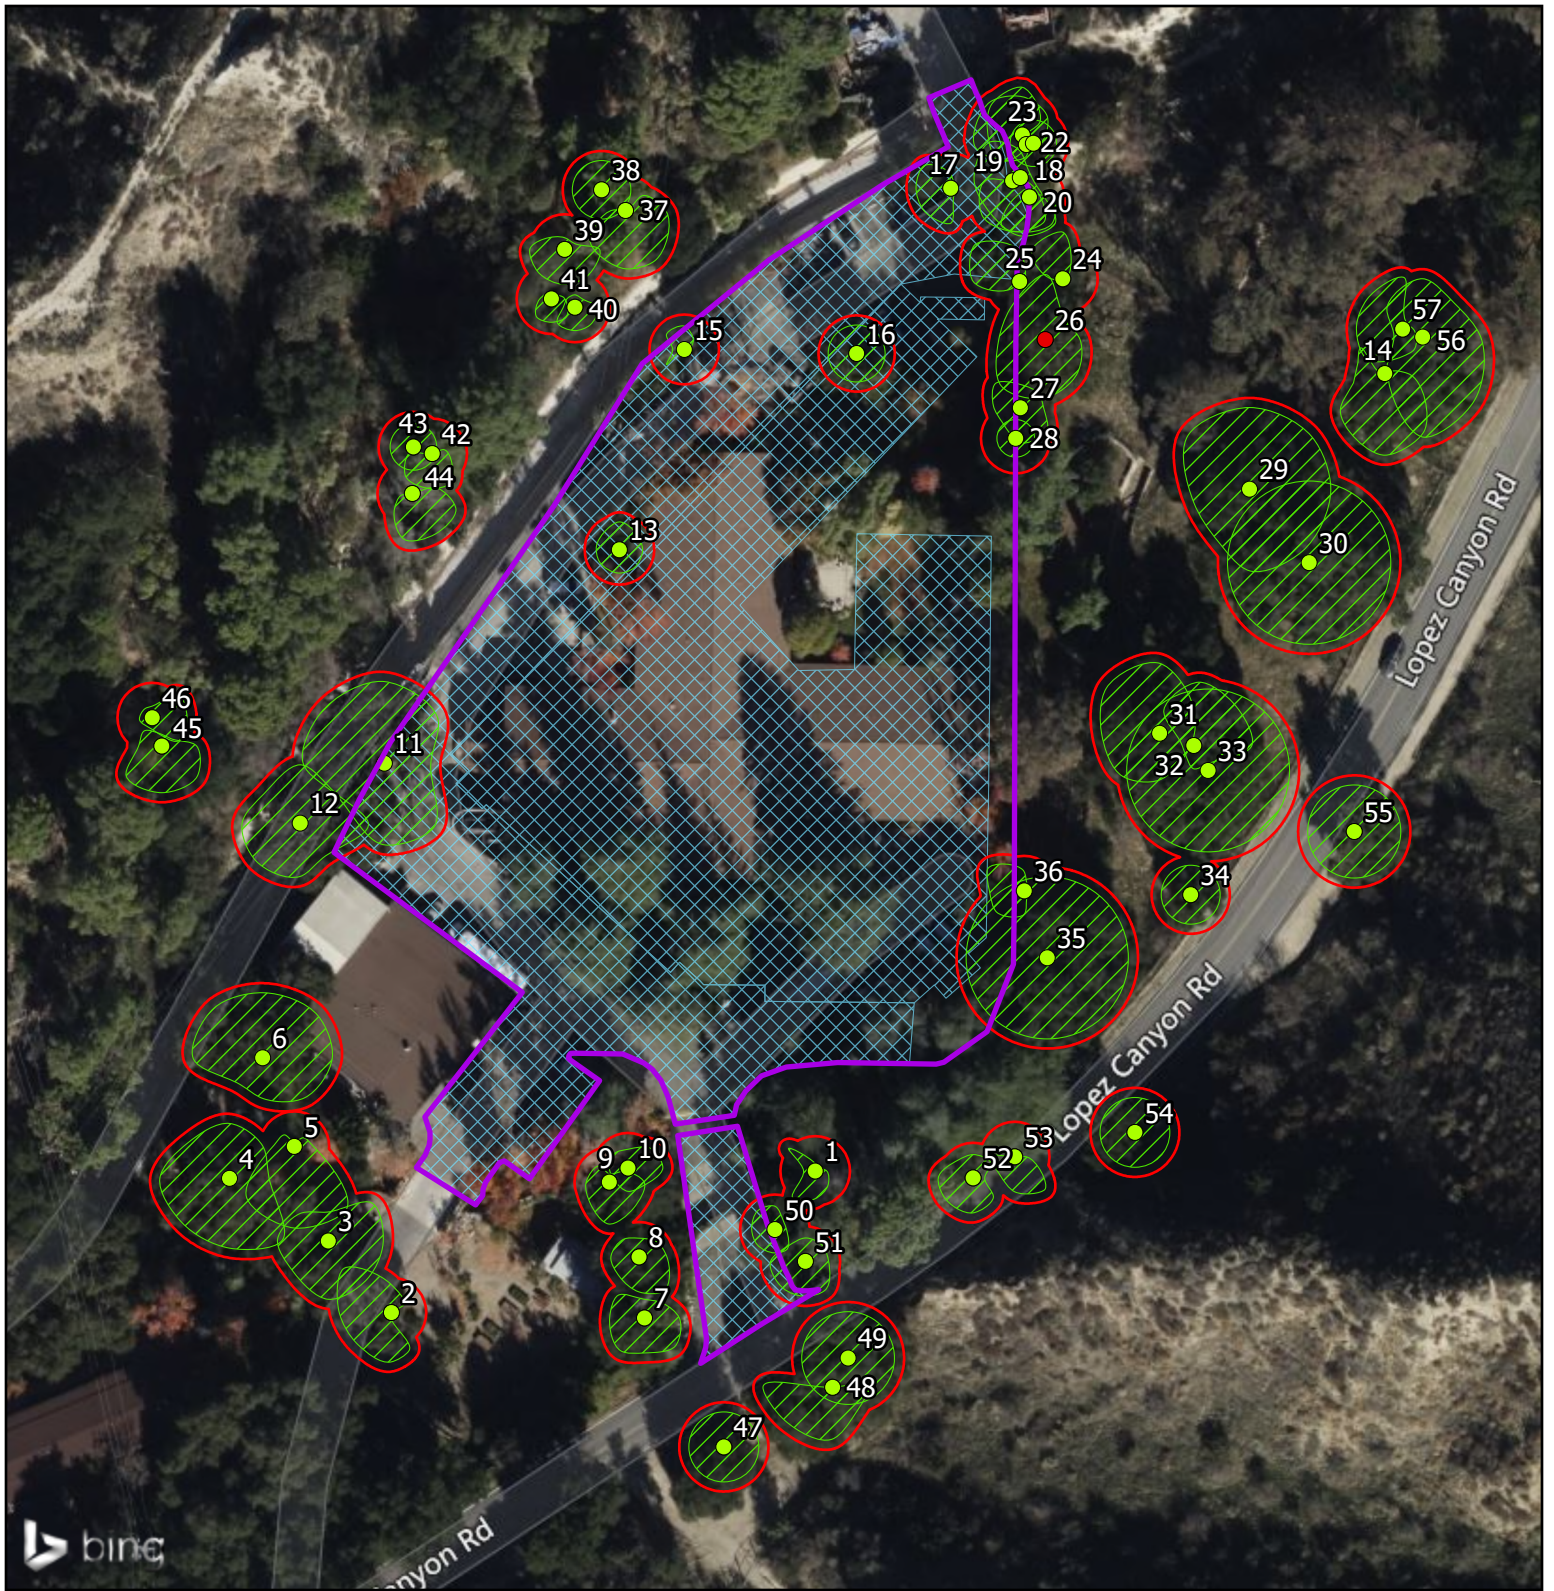
Figure 3. Oak Tree Survey

The proposed redevelopment of the Sequoia building would result in the removal of 4 protected oak trees, and encroachment into the TPZ of 12 oaks. No heritage trees will be removed or encroached. The tree removals are necessary for the upgrades to roads and buildings proposed by the project. These results are summarized below in Table 1 below and shown in Figure 3.

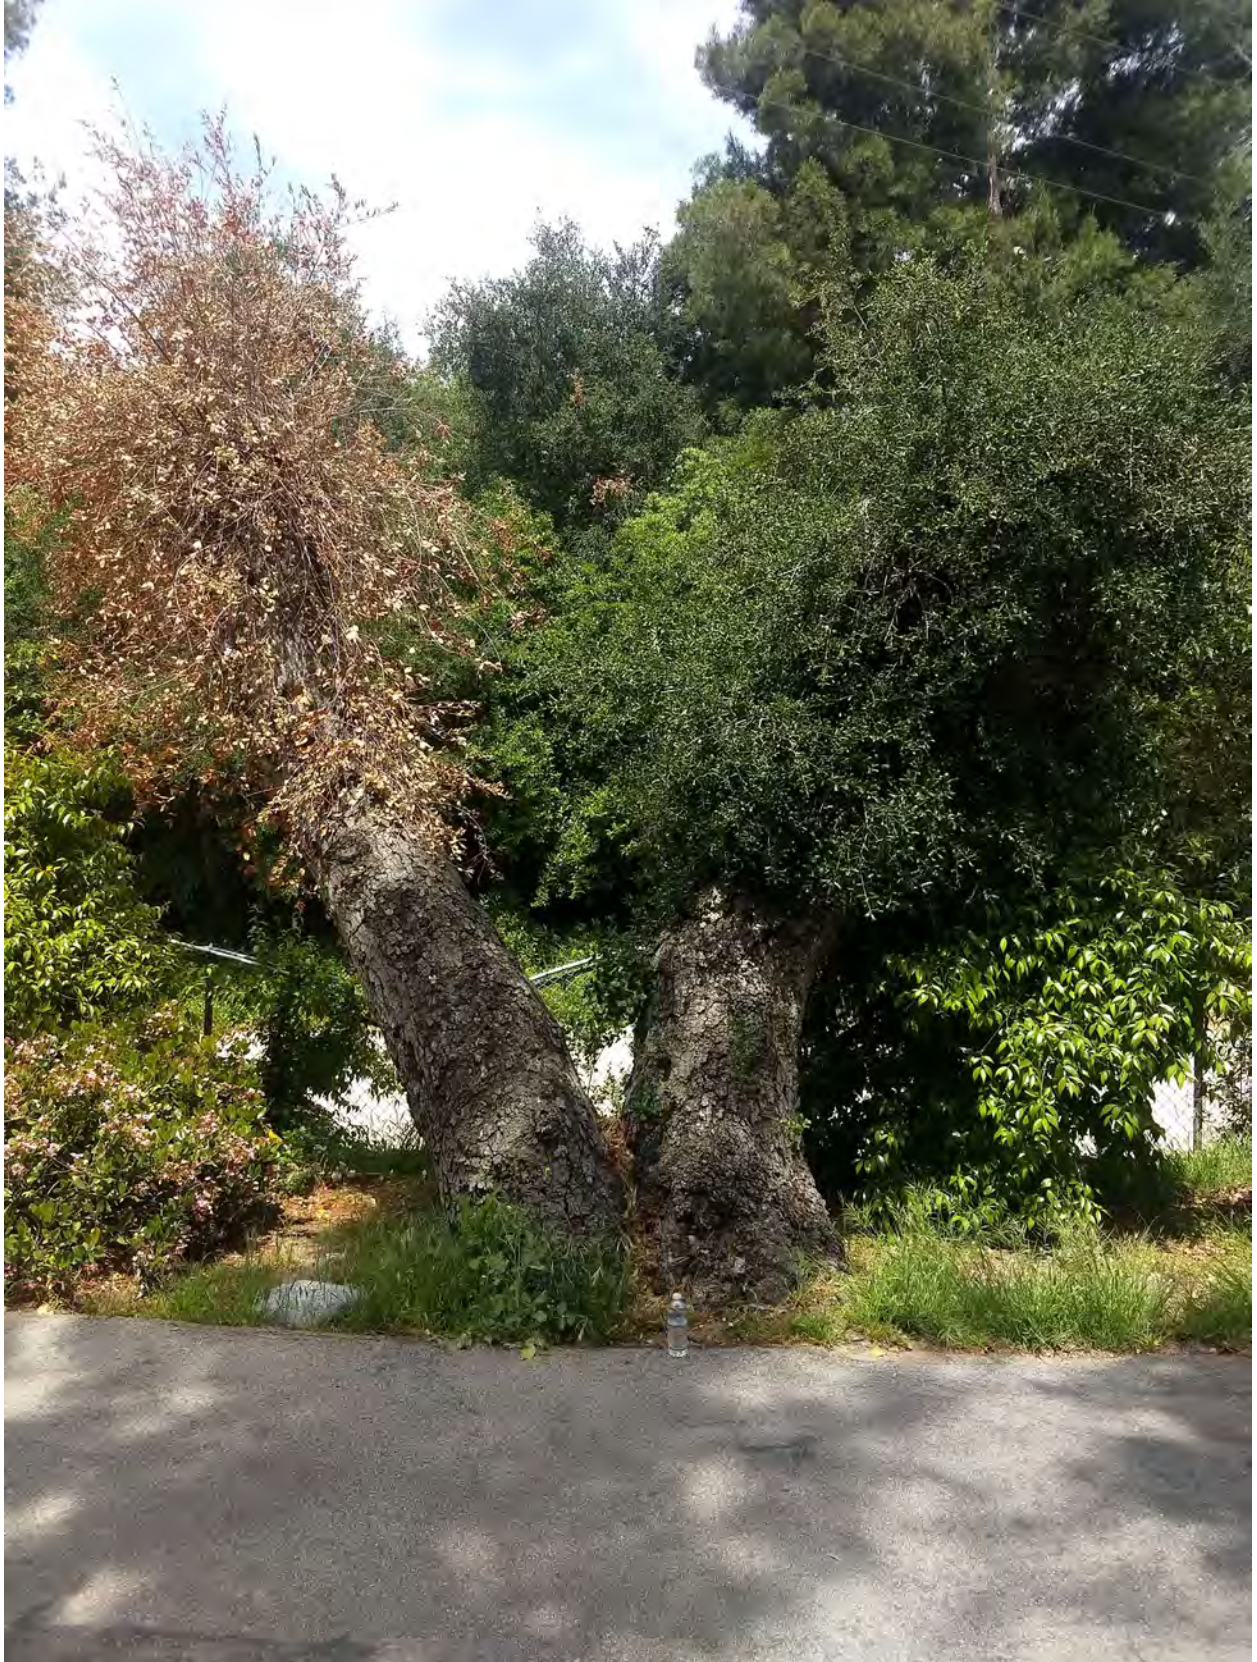
# Oak #15

Oak #15 is recommended for removal due to the poor health from being topped and the trees position beneath utility lines. Oak #26 on National Forest Land is not likely to survive, and the hollow trunk indicates that it is likely to lose more large limbs soon. Fencing exists to keep people from going near the tree from the Hope Gardens facility. To maintain the current low risk situation, South Environmental recommends the barrier remain in place.

Of the 4 oaks that will be removed, 3 of them (#11, #13, and #16) are in good health (4, or 5 health rating). Oak #15 is dead/dying (health rating of 1) and we recommend it be removed to avoid any future conflicts. Heritage Oak #26 will not be impacted by the project because it is off the project site and not in jeopardy from project activities.

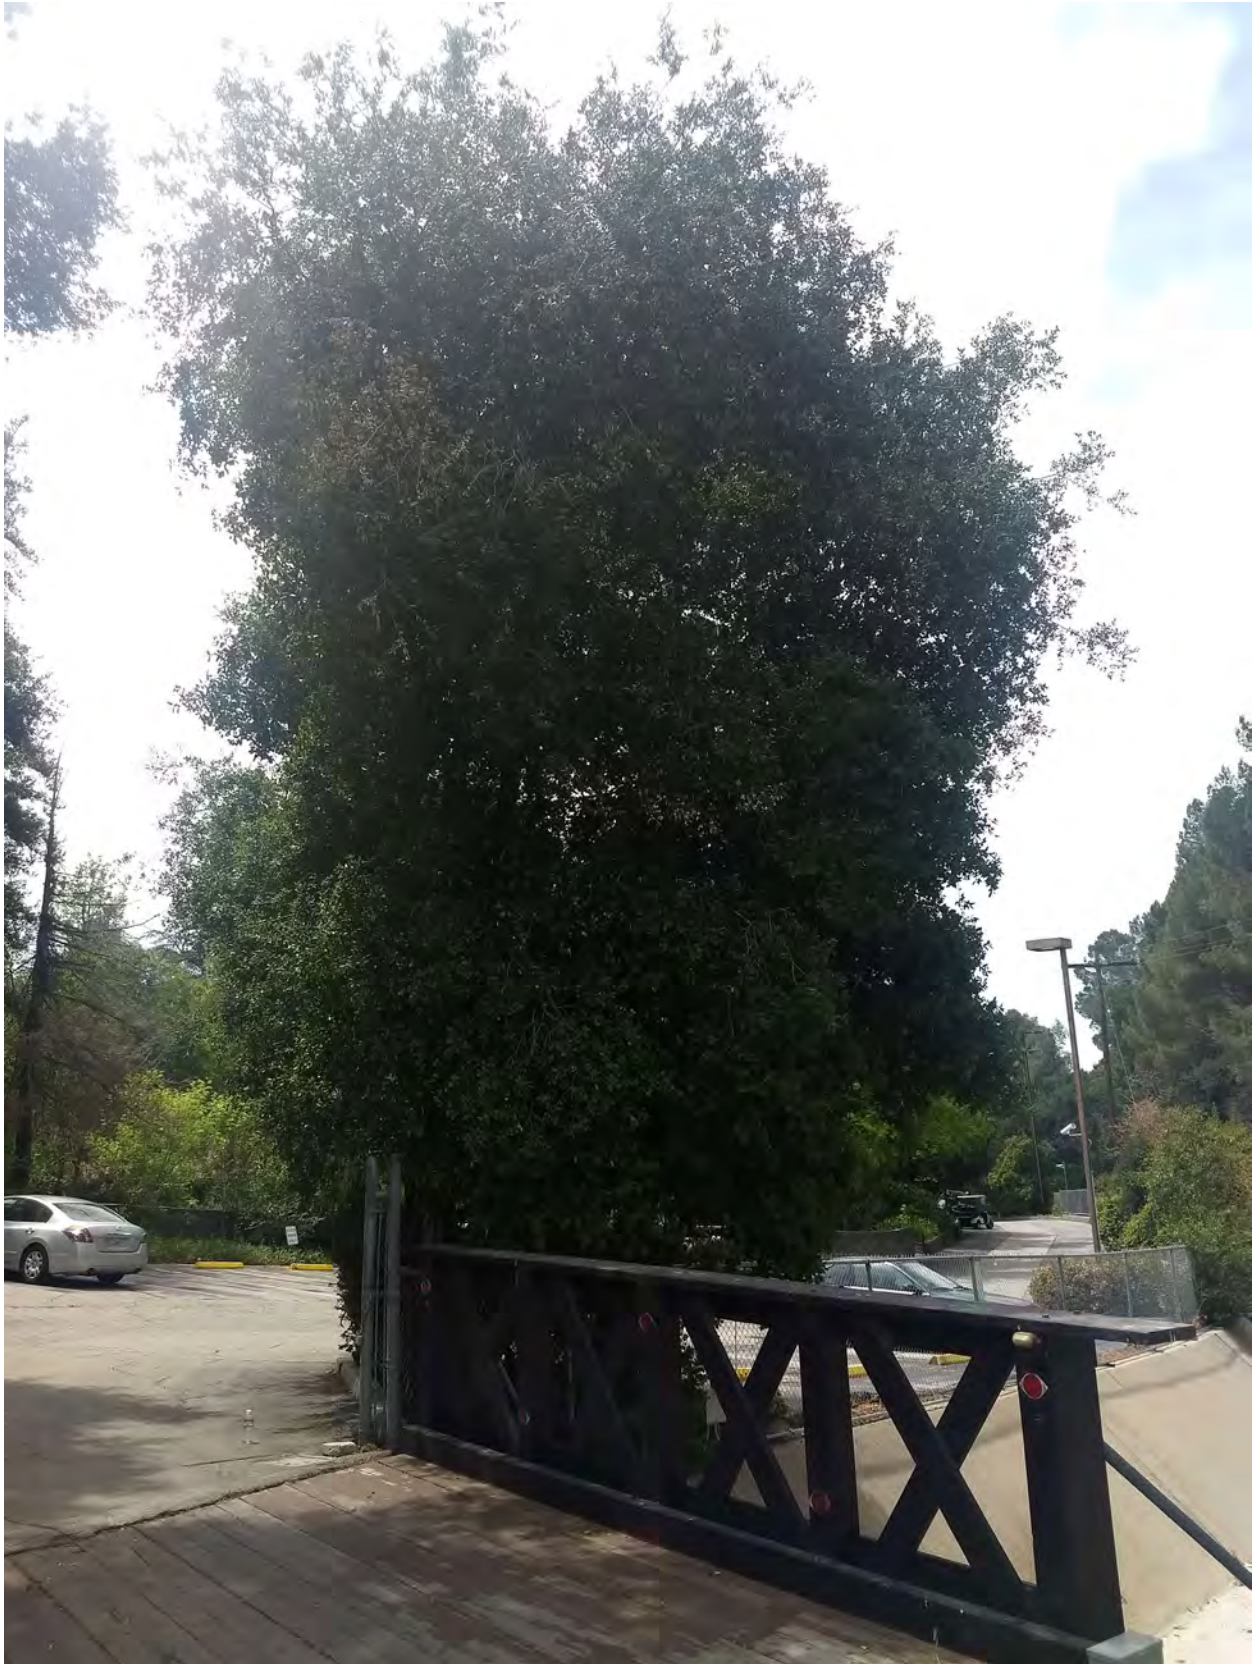
# Oak #17

- The trunk of Oak #17 is within 3-feet of proposed road improvement and the root zone has the potential to be significantly impacted. In addition, the proposed impacts would encroach approximately 98% of the trees TPZ. These impacts are from removal of existing asphalt and then resurfacing the same area. These impacts have the potential to result in death or significant decline of the tree.

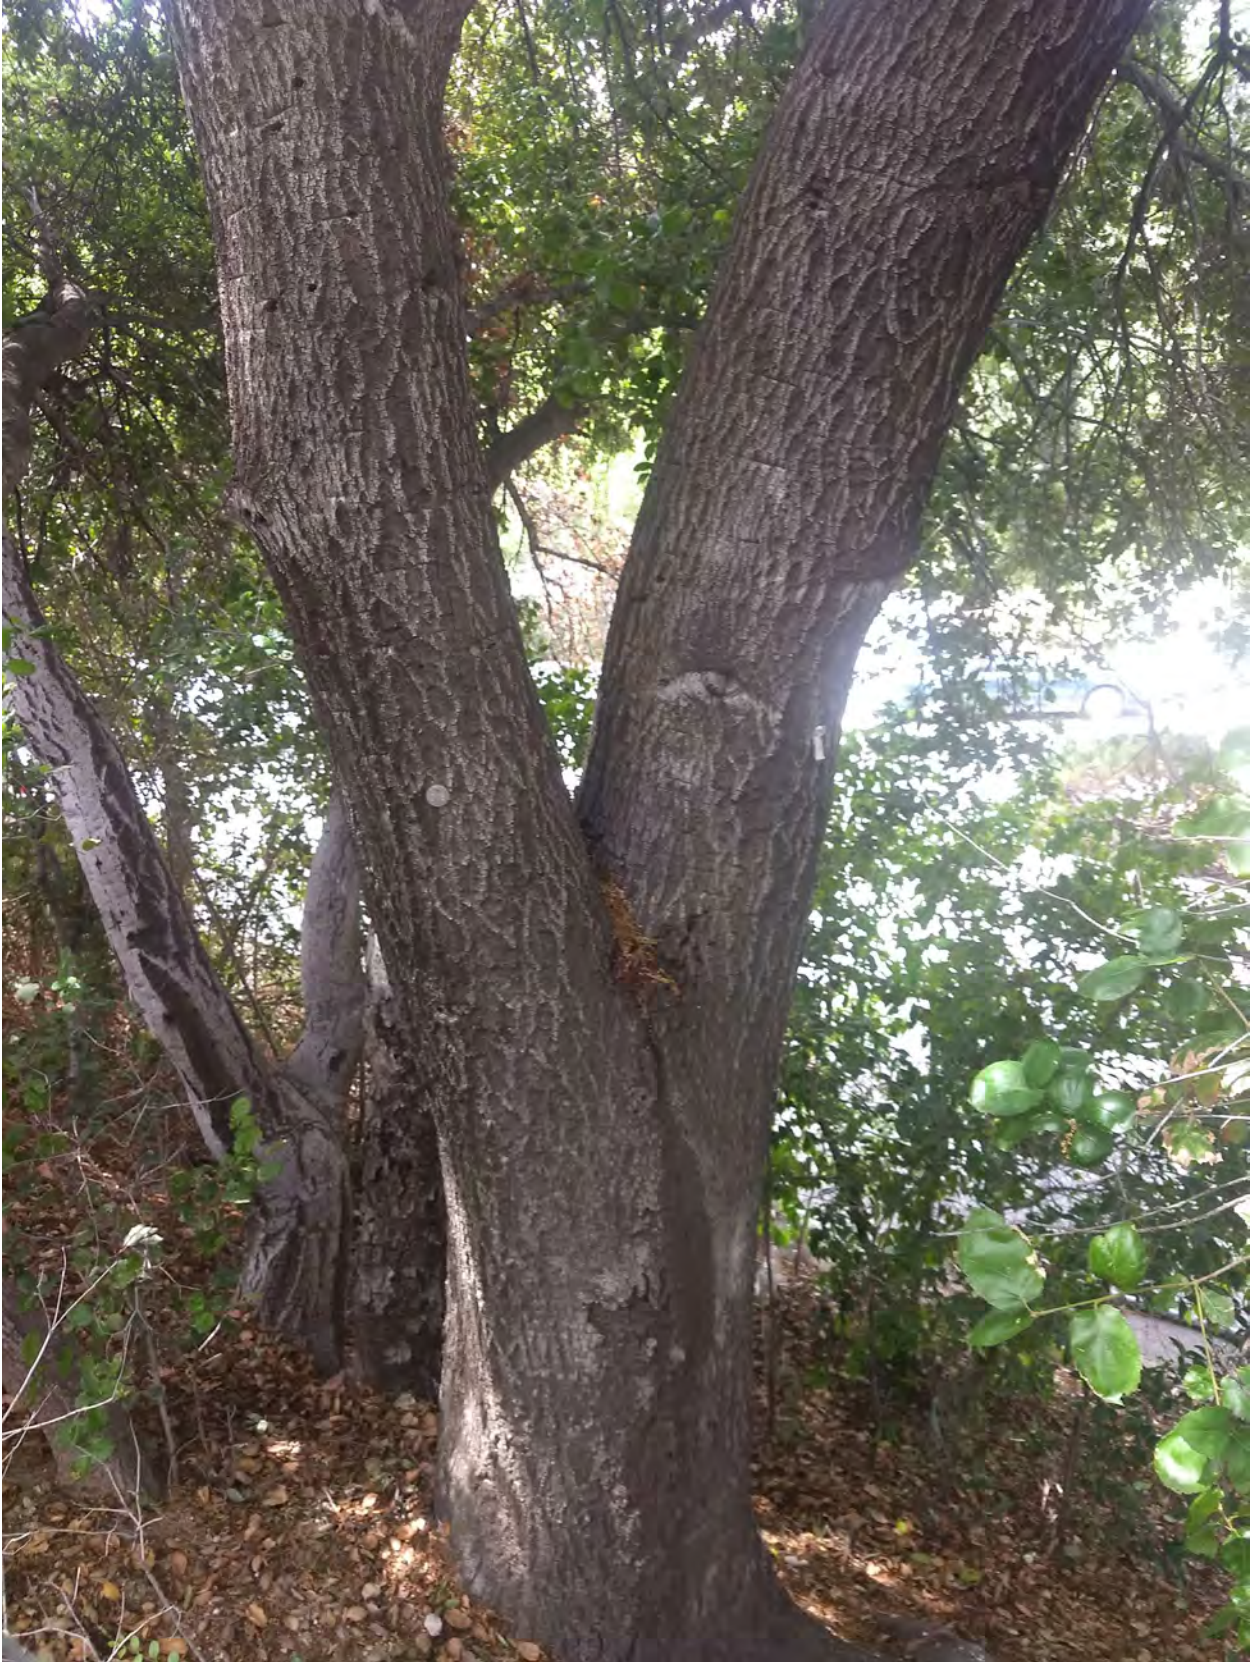
# Oak #18

- The trunk of Oak #18 is within 6-feet of proposed road improvements and the root zone has the potential to be significantly impacted. In addition, the proposed impacts would encroach approximately 50% of the trees TPZ. These impacts are from removal of existing asphalt and then resurfacing the same area. These impacts have the potential to result in death or significant decline of the tree.

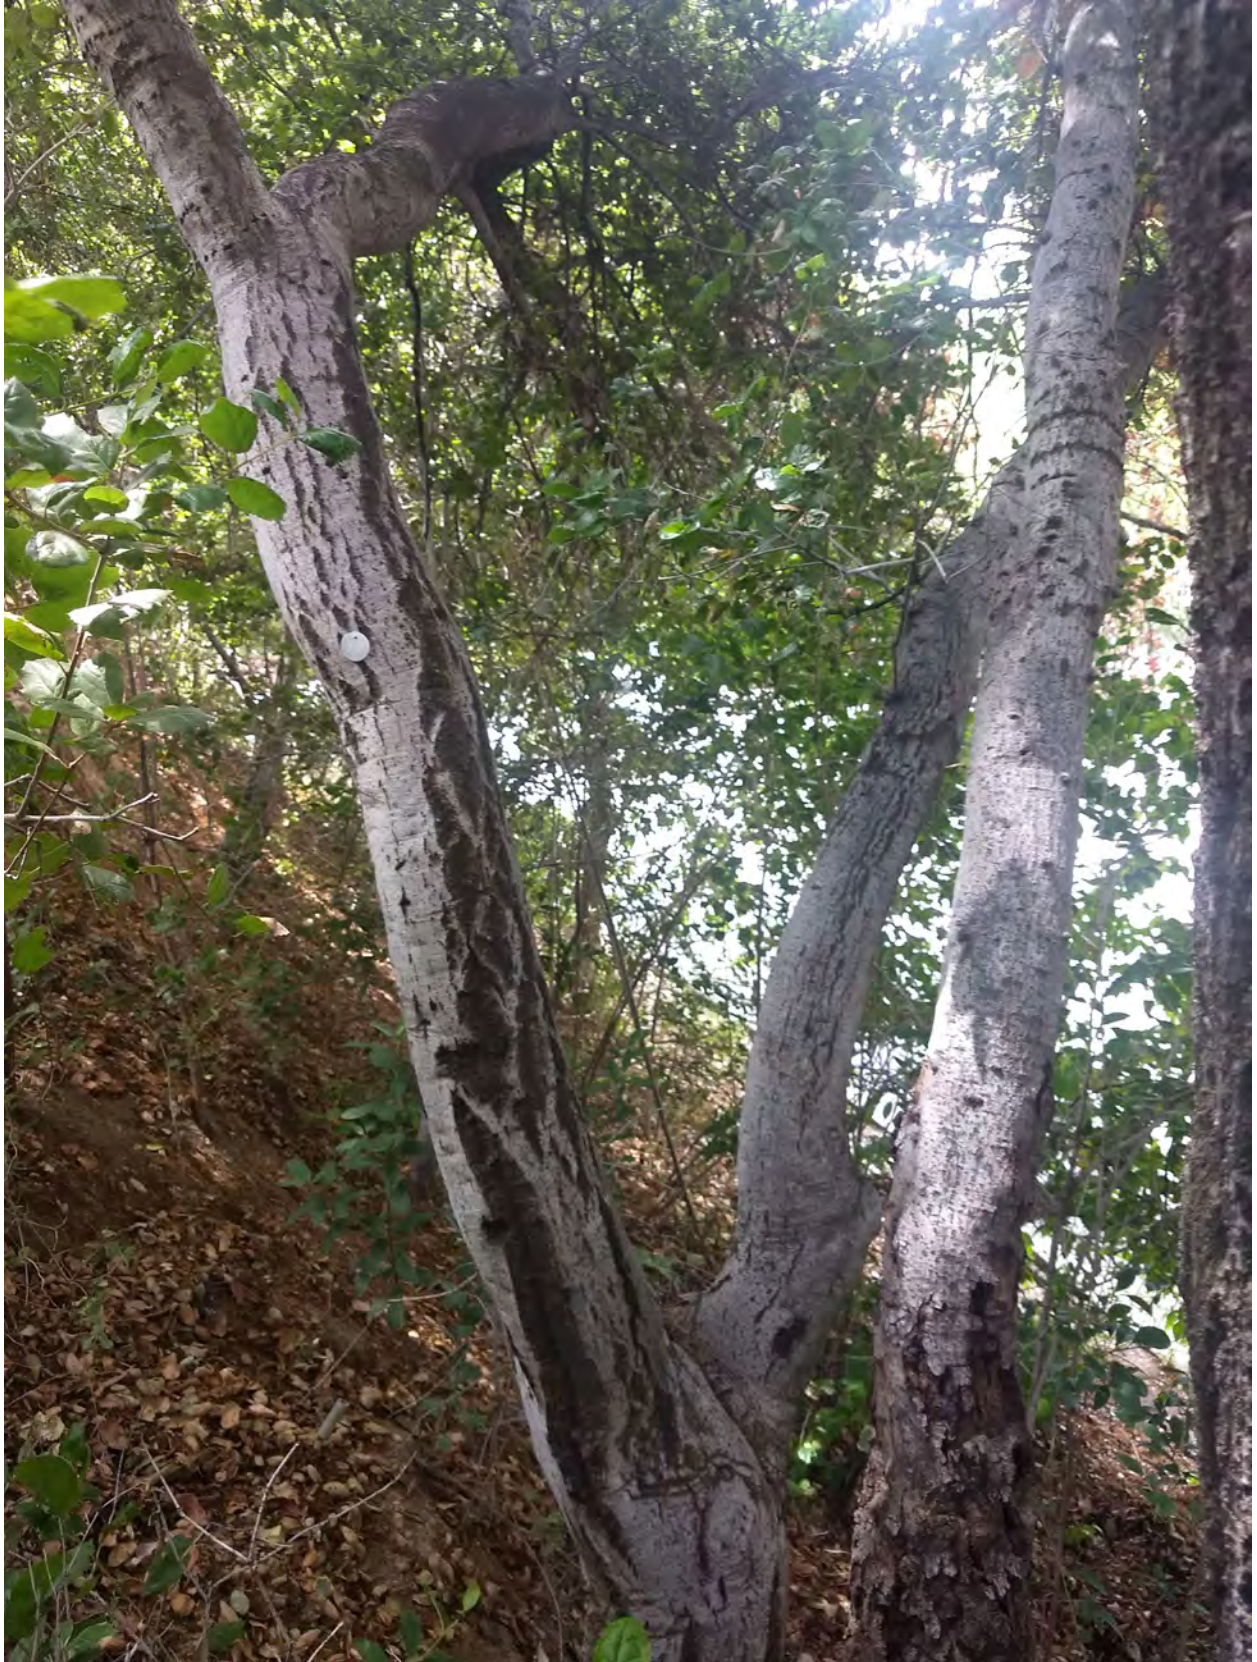
- The trunk of Oak #19 is within 2-feet of proposed road improvements and the root zone has the potential to be significantly impacted. In addition, the proposed impacts would encroach approximately 60% of the trees TPZ. These impacts have the potential to result in death or significant decline of the tree.

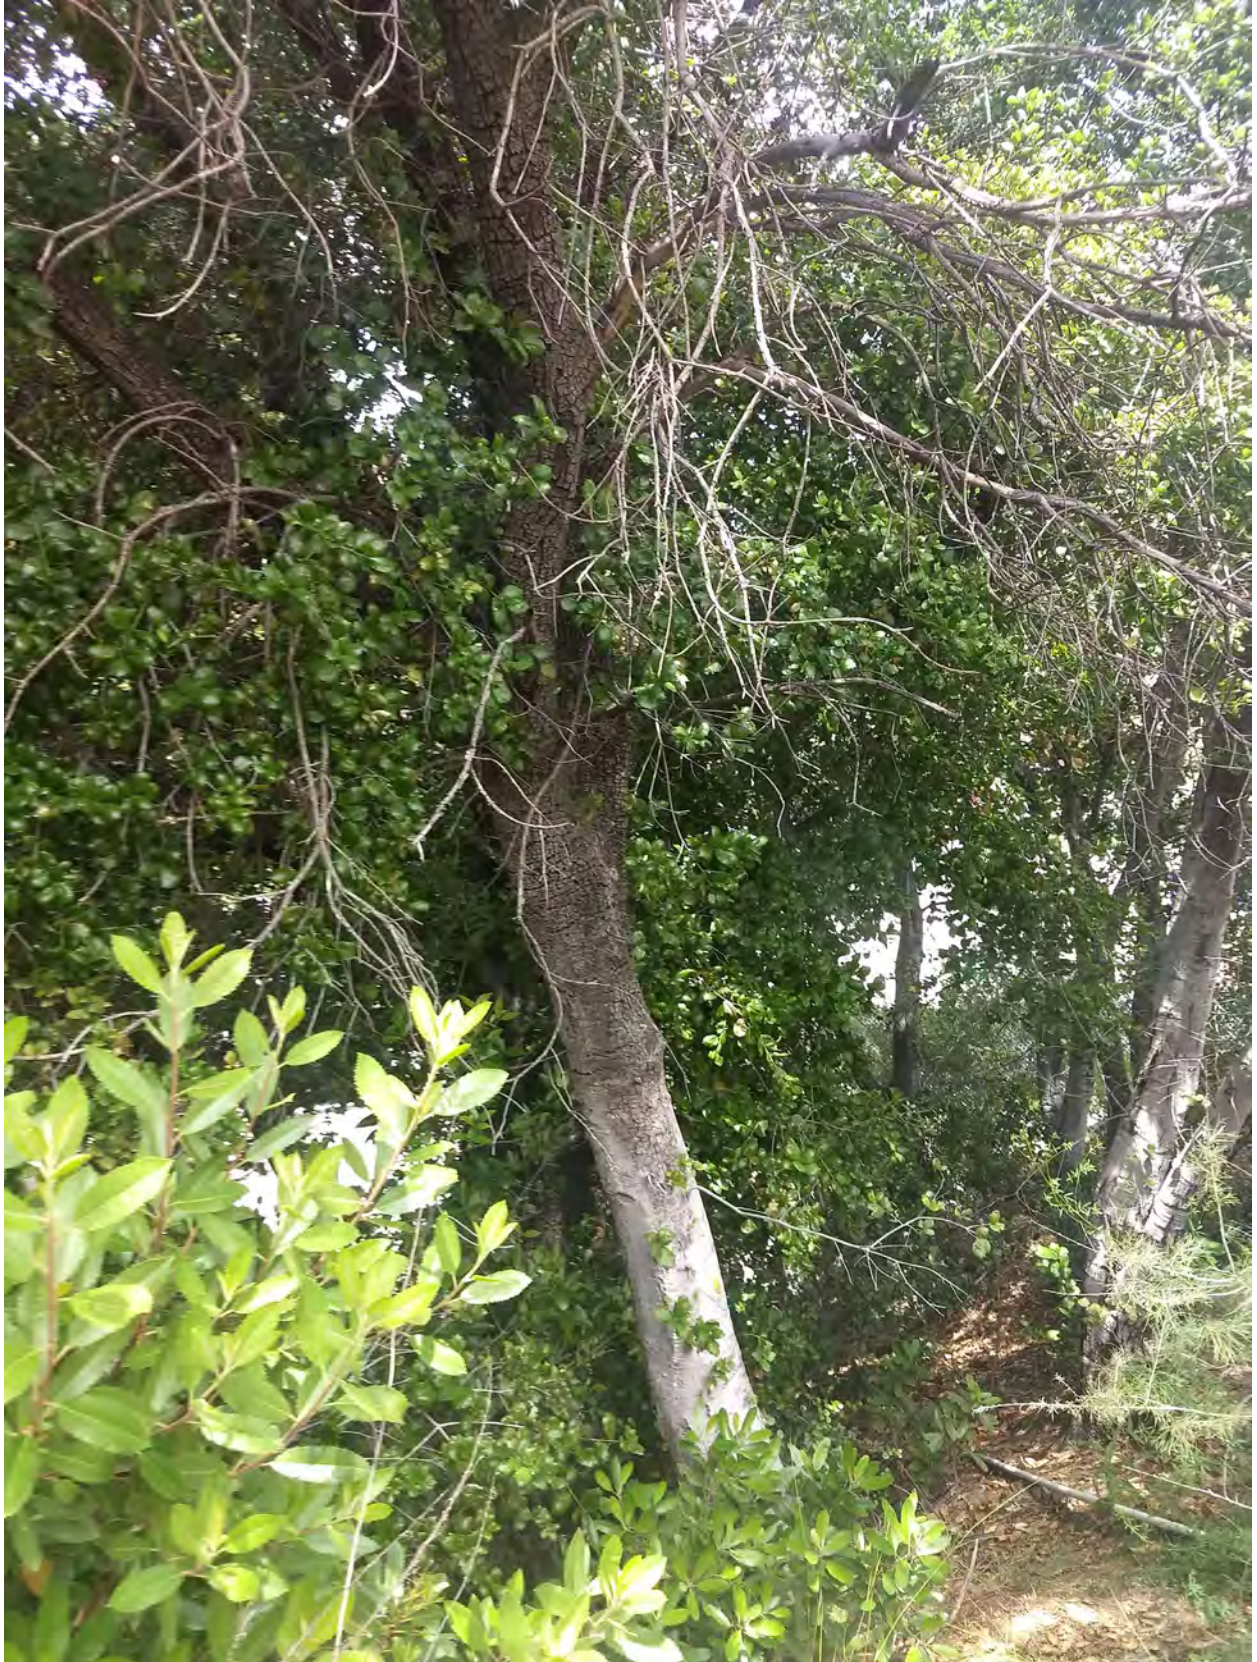
- The trunk of Oak #20 is within 5-feet of proposed road improvements and the root zone has the potential to be significantly impacted. In addition, the proposed impacts would encroach approximately 40% of the trees TPZ. These impacts have the potential to result in death or significant decline of the tree.

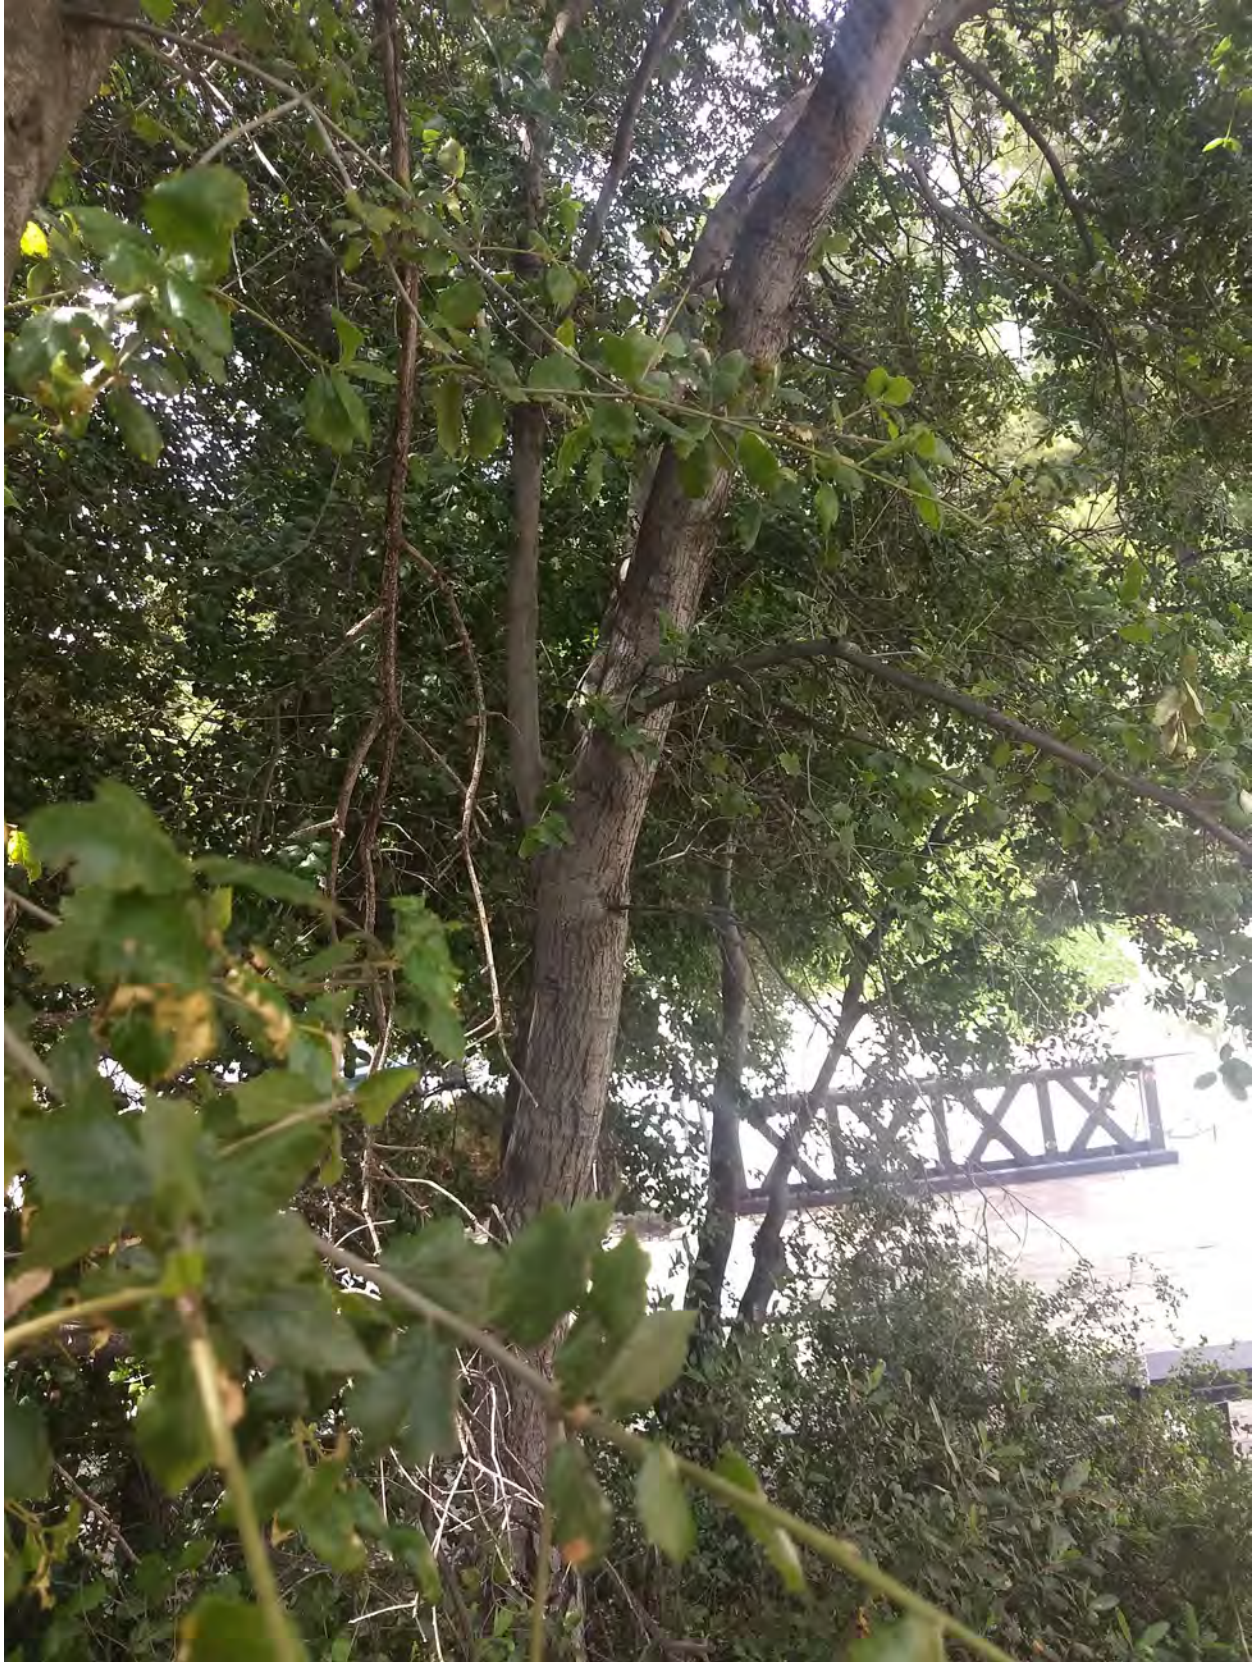
- The trunk of Oak #22 is within 13-feet of proposed road improvements and the root zone has the potential to be significantly impacted. In addition, the proposed impacts would encroach approximately 20% of the trees TPZ. These impacts have the potential to result in death or significant decline of the tree.

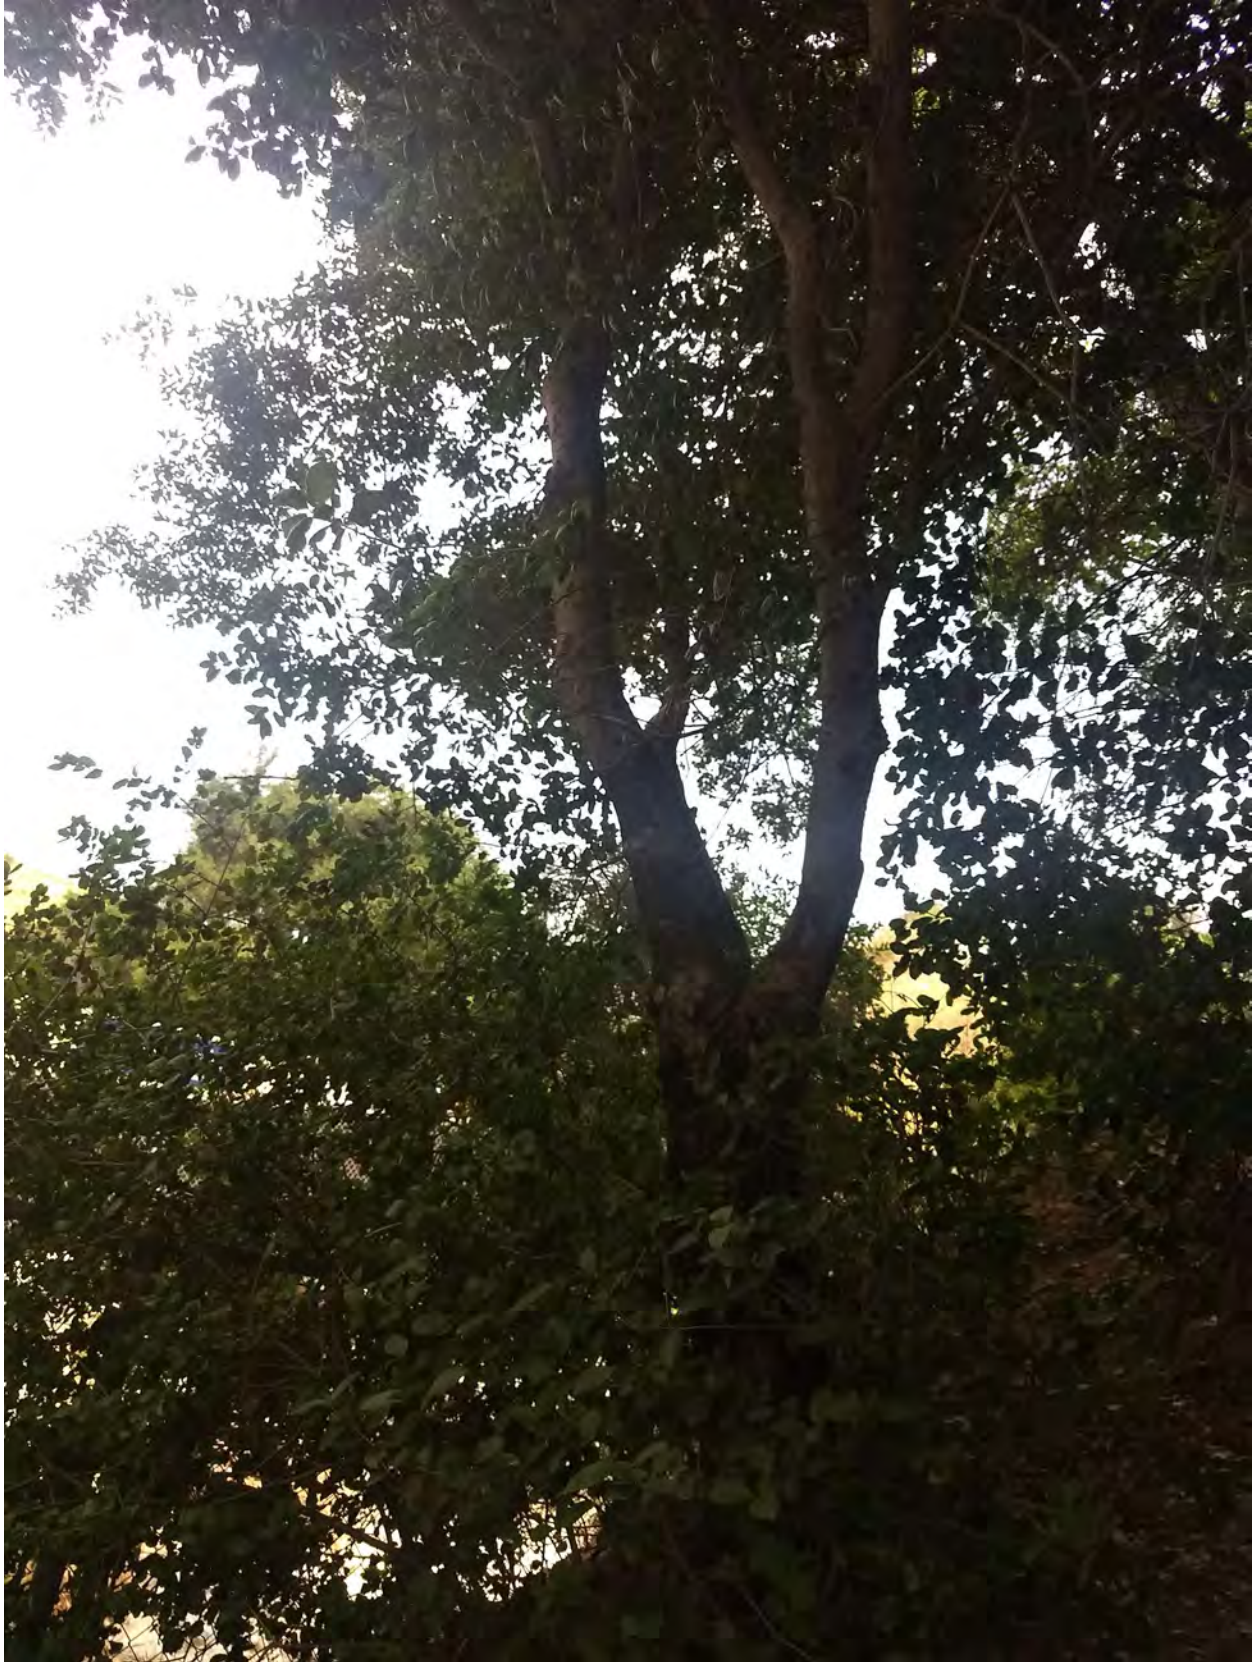
- The trunk of Oak #23 is within 12-feet of proposed road improvements and the root zone has the potential to be significantly impacted. In addition, the proposed impacts would encroach approximately 20% of the trees TPZ. These impacts have the potential to result in death or significant decline of the tree.

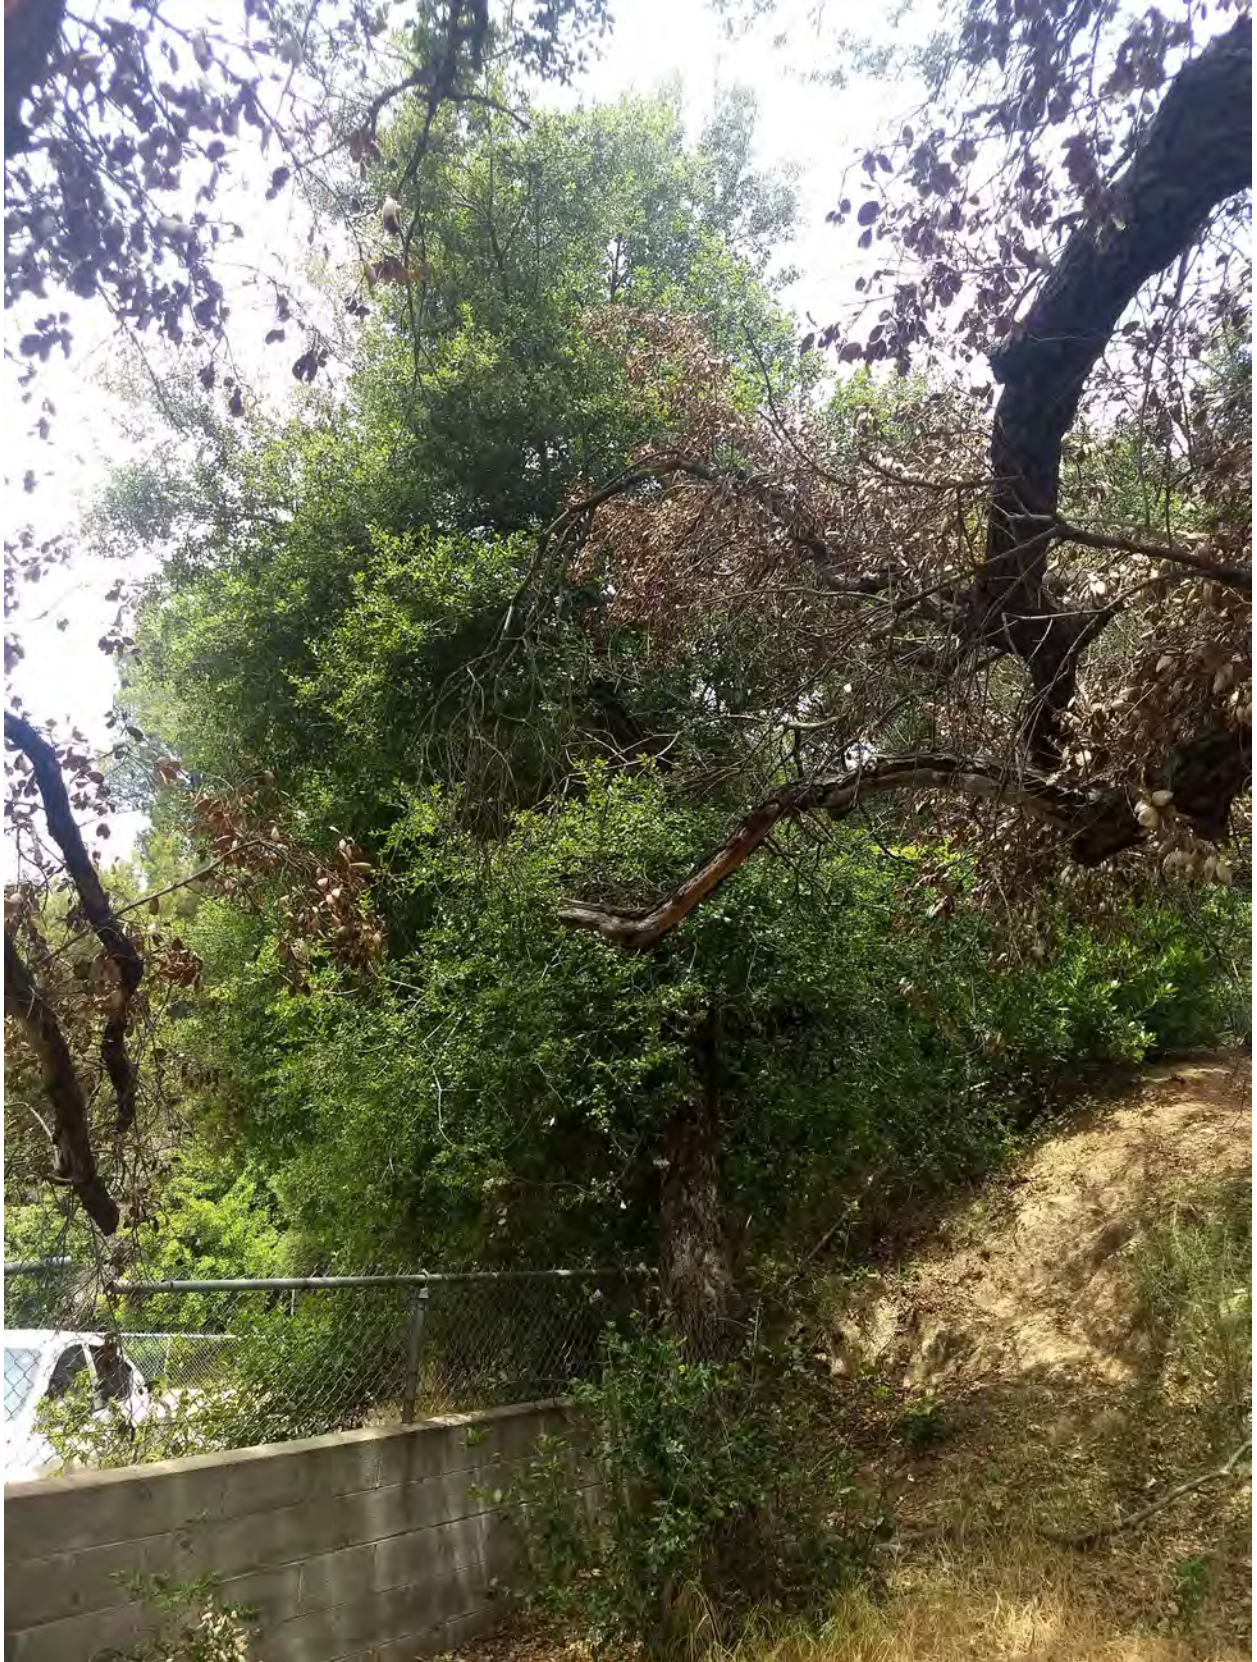
# Oak #25

- Oak #25 is within 2-feet of proposed road improvements and the root zone has the potential to be significantly impacted. In addition, the proposed impacts would encroach approximately 75% of the trees TPZ. These impacts have the potential to result in death or significant decline of the tree.
