# Oak Tree Survey Report

## Hope Gardens Sequoia Building Project

**September 2020 (Updated December 2022)**

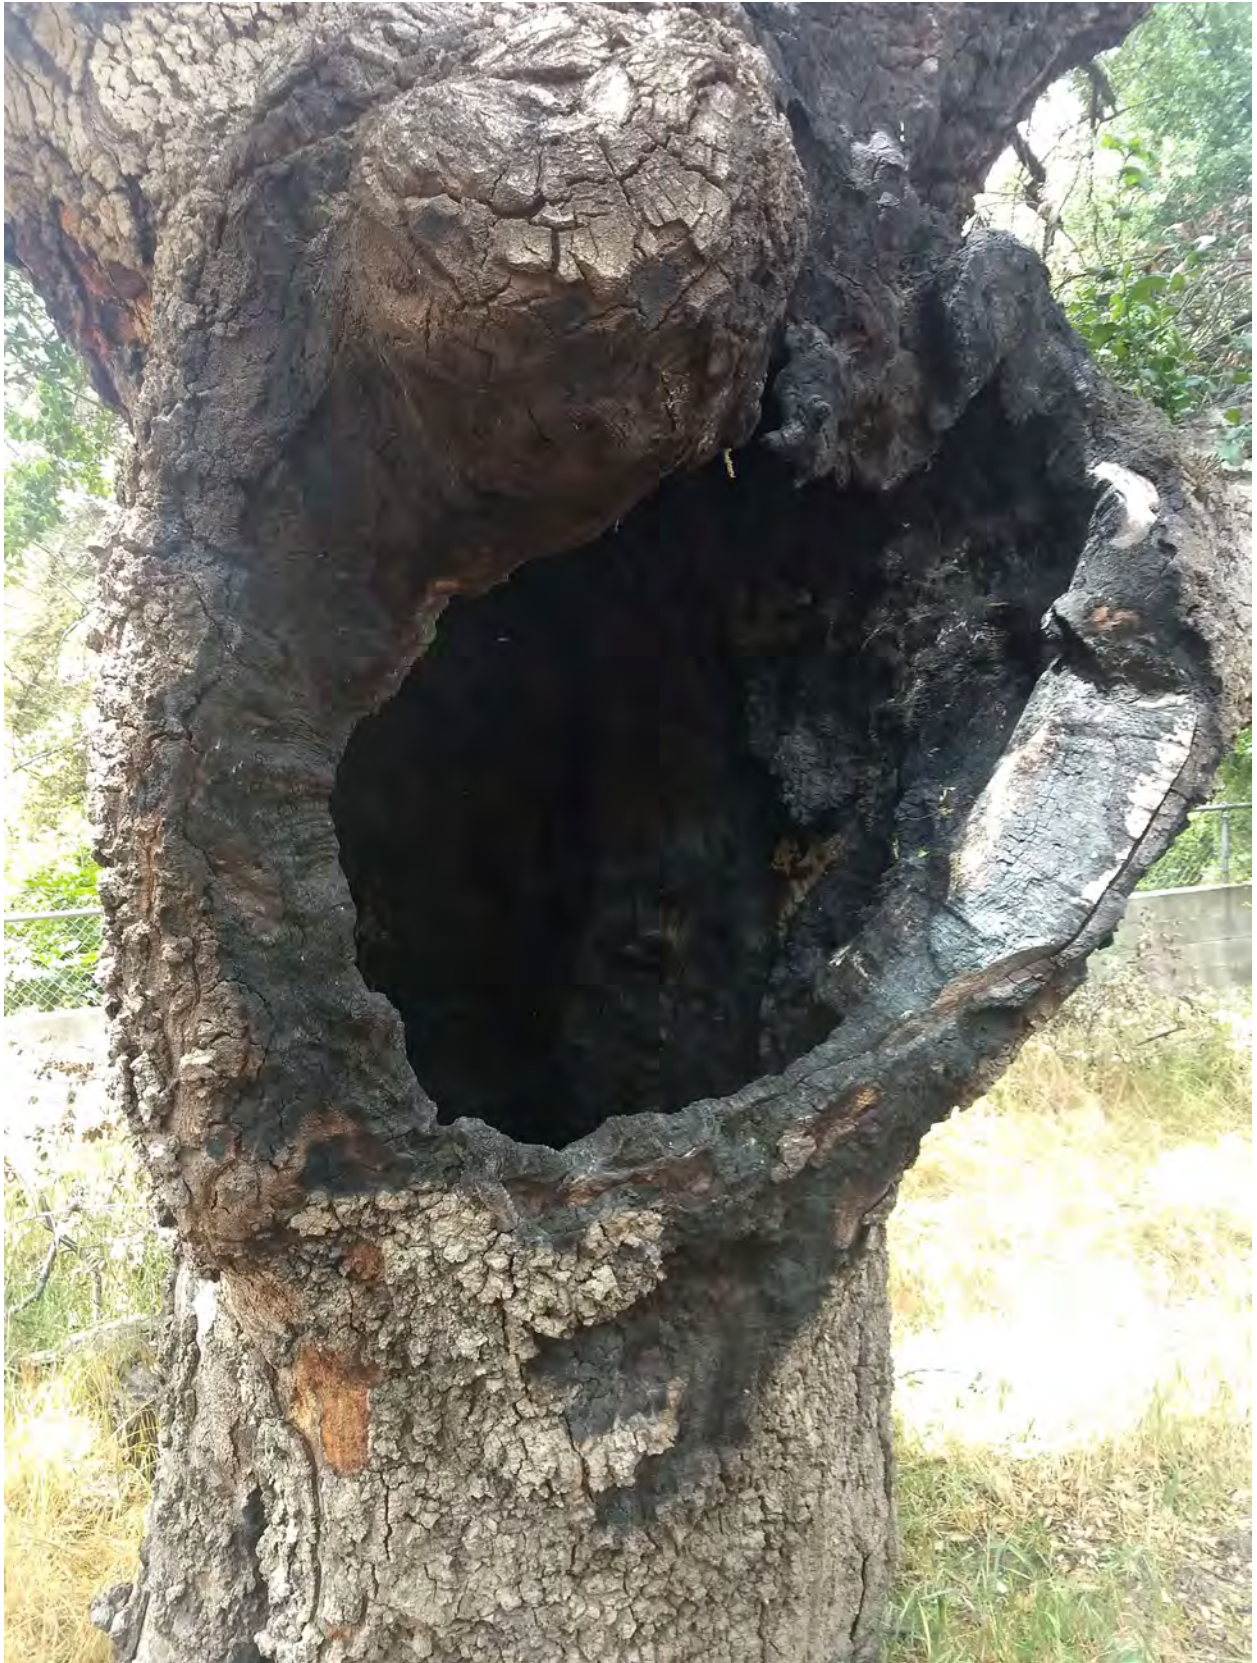
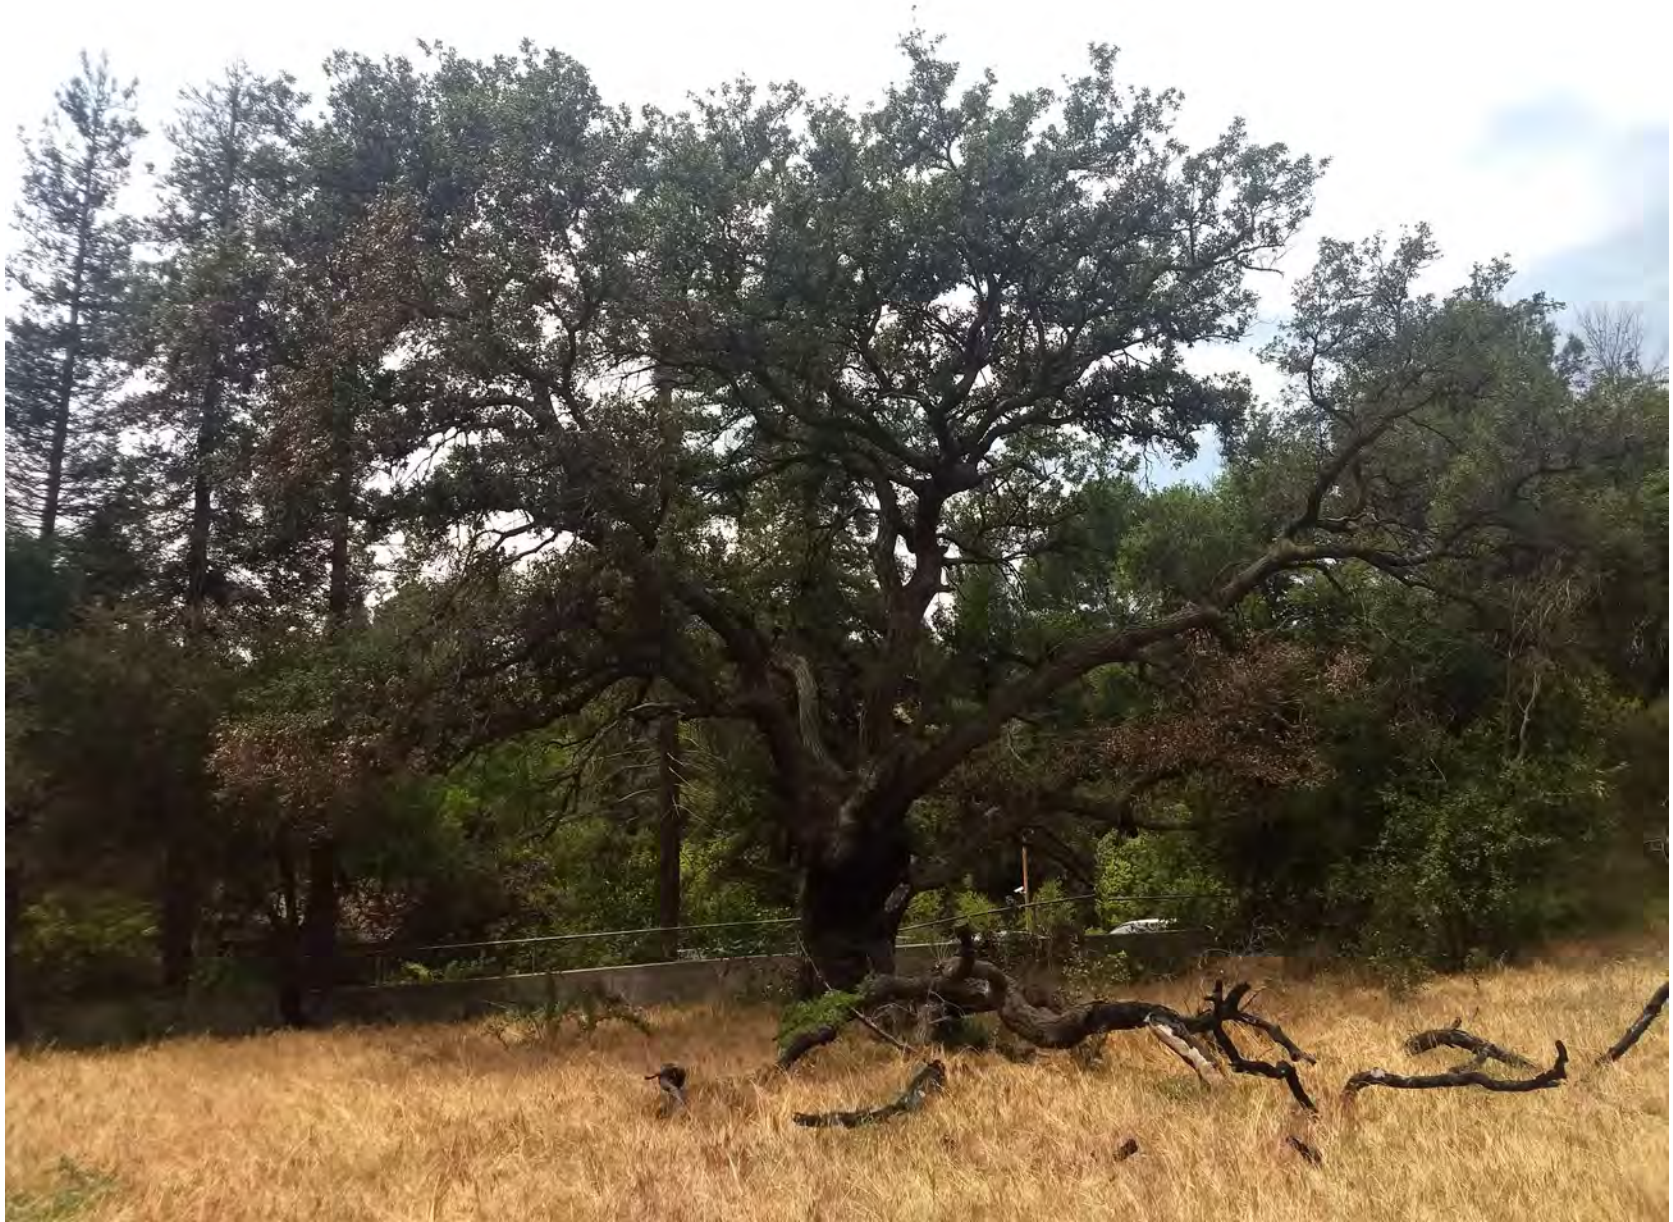
## Oak #26 (Hollow Trunk)

Oak #15 is recommended for removal due to the poor health from being topped and the trees position beneath utility lines. Oak #26 on National Forest Land is not likely to survive, and the hollow trunk indicates that it is likely to lose more large limbs soon. Fencing exists to keep people from going near the tree from the Hope Gardens facility. To maintain the current low risk situation, South Environmental recommends the barrier remain in place.

Of the 4 oaks that will be removed, 3 of them (#11, #13, and #16) are in good health (4, or 5 health rating). Oak #15 is dead/dying (health rating of 1) and we recommend it be removed to avoid any future conflicts. Heritage Oak #26 will not be impacted by the project because it is off the project site and not in jeopardy from project activities.

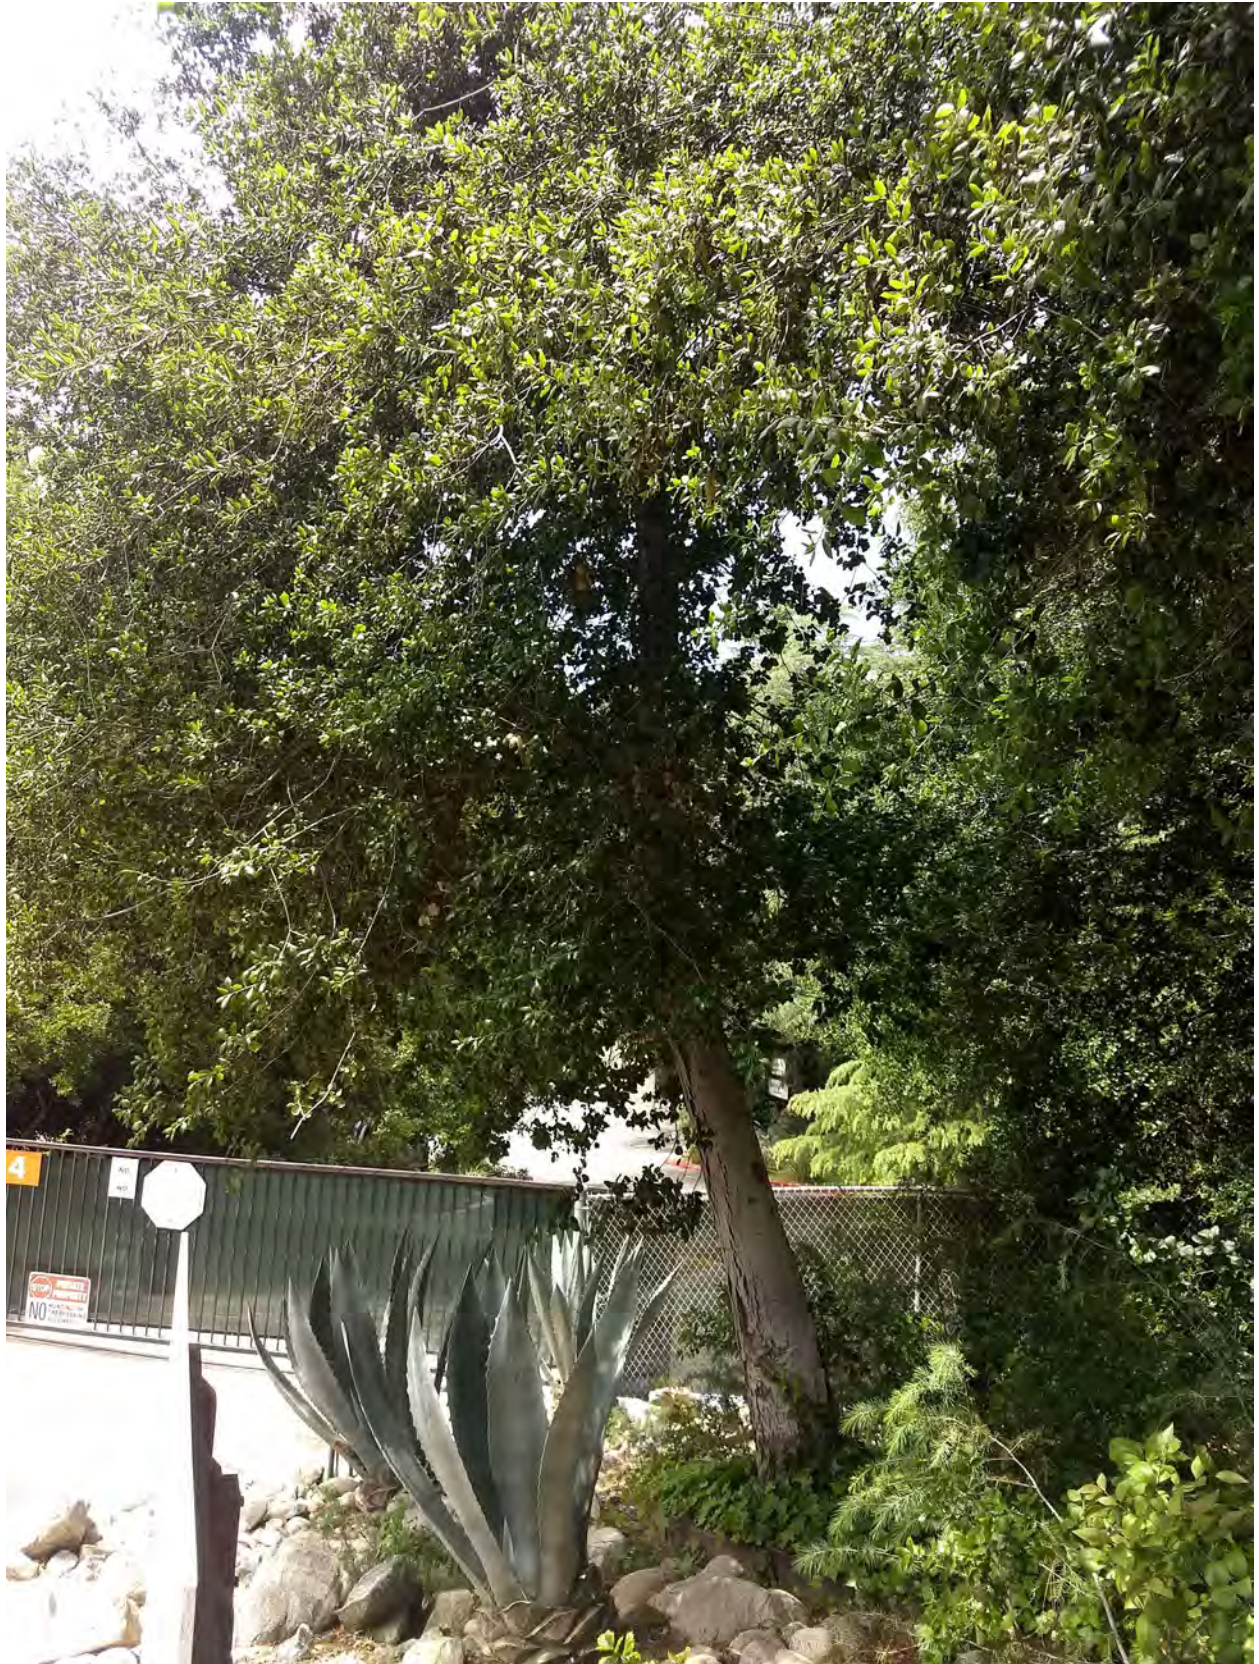
# Oak #50

- Oak #50 is within 3.0-feet of proposed road improvements and the root zone has the potential to be significantly impacted. In addition, the proposed impacts would encroach approximately 50% of the trees TPZ. These impacts have the potential to result in death or significant decline of the tree.

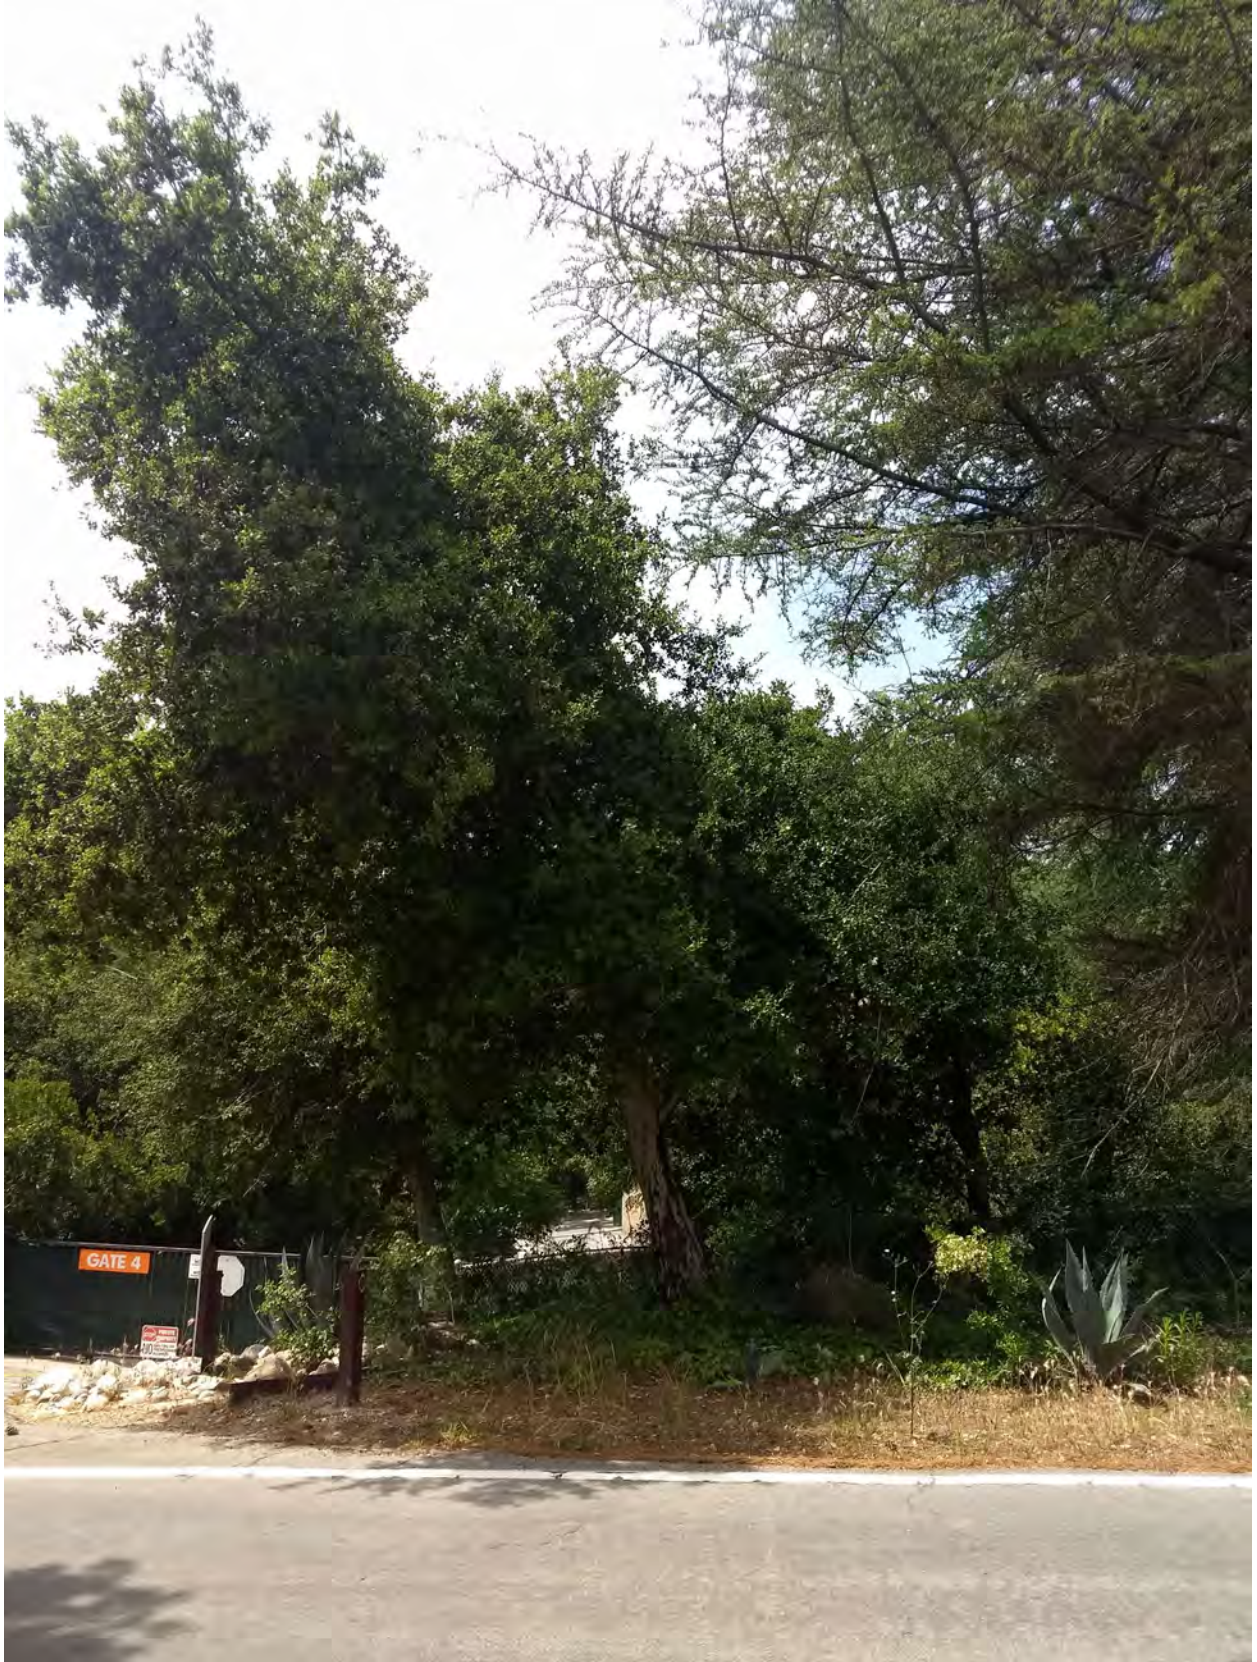
# Oak #51

- Oak #51 is within 12 feet of proposed asphalt resurfacing and project encroachment into the TPZ is at approximately 20%. Using the methods described in the ISA's Managing Trees During Construction Second Edition (ISA 2016) for calculating Critical Root Zone (CRZ) of trees, this oak is a mature tree with a high tolerance to construction damage and a CRZ diameter of 8.6-feet. Although the tree is within 12-feet of construction the CRZ is not within the impact area based on the above calculation and the encroachments into the TPZs of less than 20% indicates that this tree will not be significantly impacted by the construction.
