Entrada South Oak Tree Report

**OAK TREE REPORT
ENTRADA SOUTH, VTTM 53295
THE OLD ROAD AND MAGIC MOUNTAIN PARKWAY
UNINCORPORATED LOS ANGELES COUNTY**

**DECEMBER 22, 2021
AMENDED: MARCH 31, 2023**

**Re: Oak Tree Report Amendment - Entrada South, VTTM 53295
Unincorporated Los Angeles County
Oak Tree Permit No.: ROAK-200700018**

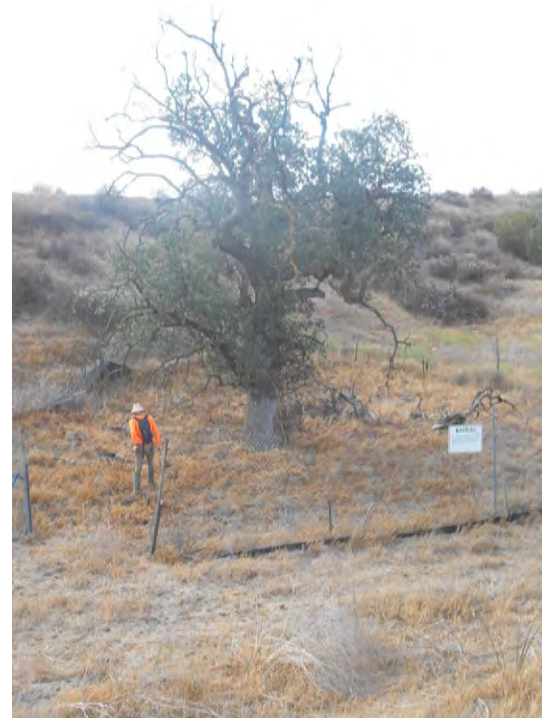
Tree No.31

31	<i>Quercus lobata</i>	31.5		35	15	13	23	14	40	F		A	S	X	X	X						Ex			C	D	F	C-	old 28, TW #32; epicormic recovery good with rains
32	<i>Quercus lobata</i>	22.8		35	23	18	18	15	50	F		A	S	X	X	X					X	Ex			C	C	F	C	old 29, TW #23; some top/tip growth; recovery good with rains; old fire damage

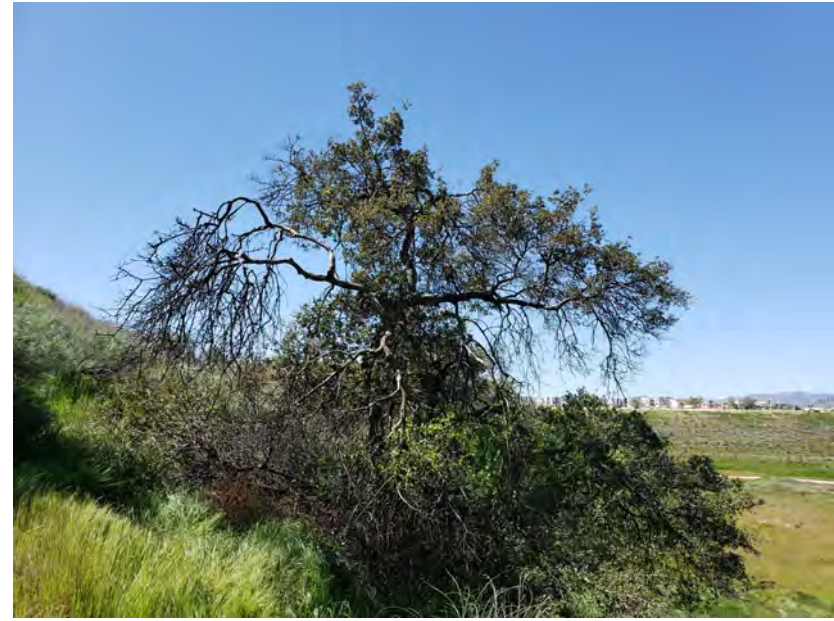
Tree No.156

156	<i>Quercus berberidifolia</i>	9 @ 3.5'		25	23	12	10	20																	C-	C-	F	C-	old tag 158, HOB, significant dieback on south and east, recovery growth noted on north and west
