## REPORT TO THE REGIONAL PLANNING COMMISSION

| PROJECT NUMBER: | PRJ2021-004371-(3) | |
| PERMIT NUMBER(S): | Major Coastal Development Permit RPPL2021012462 | |

# TAPIA WATER RECLAMATION FACILITY: 003 OUTFALL ACCESS MANHOLE INSTALLATION

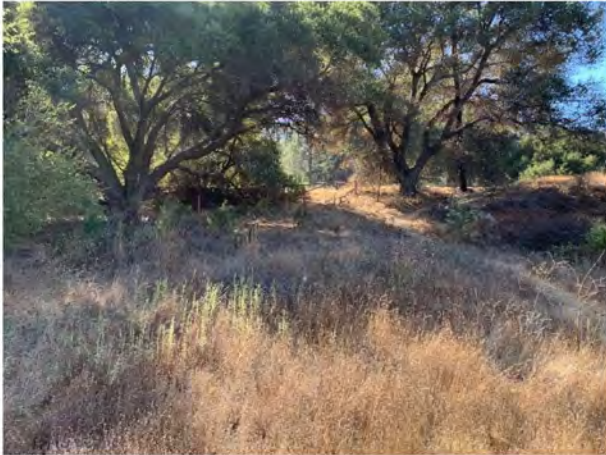
**Figure 5 Project Site Photos**

**Photograph 1.** Access road to existing pipeline looking toward Malibu Canyon Road.

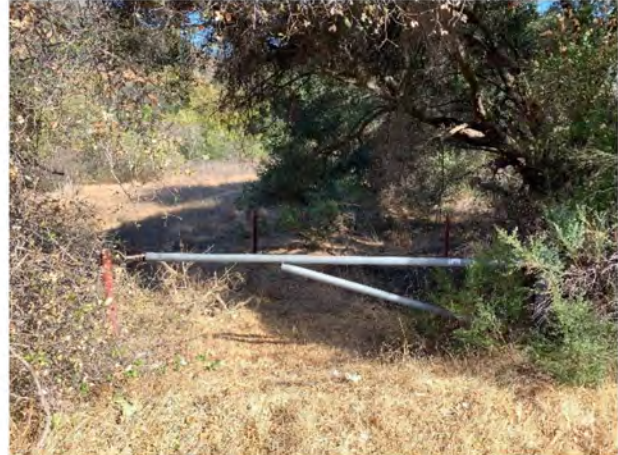
**Photograph 2.** Access to 003 Outfall on the east side of Malibu Canyon Road.

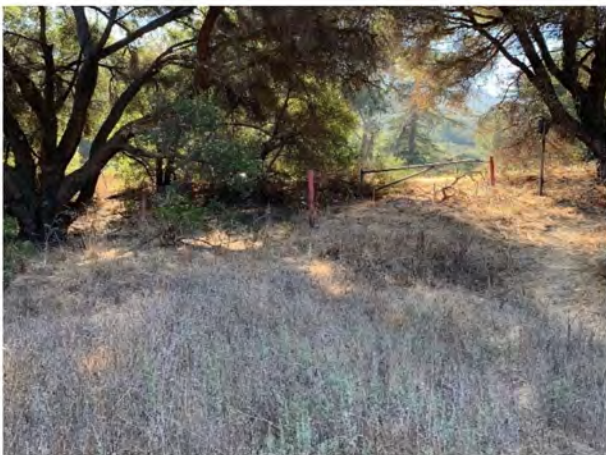
**Photograph 3.** Access road to 003 Outfall looking toward Malibu Canyon Road.

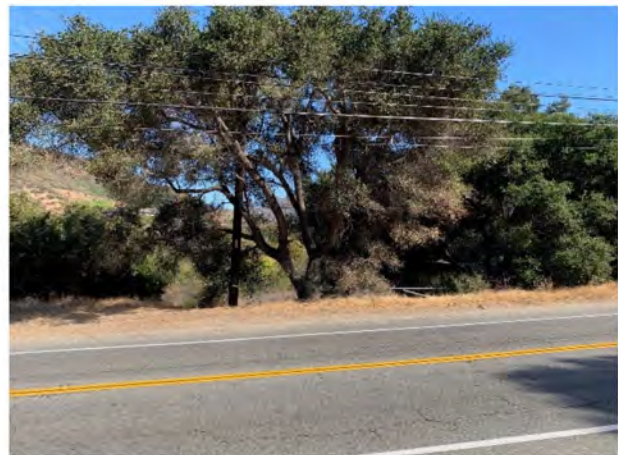
**Photograph 4.** View toward existing pipeline across Malibu Canyon Road.

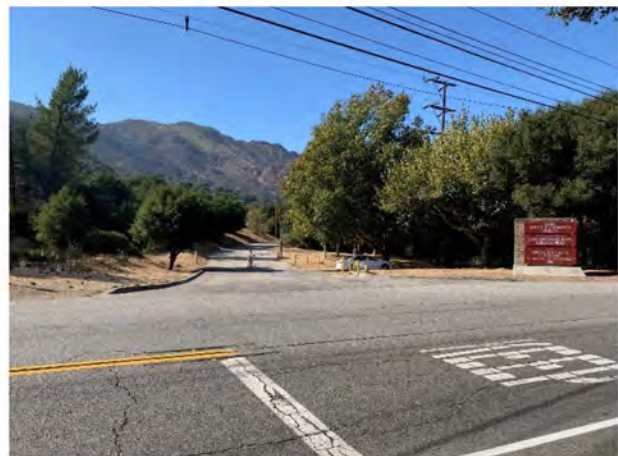
**Photograph 6.** Entrance to Tapia Water Reclamation Facility from Malibu Canyon Road.

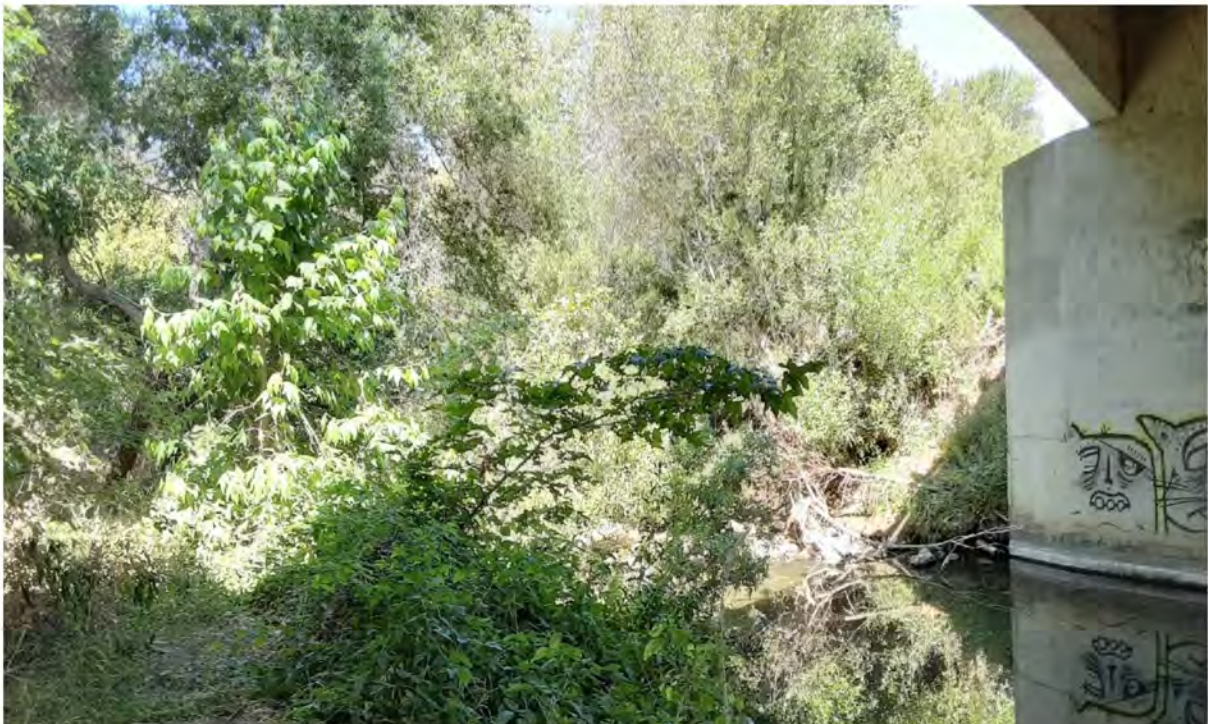
**Photograph 2.** California sycamore woodlands (*Platanus racemosa* – *Quercus agrifolia* woodland association) in Malibu Creek with open water present as the creek passes under Las Virgenes Road, facing west. Photo location 2. 7/21/2021

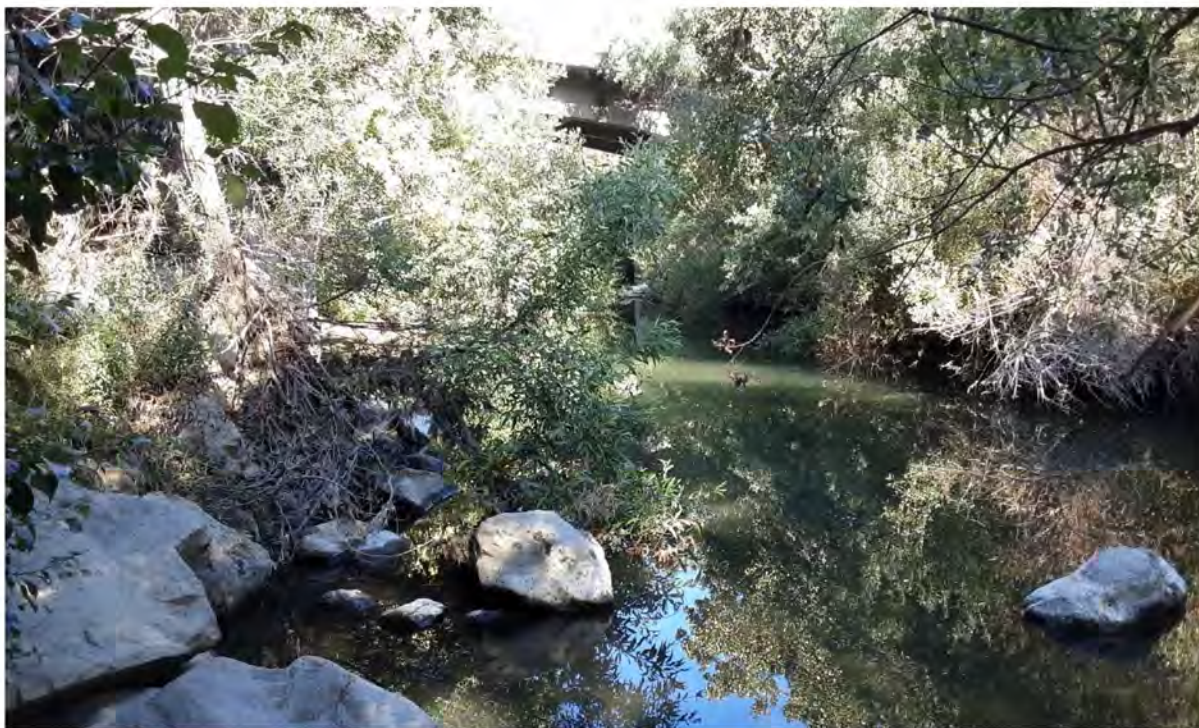
**Photograph 3.** Surface water in Malibu Creek, surrounded by riparian vegetation, facing west. Photo location 3. 8/4/2021

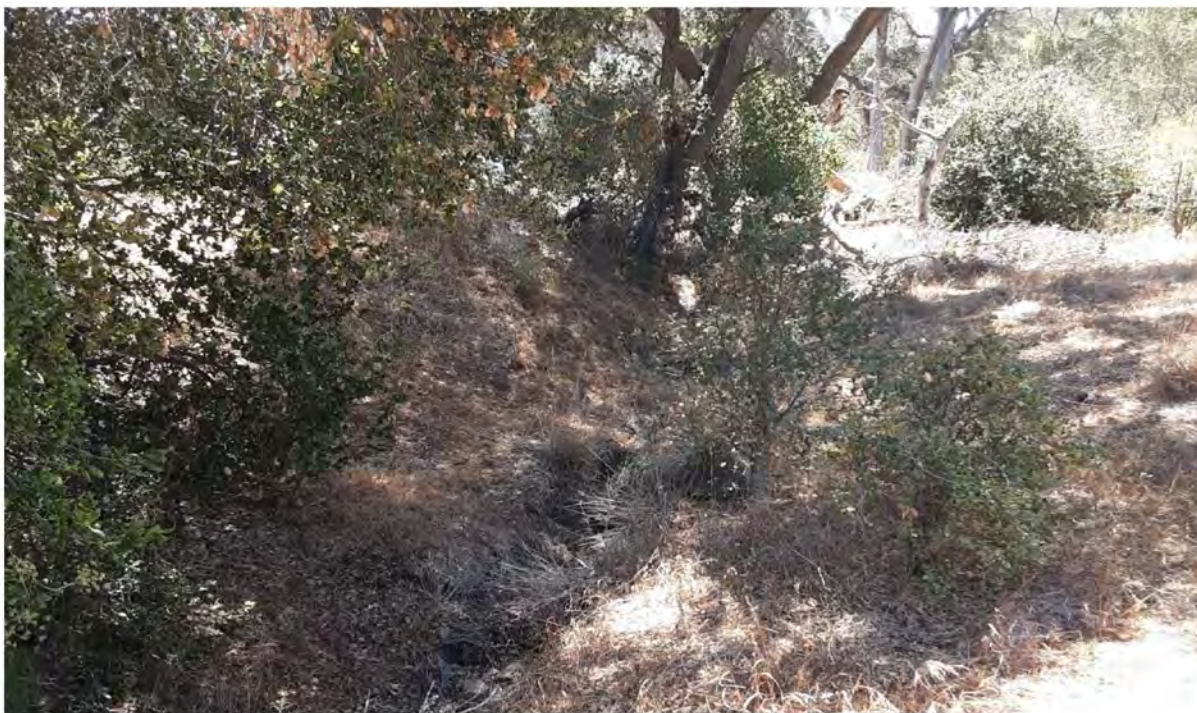
**Photograph 5.** Natural portion of the ephemeral drainage under coast live oak canopy, facing south. Photo location 5. 7/21/2021

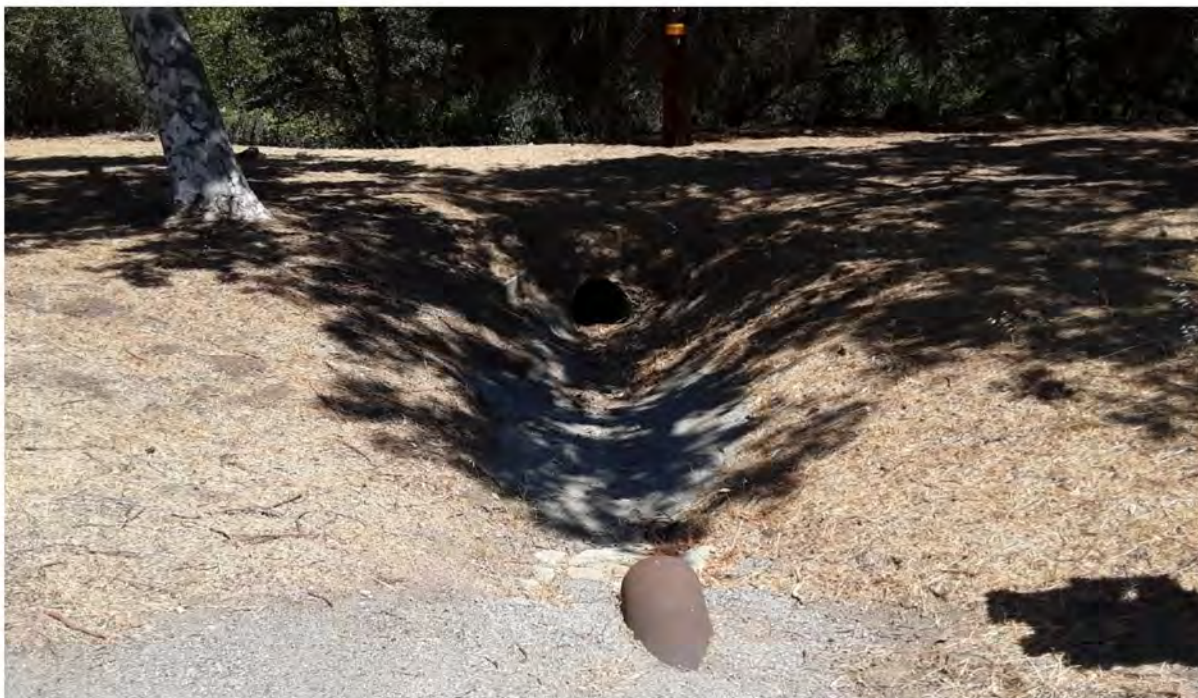
**Photograph 6.** Ephemeral ditch: outlet of culvert under Tapia WRF access road, concrete-lined ditch, and inlet of culvert that leads to Malibu Creek, facing north. Photo location 6. 7/21/2021

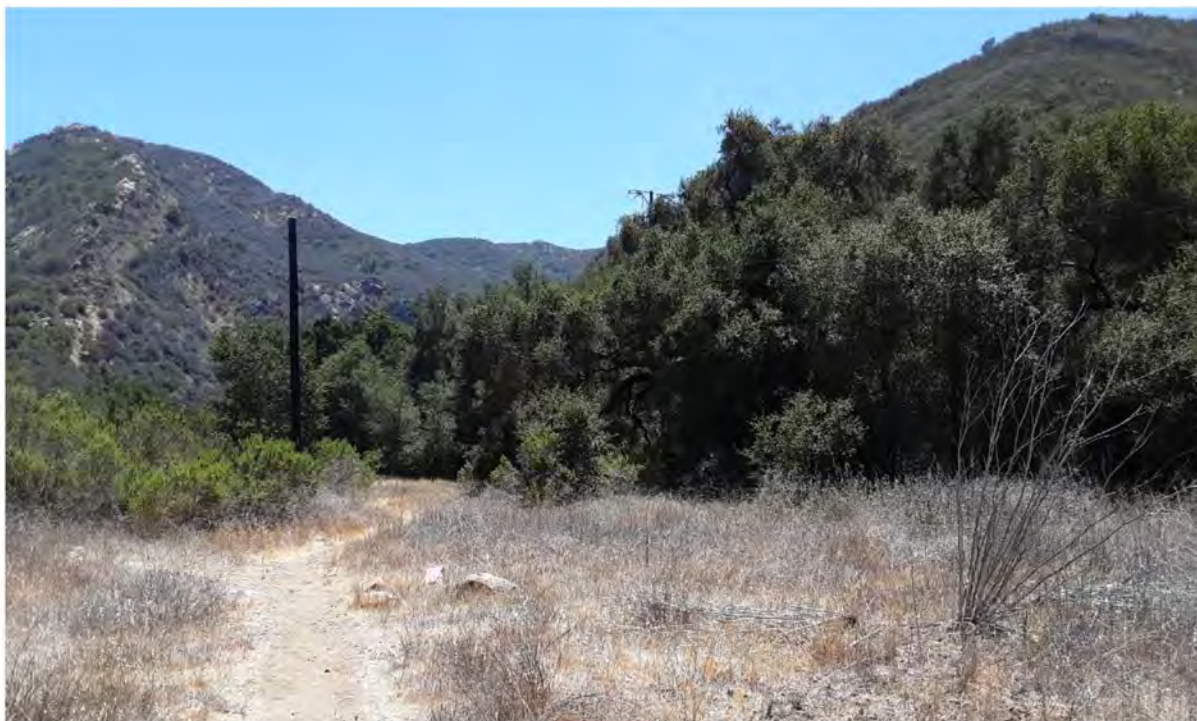
**Photograph 7.** View of dirt trail along pipeline that passes through upland mustards with scattered coyote brush. Edge of coast live oak woodland and forest on right, facing south. Photo location 7. 7/21/2021

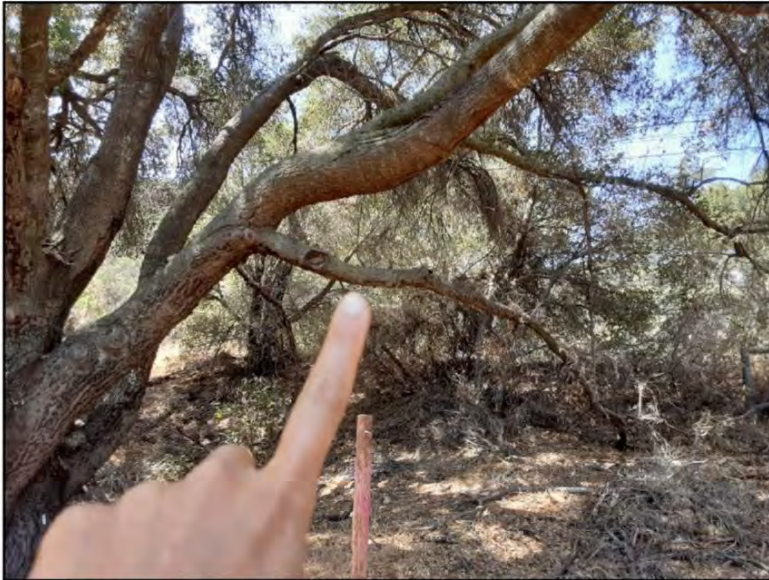
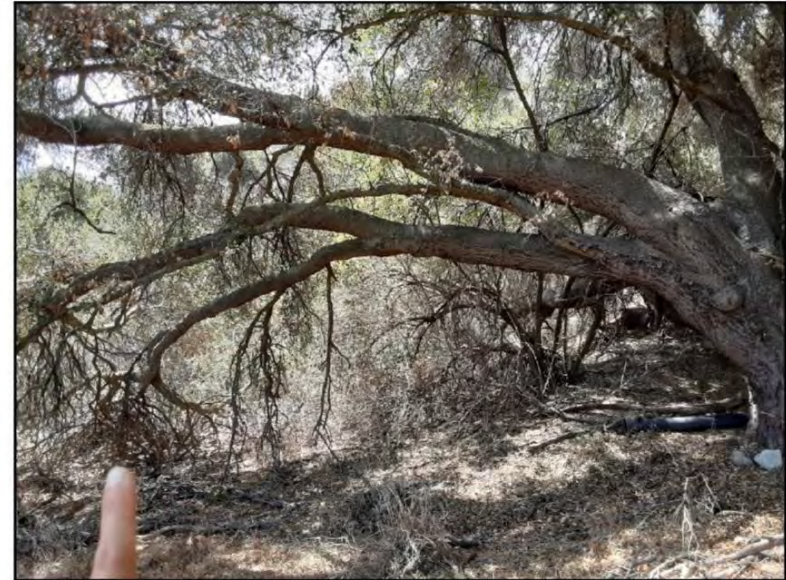
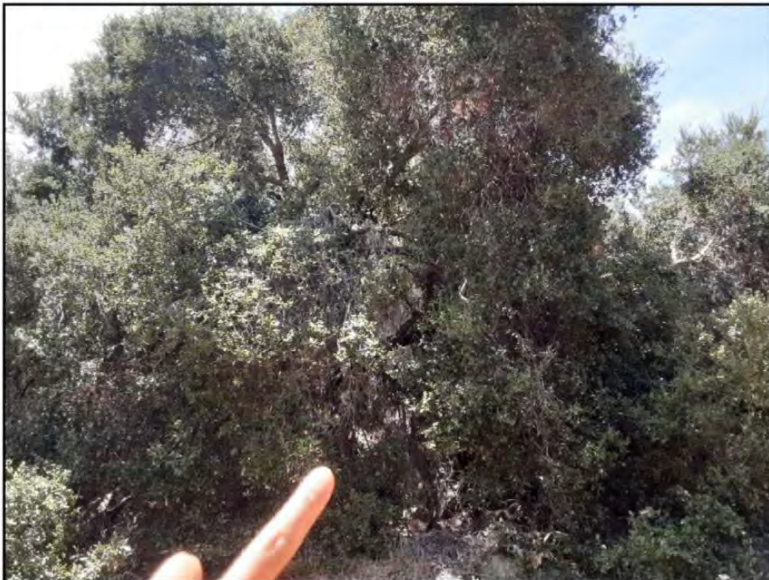
Tree #20 Coast Live Oak (*Quercus agrifolia*)

| Tree ID # | Common Name | Scientific Name | Number of Trunks | Individual Trunk Diameters (inches) | Aggregate Trunk Diameters (inches) | Tree Height (feet) | Crown Spread (N, NE, E, SE, S, SW, W, NW) | Overall Health | Notes | Damage/Issues |
|---|---|---|---|---|---|---|---|---|---|---|
| 20 | Coast Live Oak | <i>Quercus agrifolia</i> | 2 | 13.5, 45 | 47 | 55 | 25, 25, 30, 25, 25, 20, 25, 25 | Poor | selective pruning to remove dead and decaying lower branches | sparse crown dieback dead lower branches touching ground flagging, anthracnose |

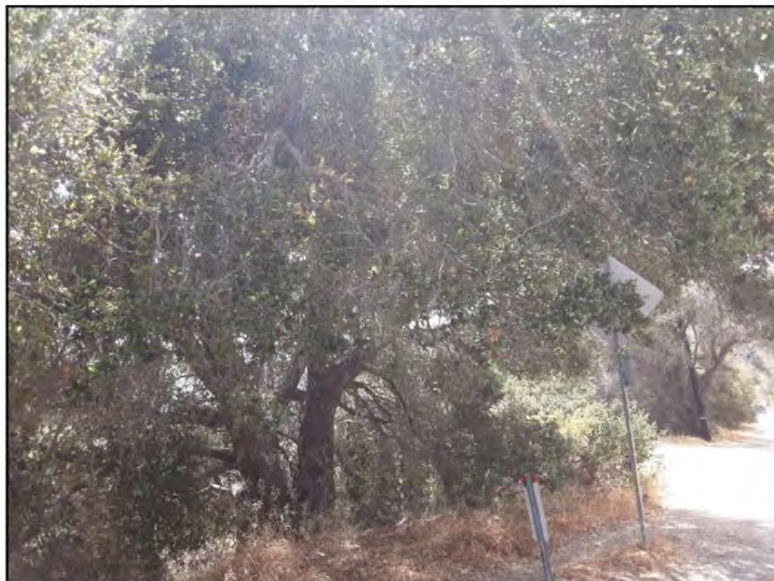
Tree #22 Coast Live Oak (*Quercus agrifolia*)

| Tree ID # | Common Name | Scientific Name | Number of Trunks | Individual Trunk Diameters (inches) | Aggregate Trunk Diameters (inches) | Tree Height (feet) | Crown Spread (N, NE, E, SE, S, SW, W, NW) | Overall Health | Notes | Damage/Issues |
|---|---|---|---|---|---|---|---|---|---|---|
| 22 | Coast Live Oak | <i>Quercus agrifolia</i> | 1 | 28 | 28 | 55 | 30, 28, 25, 25, 20, 20, 20, 30 | Fair | utility pole through crown, no significant previous pruning observed | sparse crown dieback |

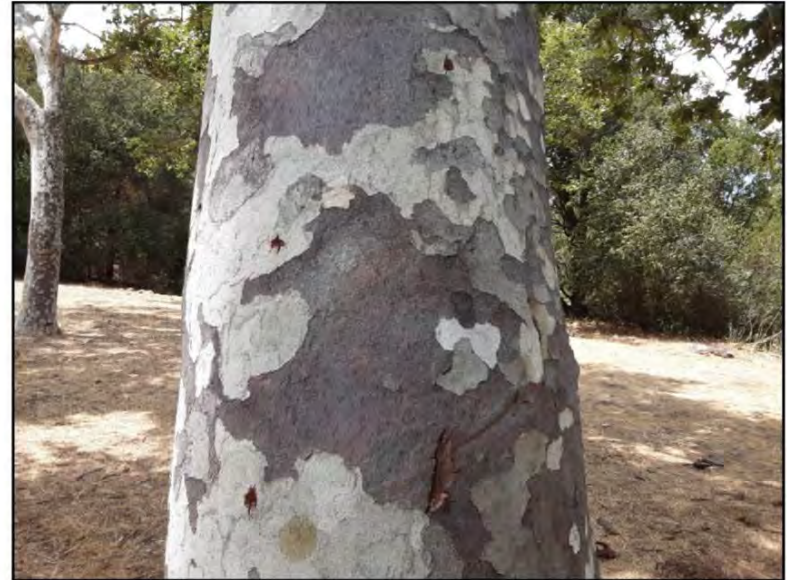
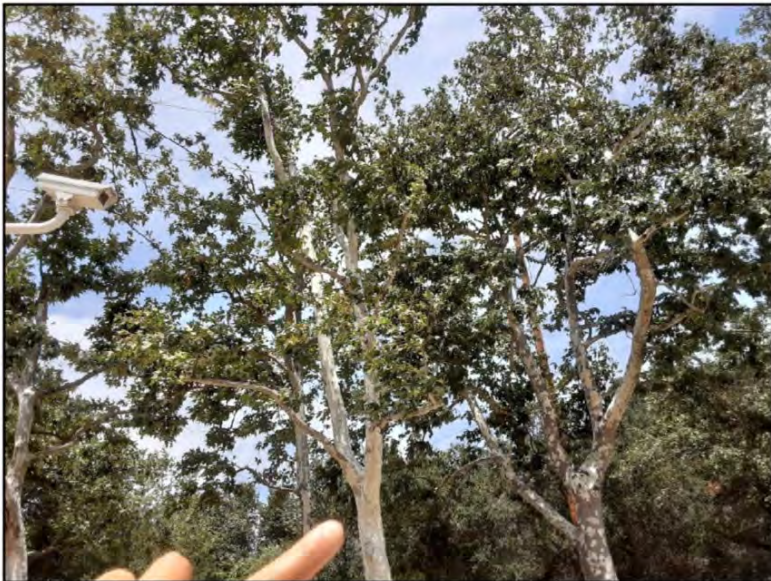
Tree #34 California sycamore (*Platanus racemosa*)

| Tree ID # | Common Name | Scientific Name | Number of Trunks | Individual Trunk Diameters (inches) | Aggregate Trunk Diameters (inches) | Tree Height (feet) | Crown Spread (N, NE, E, SE, S, SW, W, NW) | Overall Health | Notes | Damage/Issues |
|---|---|---|---|---|---|---|---|---|---|---|
| 34 | California sycamore | <i>Platanus racemosa</i> | 1 | 18 | 18 | 60 | 20, 15, 18, 20, 18, 15, 15, 15 | Good | | woodpecker damage along trunk and branches |

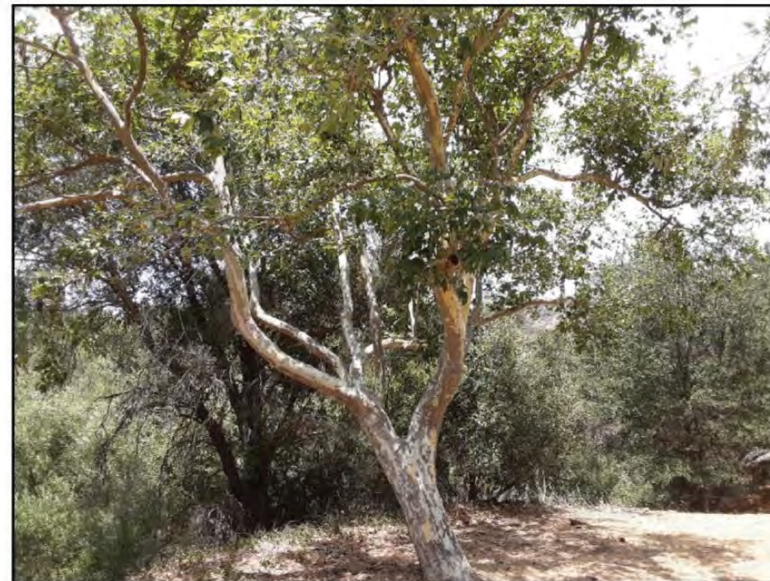
Tree #37 California sycamore (*Platanus racemosa*)

| Tree ID # | Common Name | Scientific Name | Number of Trunks | Individual Trunk Diameters (inches) | Aggregate Trunk Diameters (inches) | Tree Height (feet) | Crown Spread (N, NE, E, SE, S, SW, W, NW) | Overall Health | Notes | Damage/Issues |
|---|---|---|---|---|---|---|---|---|---|---|
| 37 | California sycamore | <i>Platanus racemosa</i> | 1 | 16 | 16 | 65 | 10, 12, 10, 20, 20, 25, 20, 15 | Good | stress cracks on branches, previously pruned | some dieback |
