## **Appendix 5.5 (Continued)**

Hydrology (Part 8 of 15)

JOB  
**CASTAIC CREEK  
 FLUVIAL STUDY**  
 LOS ANGELES COUNTY CA

TITLE  
**HISTORICAL  
 CROSS SECTIONS  
 BY STATION**

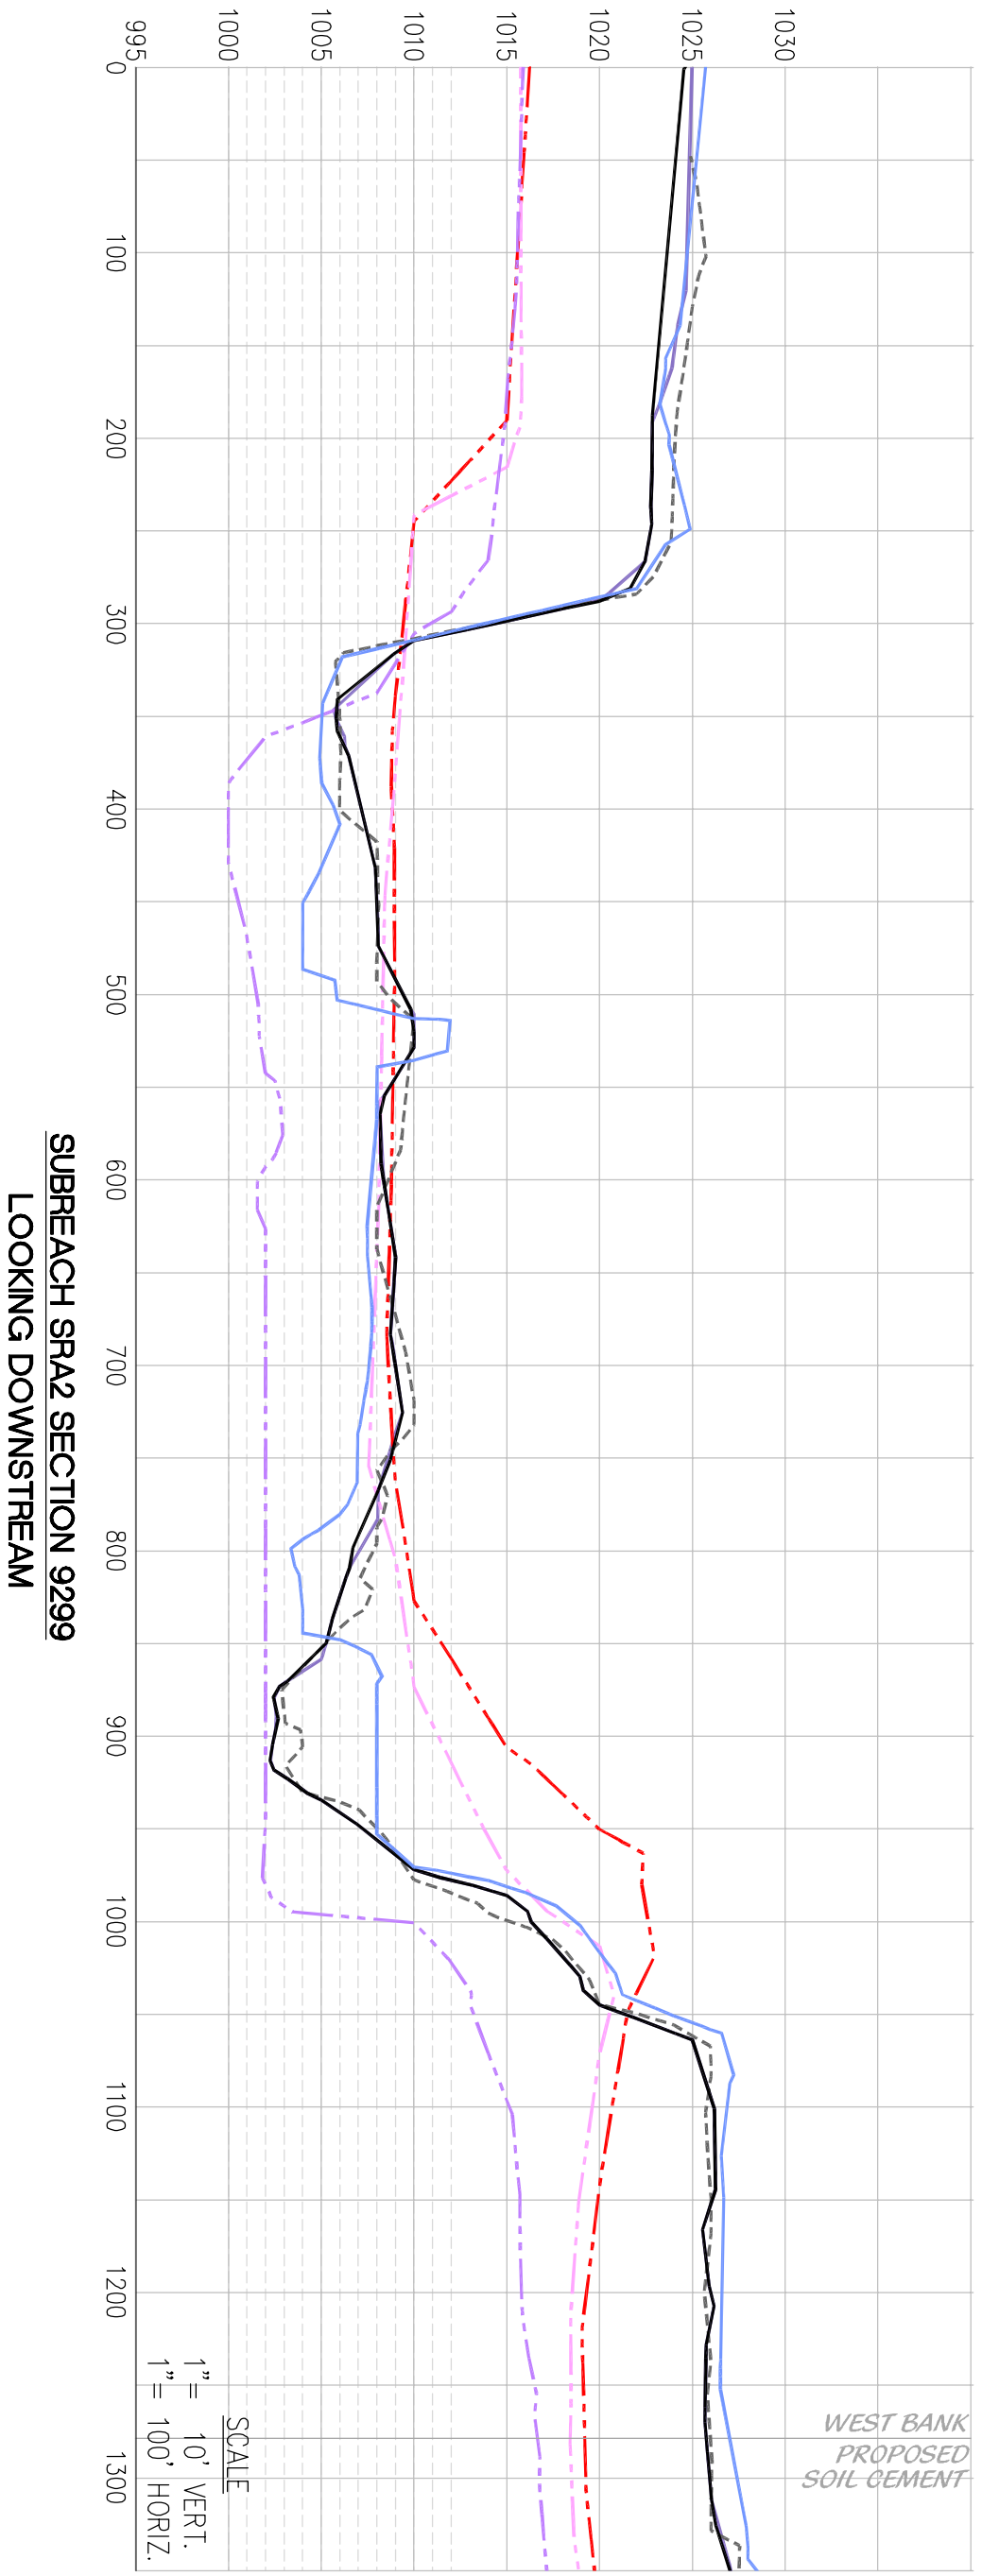
FIGURE  
**5.2A**

WEST BANK  
 PROPOSED  
 SOIL CEMENT

CROSS SECTIONAL AREAS AT STA 9299 (sf)				
ELEV	1999	2004	2005	2006
1001.0	0.0	0.0	0.0	0.0
1002.0	0.0	0.0	0.0	0.0
1003.0	0.0	27.7	19.9	0.9
1004.0	9.2	57.4	57.5	30.4
1005.0	99.0	71.2	74.8	74.0
1006.0	210.0	101.9	101.0	87.6
1007.0	275.5	169.6	175.1	177.7
1008.0	391.1	246.4	258.4	224.8
1009.0	621.0	424.8	416.4	422.1
1010.0	640.0	614.2	613.0	559.3
1011.0	654.7	665.2	665.5	670.4
1012.0	666.0	670.3	671.3	677.6
<b>Cumulative Area</b>	<b>3566.5</b>	<b>3048.5</b>	<b>3052.9</b>	<b>2924.8</b>

Section 9299 (SRA2) shows almost indiscernible change between 2004 and 2005 (Figure 5.2A) suggesting an armored condition of the bed below which it will not degrade. Between 1999 and 2005, 0.7 feet of aggradation appears to have occurred (Table 5.1A-B) on the section as a whole, although the thalweg is lower in 2005. The reason for this aggradation is unclear, however, it appears that the bed is recovering from historical gravel mining operations (shown in 1963 historical topography Appendix Chapter 5) that lowered the bed well below its present condition. The presence of a resistant Saugus formation sandstone outcrop at approximately station 1000 is evident in the 1930 and 1999-2005 topographies. The outcrop is not as evident in the 1947 and 1963 sections because of the limits of the historical topographies' resolutions on this portion of the Creek from these years. However, historical photographs (personal communication, Brian Swanson, Allan E. Seward Engineering Geology, May, 2005) do indicate the continual presence of this outcropping over the period of record.

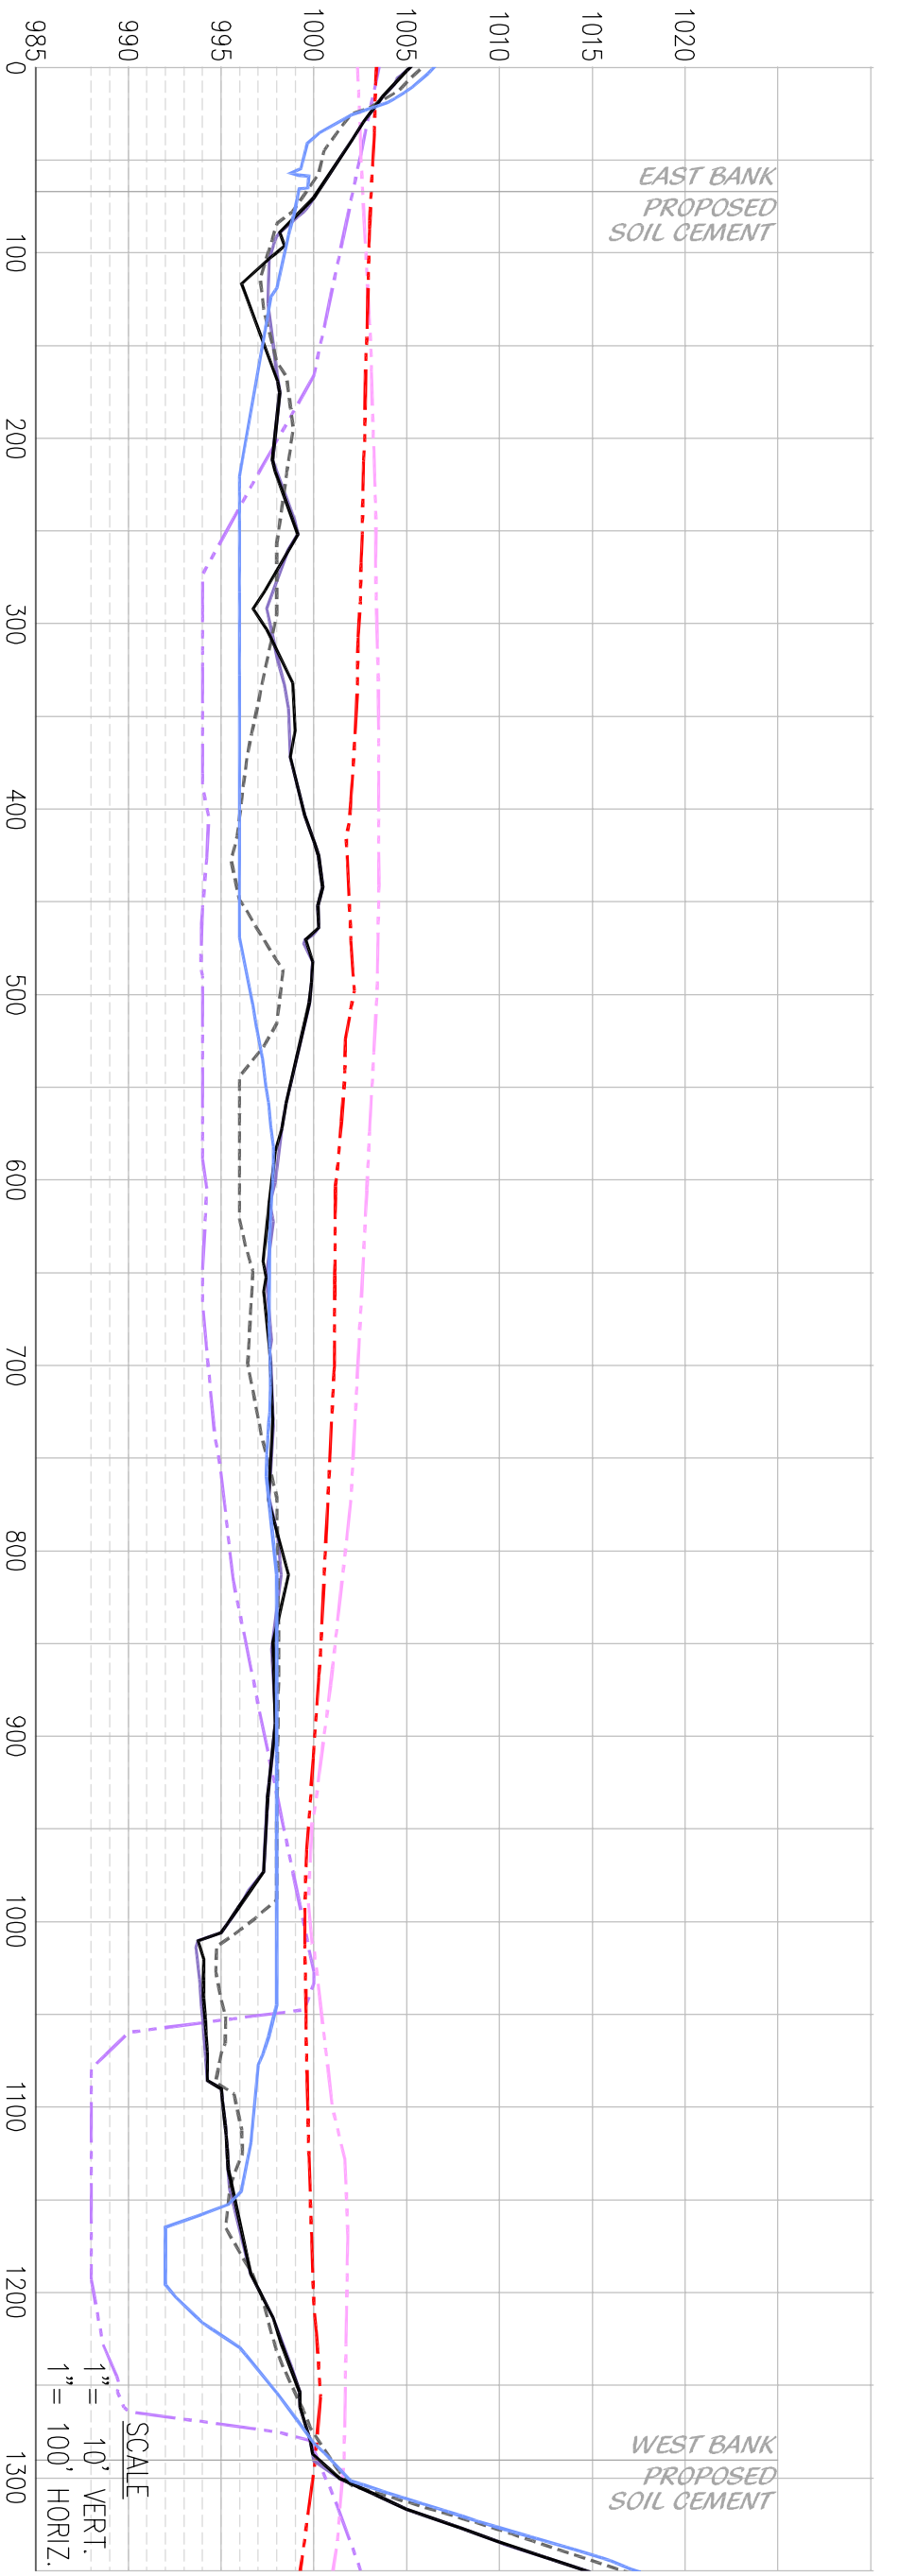
FIGURE  
**5.2B**

CROSS SECTIONAL AREAS AT STA 8050 (sf)				
ELEV	1999	2004	2005	2006
989.0	0.0	0.0	0.0	0.0
990.0	0.0	0.0	0.0	0.0
991.0	0.0	0.0	0.0	0.0
992.0	0.0	0.0	0.0	0.0
993.0	38.5	0.0	0.0	0.0
994.0	51.9	6.0	0.0	0.0
995.0	64.3	74.8	65.9	8.4
996.0	77.3	136.3	134.0	112.5
997.0	419.0	216.0	216.1	403.6
998.0	686.3	420.2	439.3	638.7
999.0	1164.2	877.3	871.5	1098.0
1000.0	1215.4	1084.5	1081.1	1197.0
<b>Cumulative Area</b>	<b>3716.8</b>	<b>2815.0</b>	<b>2807.9</b>	<b>3458.2</b>

**SUBREACH SRA3 SECTION 8050  
LOOKING DOWNSTREAM**

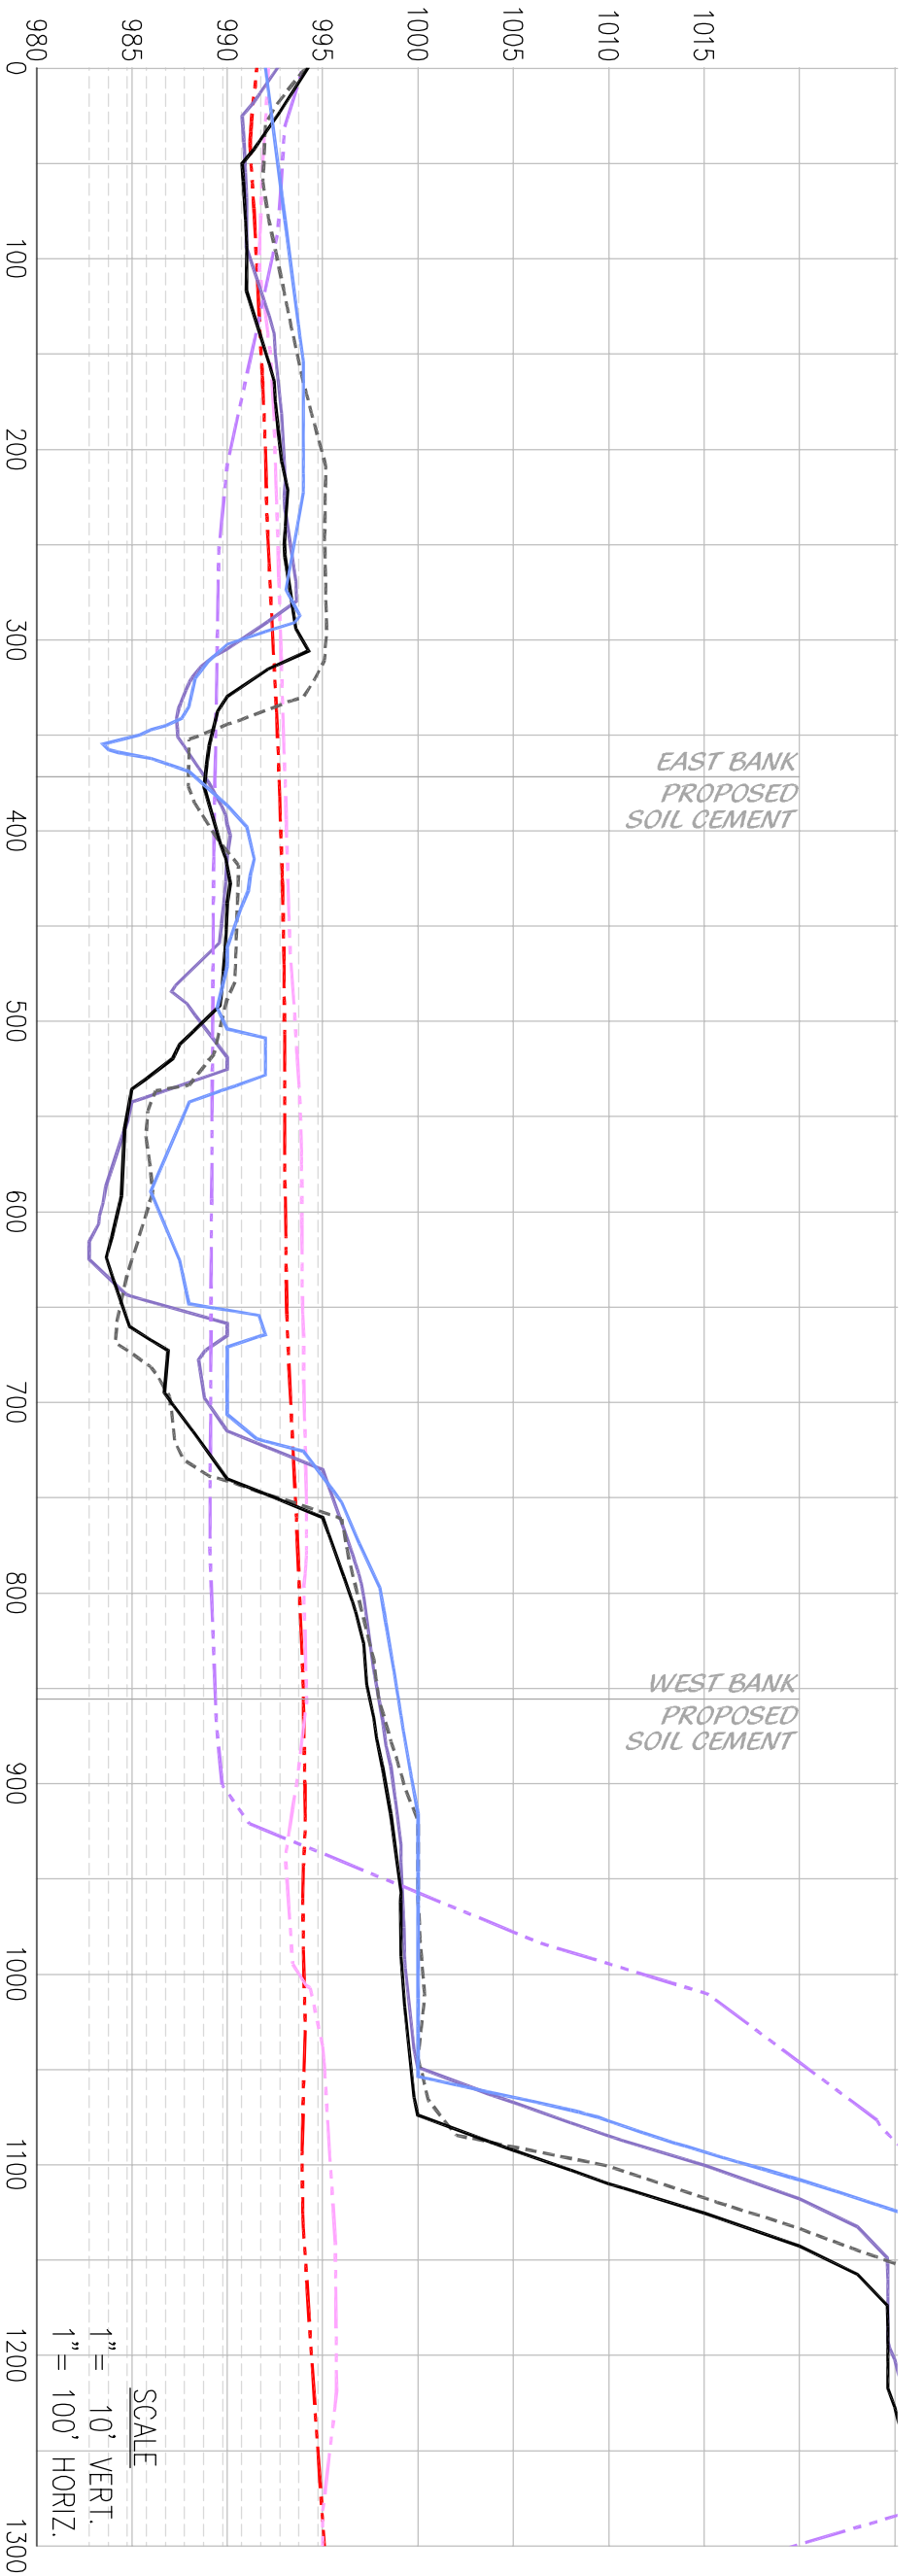
FIGURE  
**5.2C**

**SUBREACH SRA4 SECTION 6624  
LOOKING DOWNSTREAM**

CROSS SECTIONAL AREAS AT STA 6624 (sf)				
ELEV	1999	2004	2005	2006
983.8	0.3	30.0	0.4	0.0
984.8	6.3	74.4	47.7	14.5
985.8	14.5	99.2	120.1	59.5
986.8	36.8	109.8	142.5	133.9
987.8	103.1	127.7	184.4	176.1
988.8	159.4	193.6	211.1	227.9
989.8	207.7	281.2	235.2	273.3
990.8	288.2	398.4	399.5	340.9
991.8	370.8	492.3	492.6	403.3
992.8	457.4	564.8	564.8	462.8
993.8	573.3	690.2	685.8	536.2
994.8	737.1	754.8	754.8	601.2
<b>Cumulative Area</b>	<b>2954.9</b>	<b>3816.5</b>	<b>3838.9</b>	<b>3229.6</b>

Section 6624 (SRA4) shows continuous degradation over the period of record from 1999 to the present (1.3 feet, Table 5.1). Degradation in 1963 was likely the result of gravel mining, while more recent degradation may be the result to the completion of the upstream dam. Historical grading activities are evident on the west bank starting approximately at station 1000.

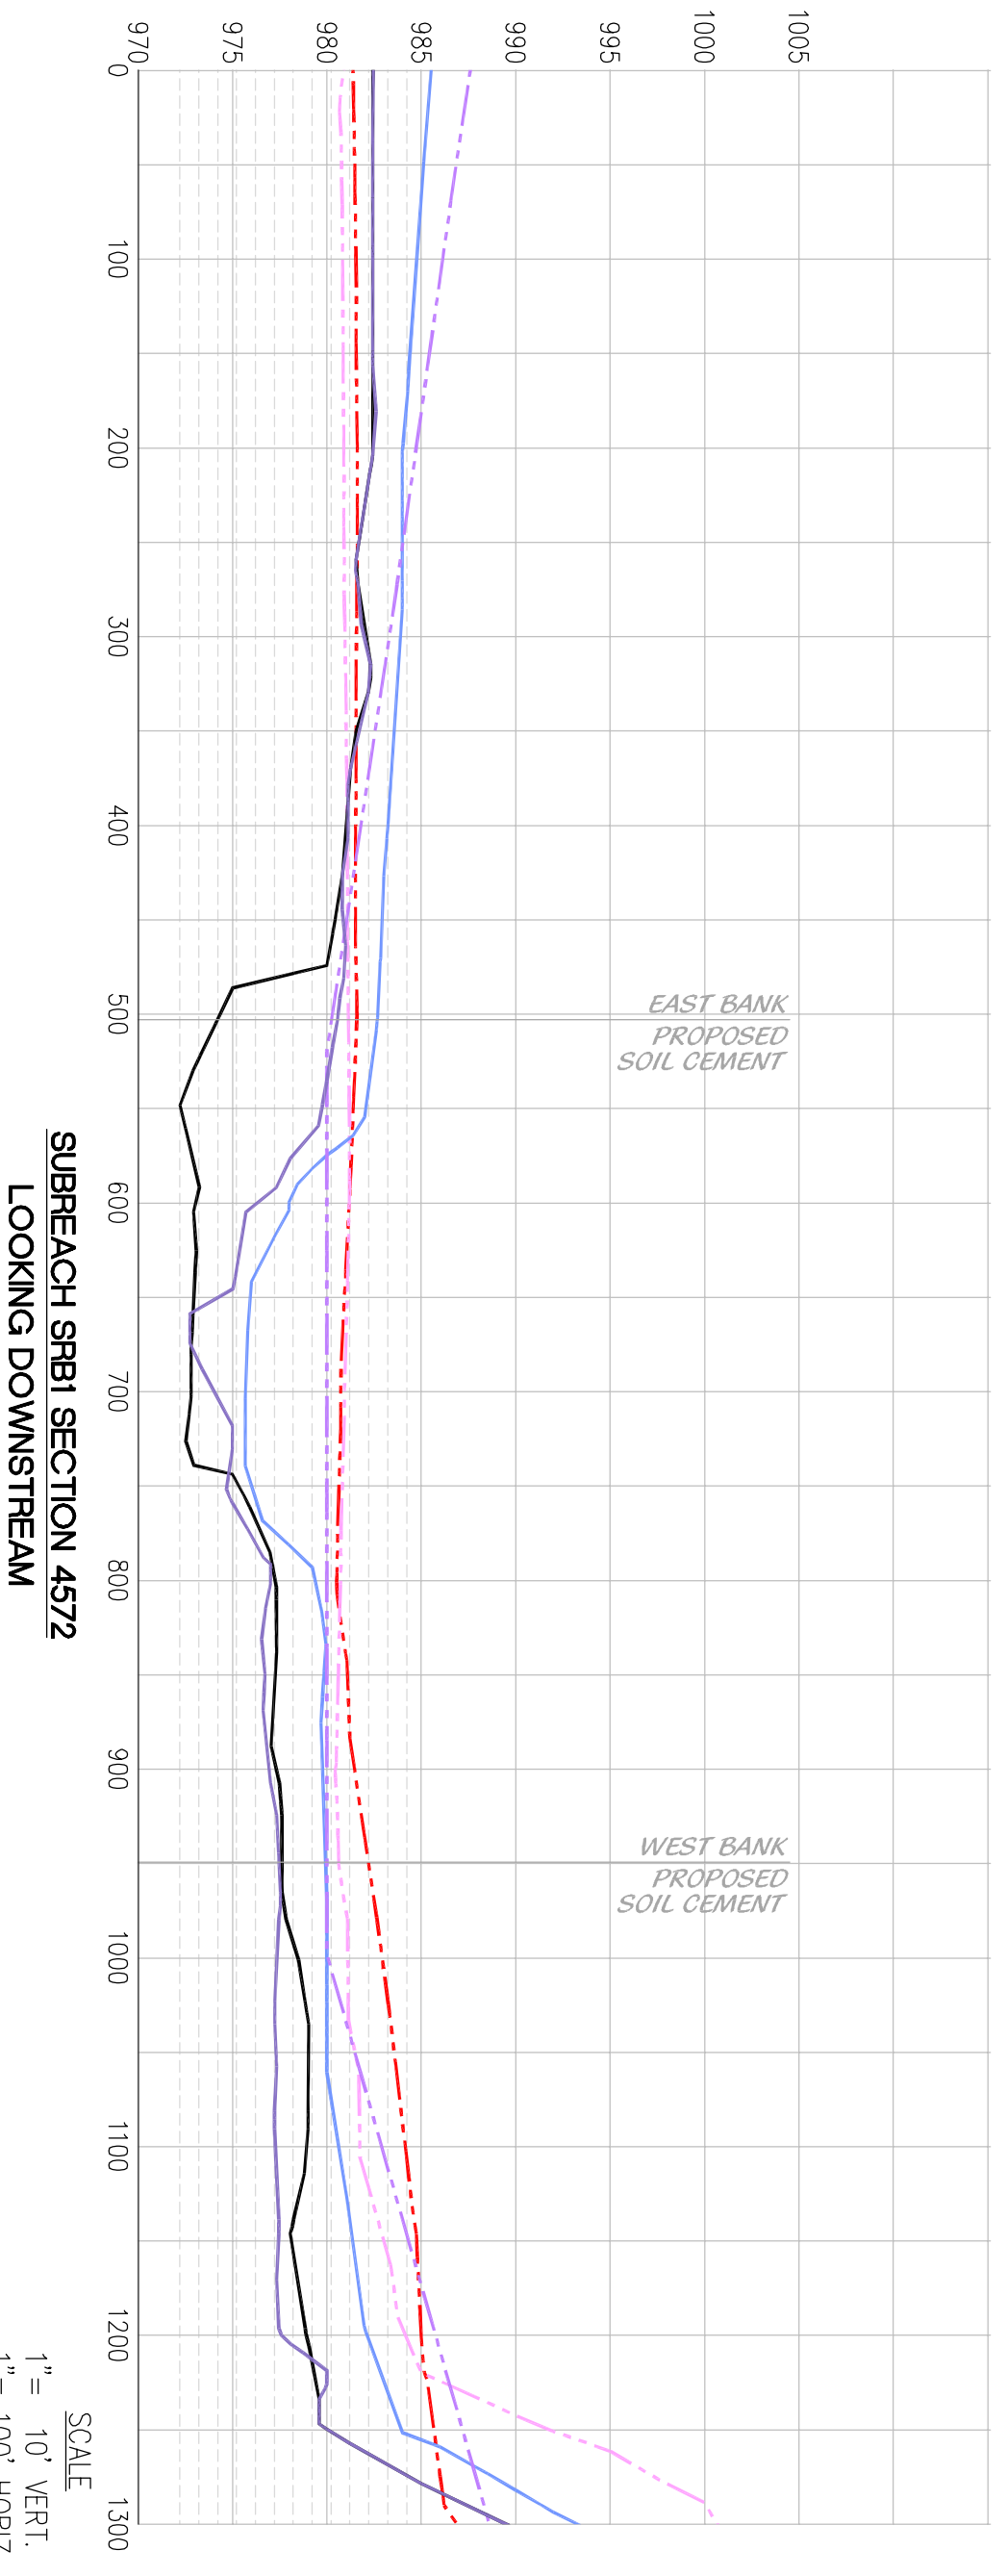
FIGURE  
**5.2D**

**SUBREACH SRB1 SECTION 4572  
LOOKING DOWNSTREAM**

Section 4572 (SRB1) shows continuous degradation for the majority of the section from 1963 until the present. Degradation was 2.1 feet between 1999 and 2005 but only 0.5 feet between 2004 and 2005 (Table 5.1). It is important to note that since 1963 the bed has continued to channelize and incise most likely from construction of the dam upstream. Additionally, agricultural activities occur on both sides of the channel in this reach so it is possible that some of the channelization will have resulted from these activities. It is important to note, however, that agricultural activities were commenced prior to the construction of the dam and data from pre-construction times does not appear to indicate incisement.

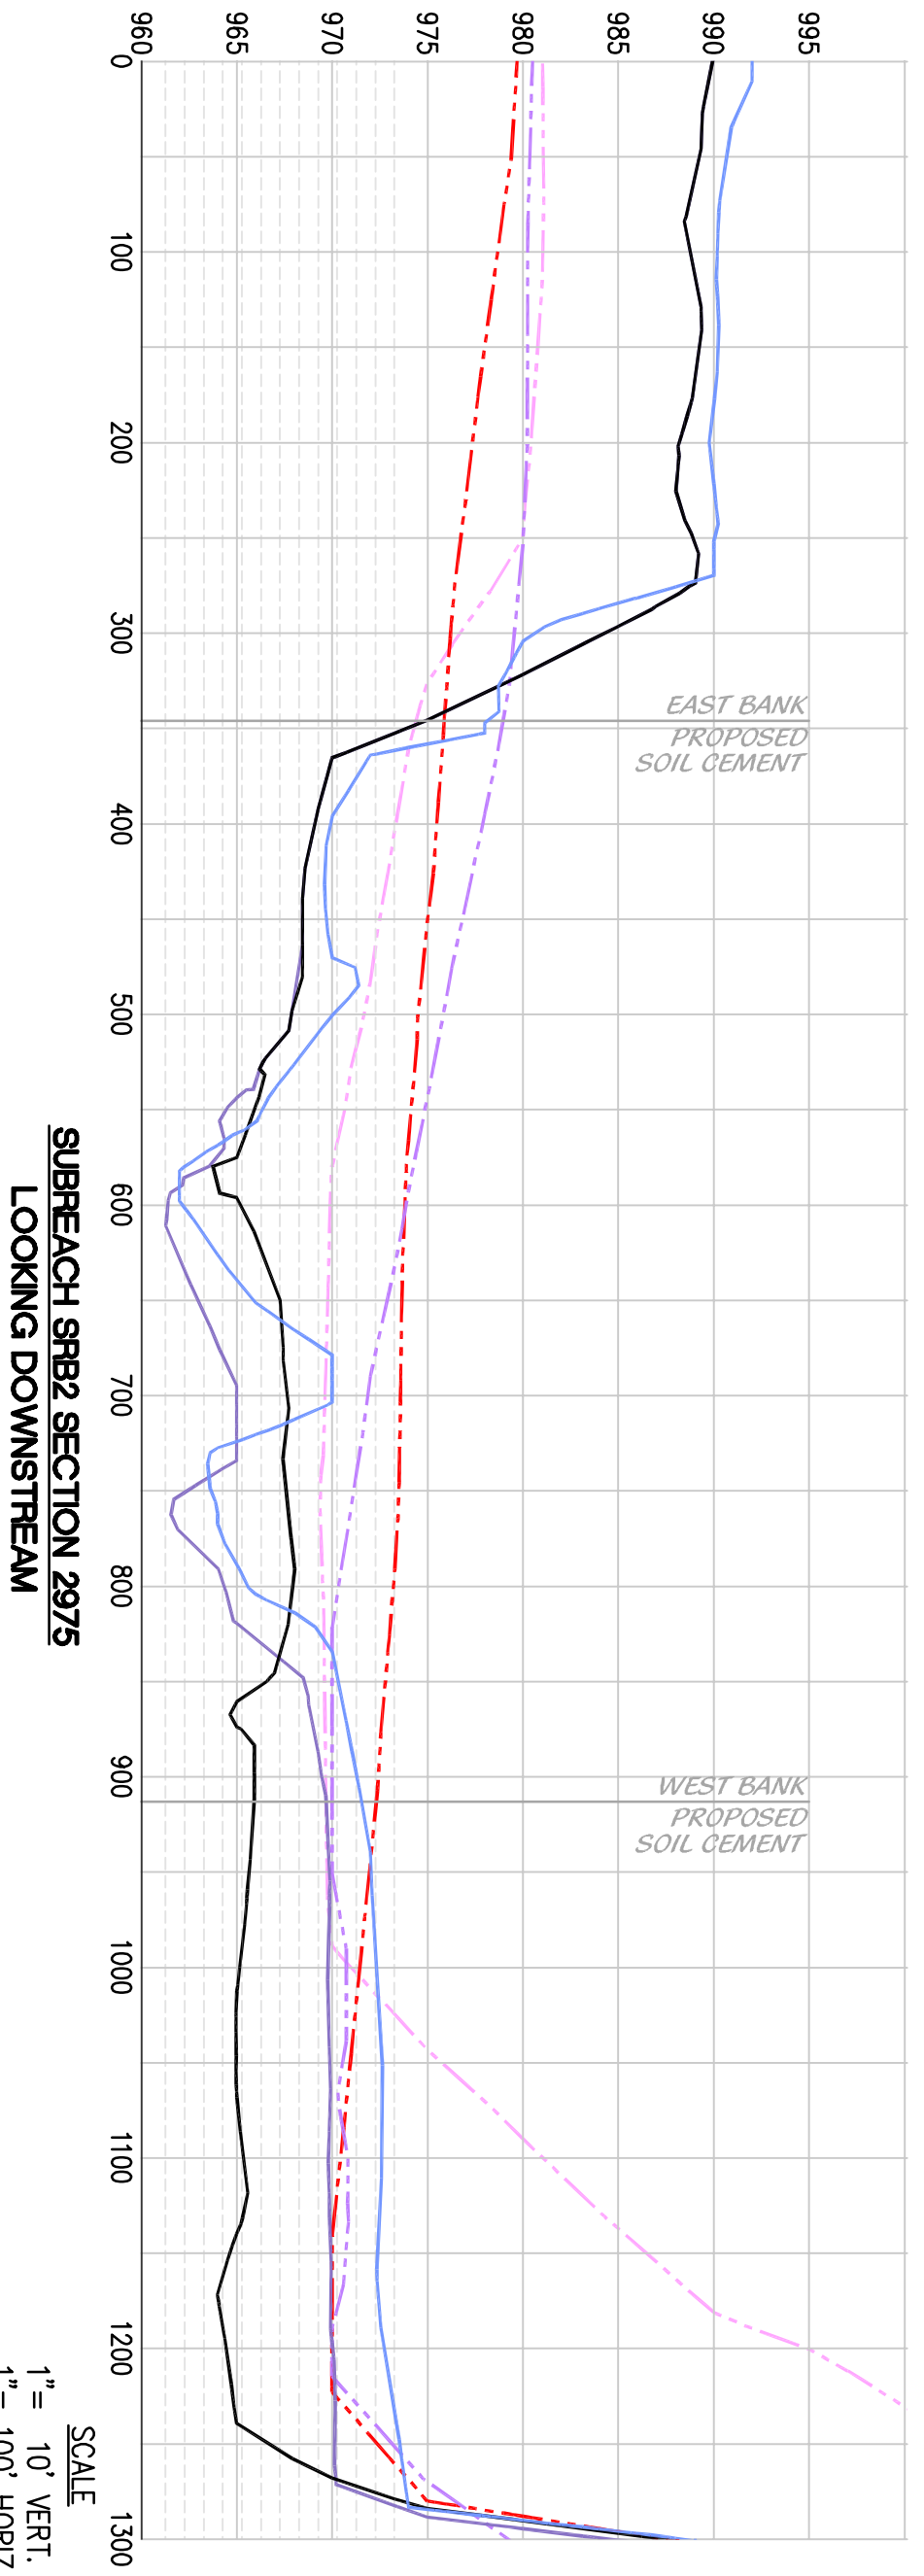
FIGURE  
**5.2E**

CROSS SECTIONAL AREAS AT STA 2975 (sf)			
ELEV	1999	2004	2005
962.3	1.3	38.9	0.0
963.3	21.0	98.5	0.0
964.3	67.1	147.4	8.4
965.3	128.2	234.6	150.7
966.3	172.6	288.7	413.8
967.3	208.2	315.0	524.0
968.3	239.2	344.0	700.4
969.3	269.5	437.6	842.9
970.3	337.3	681.9	891.6
971.3	473.8	908.7	907.6
972.3	558.3	917.6	915.6
973.3	796.4	926.0	923.0
Cumulative Area	3272.8	5338.9	6278.1

Section 2975 (SRB2) shows continuous degradation since the construction of the Dam: 2.7 feet between 1999 and 2005 with the majority of the degradation between 2004 and 2005 occurring on the west side of the bed past station 850. The thalweg depths in both 1999 and 2004 are lower than in 2005 despite the continued

degradation into 2005 suggesting that the bed is approaching the armor depth below which no additional degradation will occur. The 1930 feature from station 1000 and to the west is the result of coarse resolution of the data in this portion of the Creek for that year. Section 2627 (SRB2) in the same reach as 2975 shows the same features and trends with similar average sectional degradation (2.8 feet at section 2627 vs. 2.7 feet at section 2975).

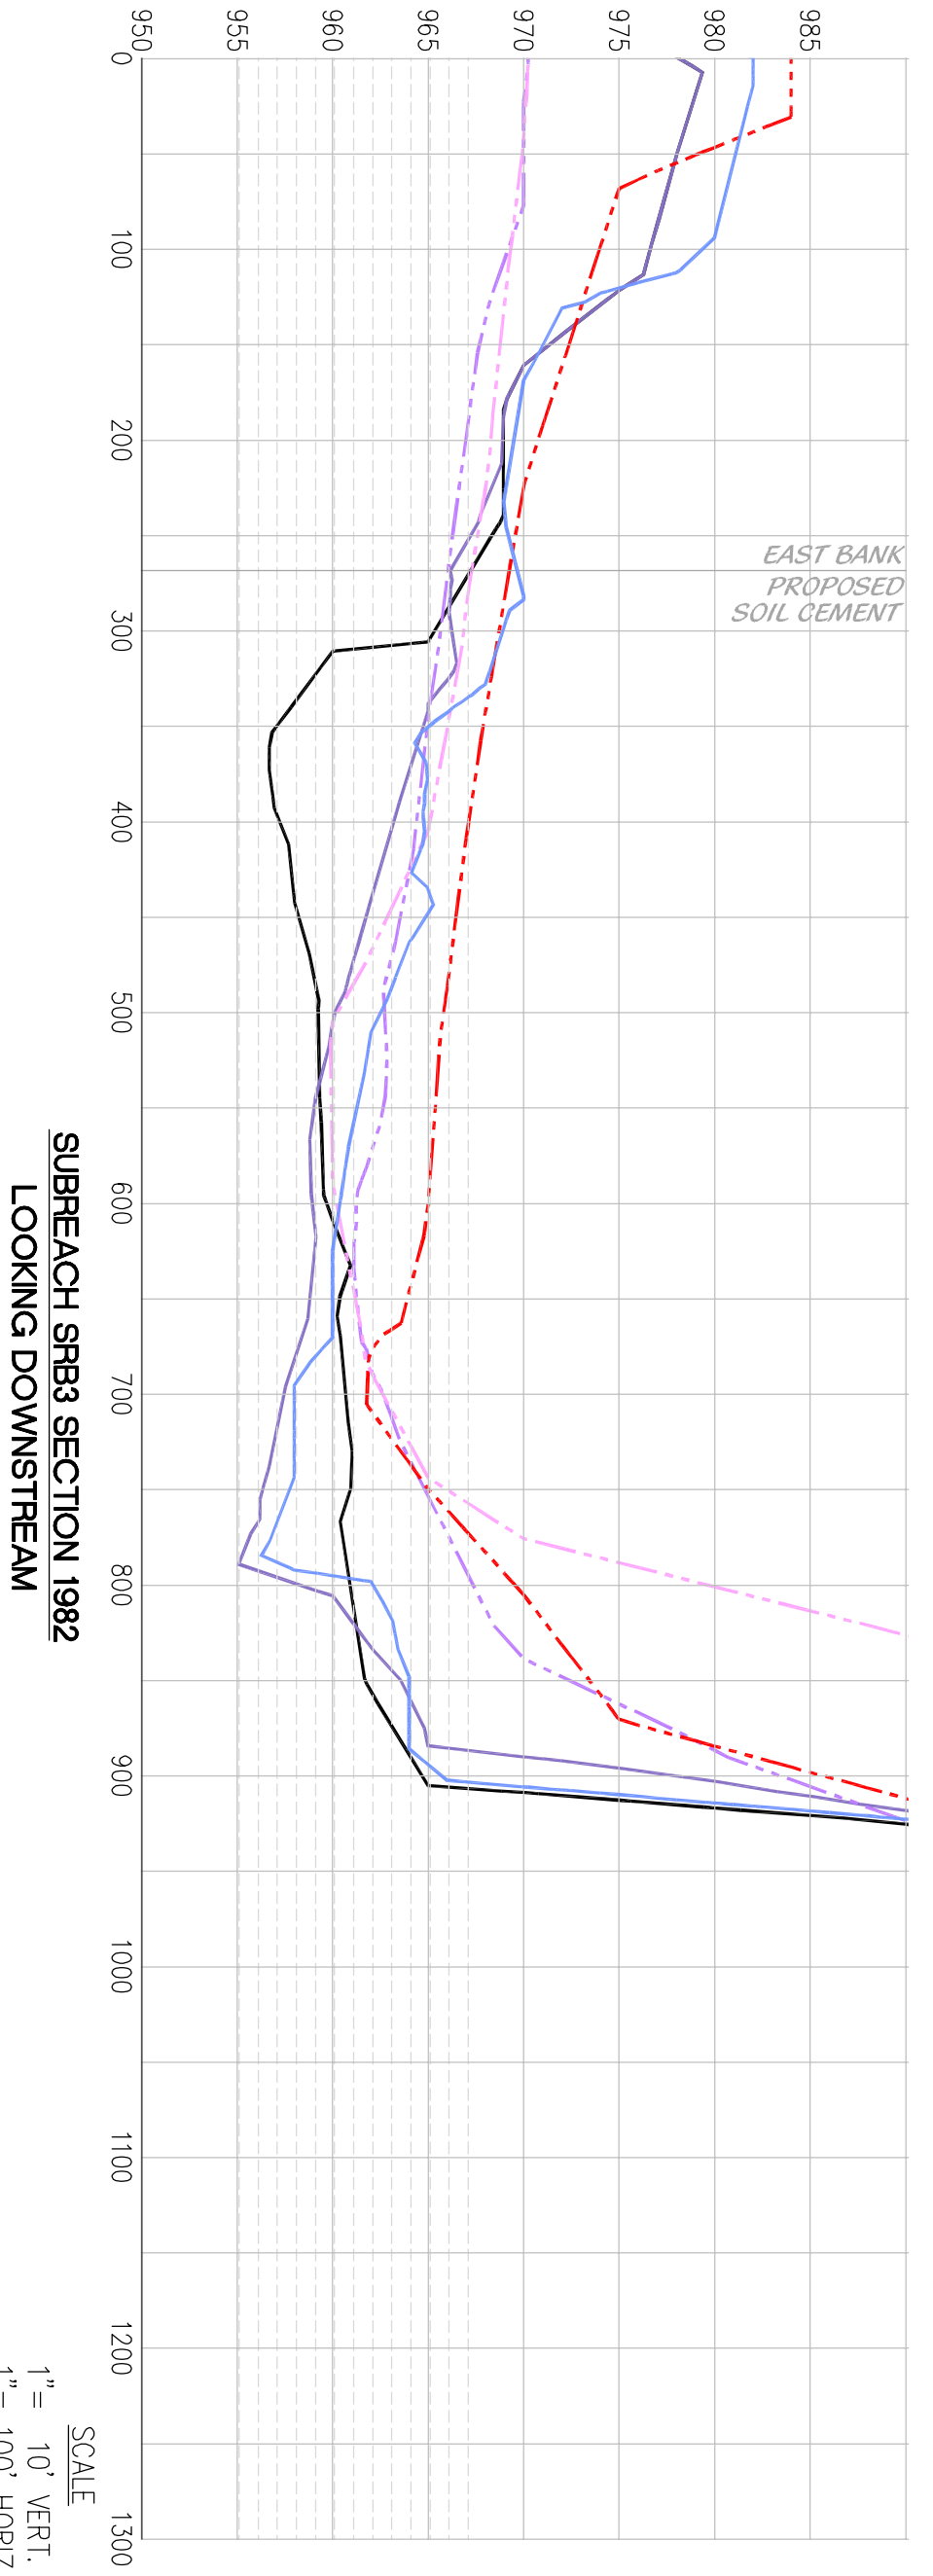
5.2G

CROSS SECTIONAL AREAS AT STA 1982 (sf)			
ELEV	1999	2004	2005
956.1	0.0	13.8	0.0
957.1	8.1	53.6	14.2
958.1	41.3	101.7	72.3
959.1	105.6	155.3	134.3
960.1	124.5	281.9	256.8
961.1	209.7	328.3	388.1
962.1	265.5	372.2	531.0
963.1	311.5	419.1	557.7
964.1	366.2	465.2	575.1
965.1	473.0	517.8	592.4
966.1	552.7	554.3	609.8
967.1	564.9	617.5	627.2
<b>Cumulative Area</b>	<b>3023.0</b>	<b>3880.7</b>	<b>4358.7</b>

Three sections reside in SRB3: 1982, 1645 and 1531. For all three sections the topographies before the construction of the Dam are somewhat variable with respect to sectional characteristics such as depth and area. It should be noted that the west bank topographic data for these years is fairly coarse in the area of this subreach so the positions and elevations of the bank should be considered relative. The highway construction can be seen on the east side of these sections. The most upstream section 1982 degraded consistently between 1999 and 2005 by 1.5 feet on average and 0.6 feet on average between 2004 and 2005. The two downstream sections, section 1645 and section 1531, both degraded between 1999 and 2005 by 0.1 and 0.2 feet on average, respectively. These two sections aggraded, however, between 2004 and 2005 by 1.6 and 0.4 feet on average, respectively. While it is unclear why the observed aggradation occurred it is presently believed to be the result of the fires of Summer, 2004 and the heavy rains of the 2004/2005 rainy season. This combination had the potential to produce high sediment runoff loading into Hasley Canyon Creek, which confluences with Castaic Creek at Commerce Center Drive. Construction occurred on Hasley Canyon Creek prior to both the burn and high discharge events. How or if the construction may have contributed to the observed aggradation on Castaic Creek is presently unclear. It is important to note that the thalweg of Castaic Creek shifted away from the northwest bank in reach SRB3 during the 2004/2005 rainy season, as seen in Figure 5.2. The County has indicated that they believe the shift of thalweg location is the result of earth moving activities. Change in the position of the thalweg may also result from the confinement of the Creek under the Highway 126 Bridge such that the outside bank can no longer erode and the inside bank can not build.

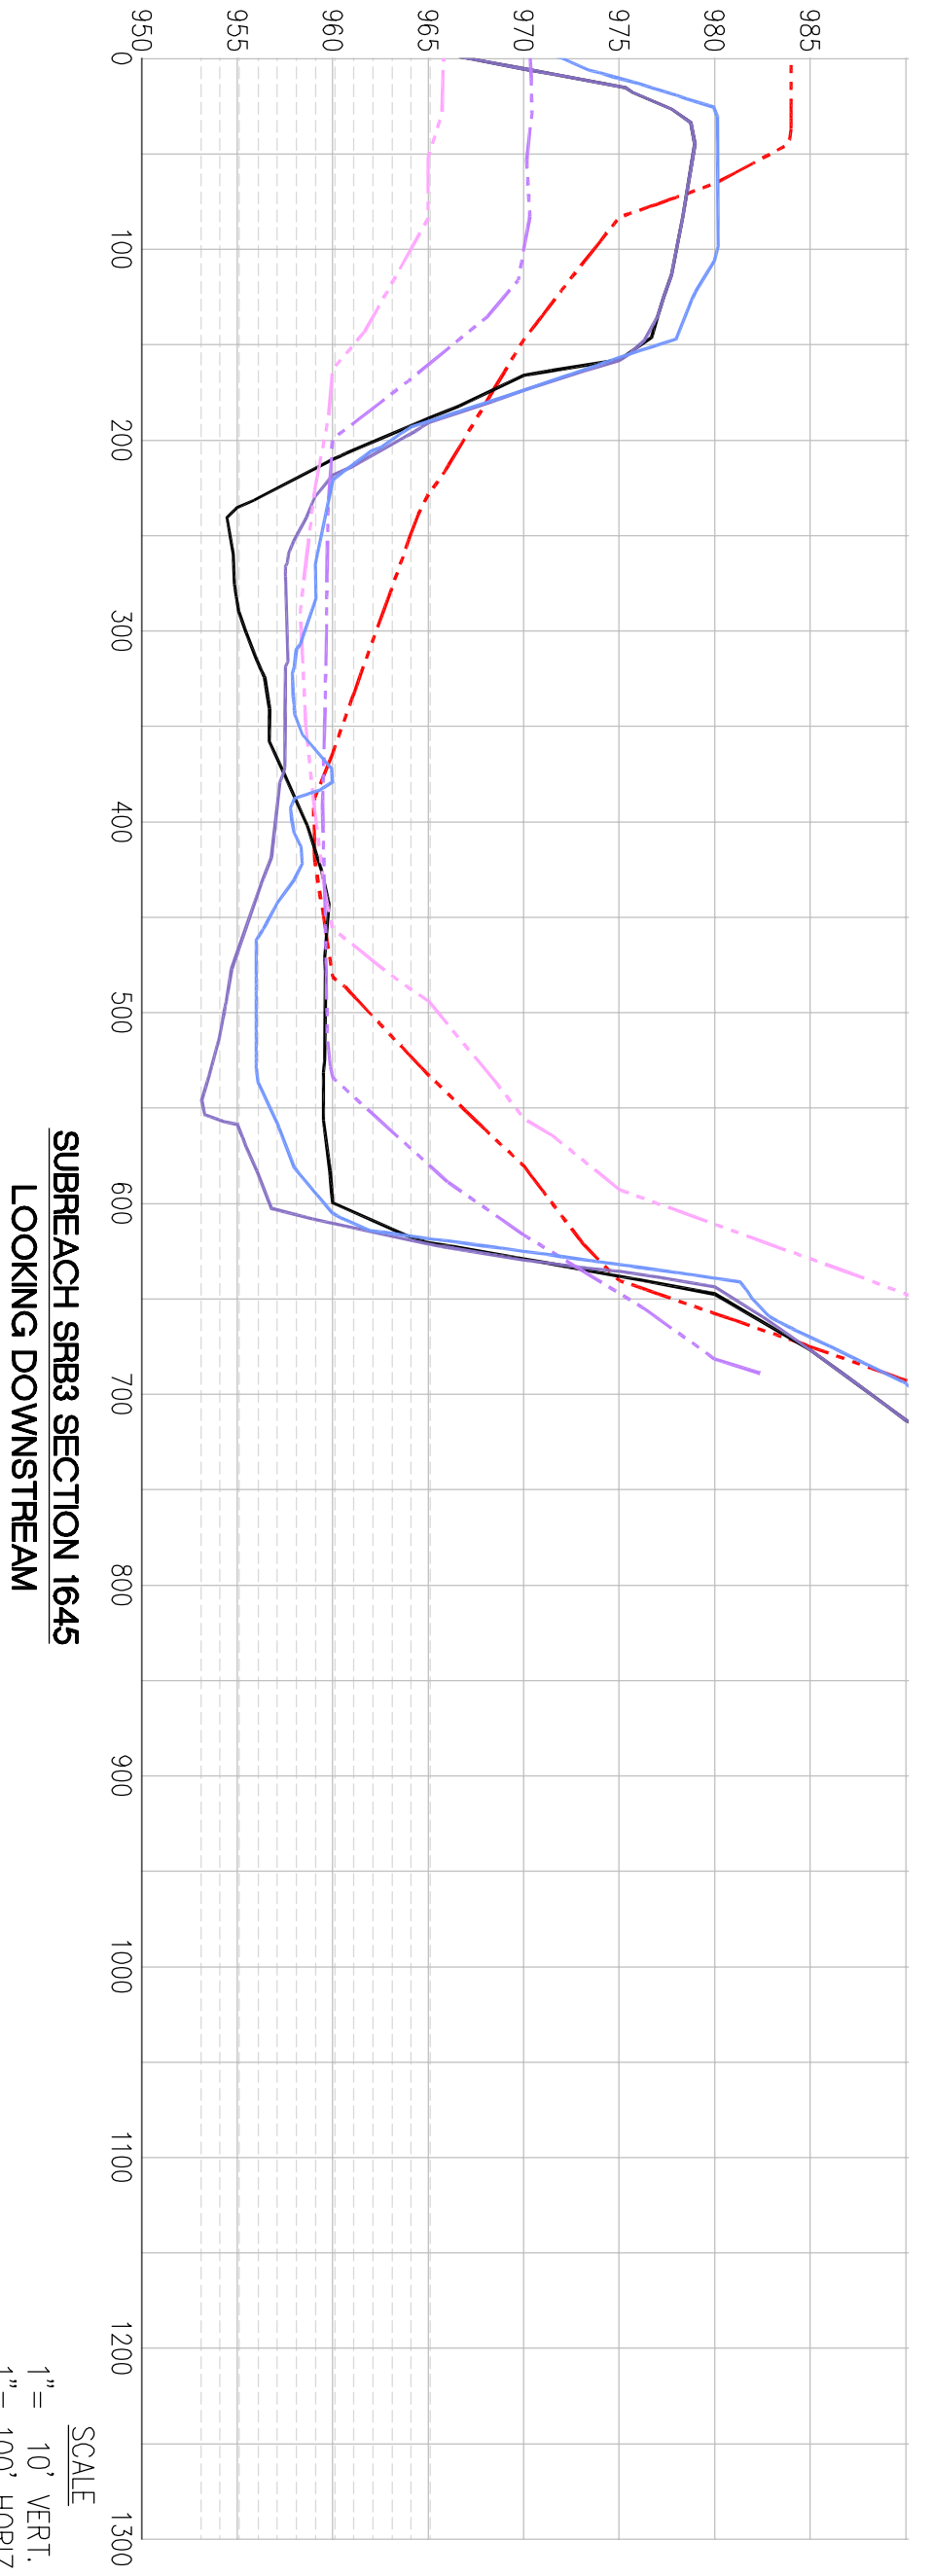
FIGURE  
**5.2H**

SUBREACH SRB3 SECTION 1645  
LOOKING DOWNSTREAM

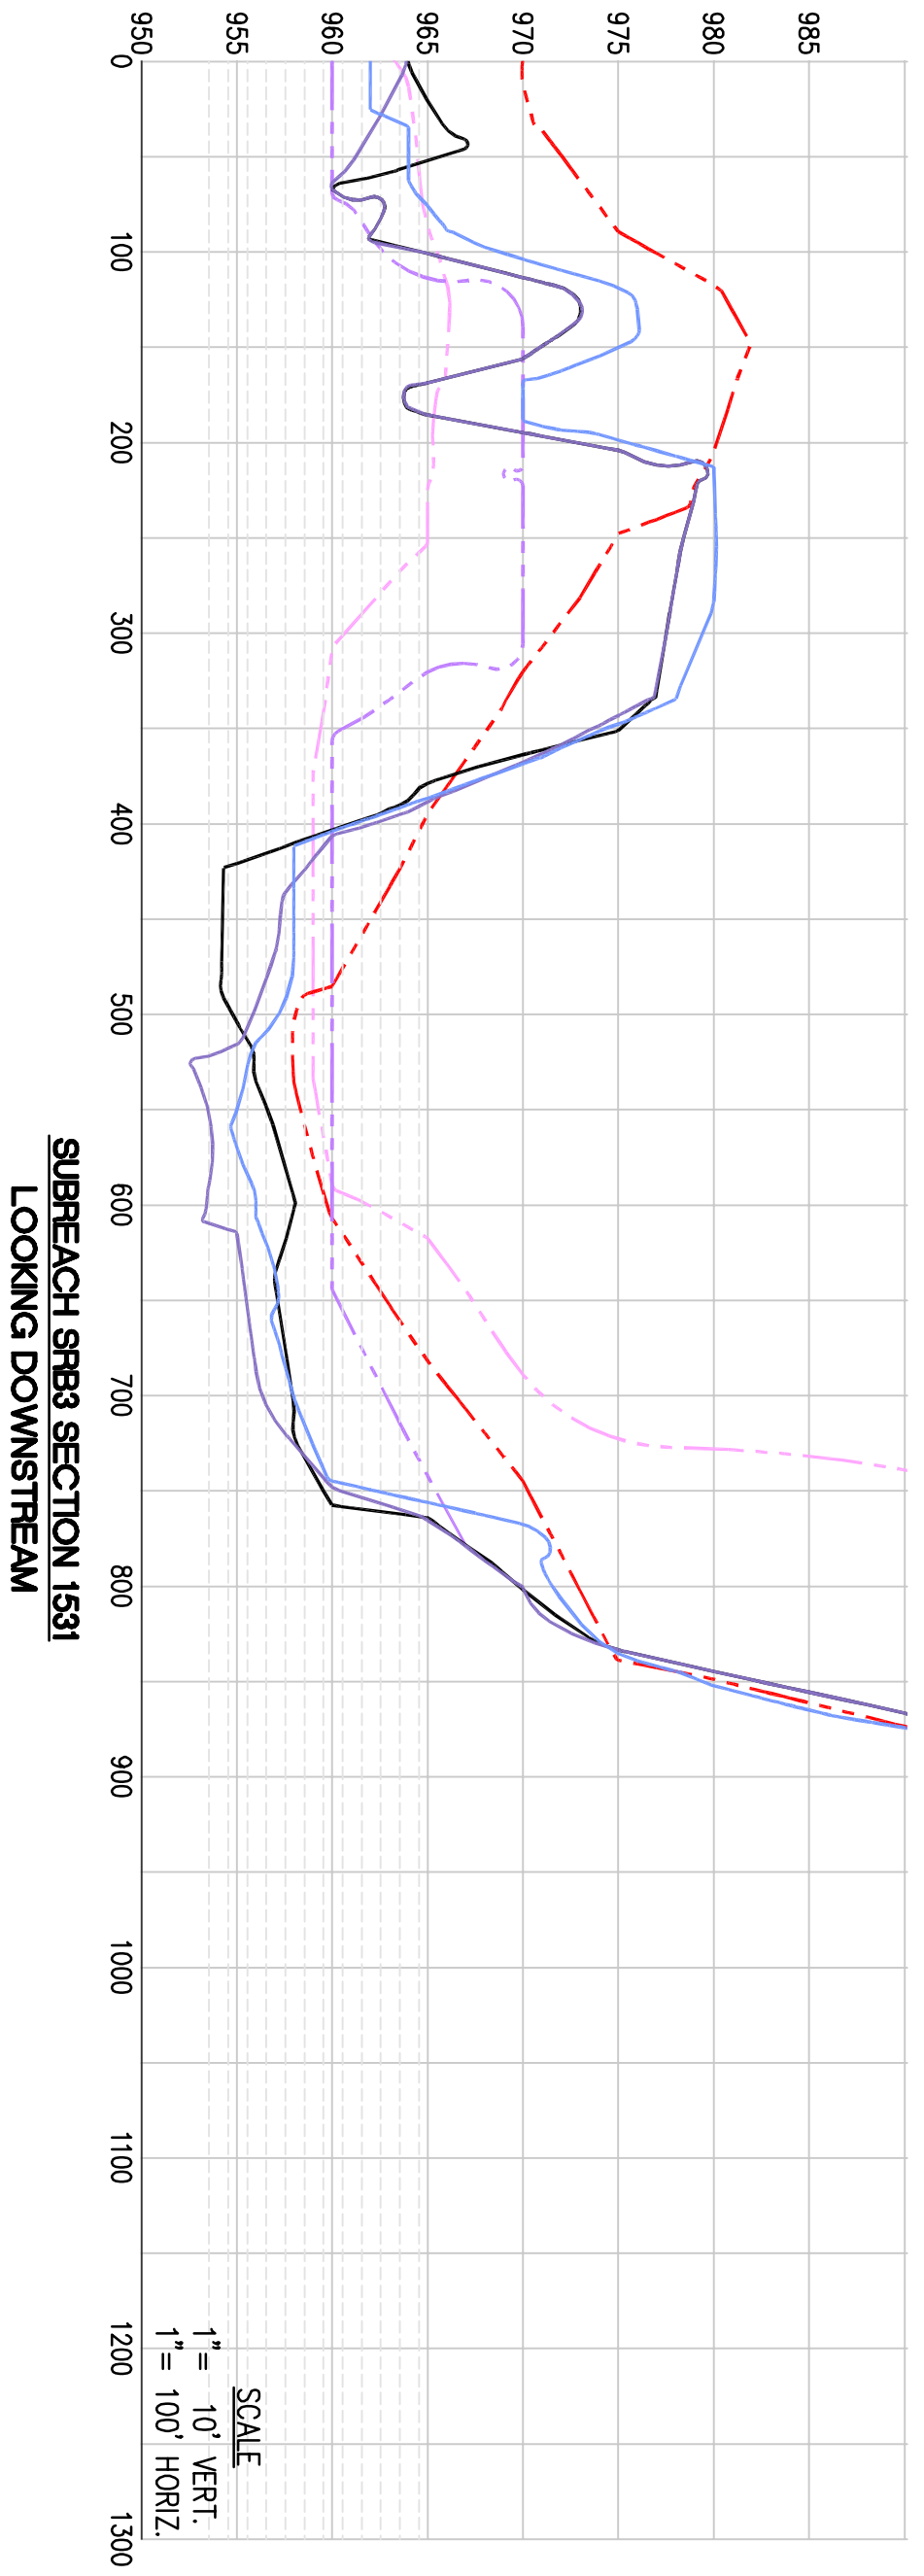
CROSS SECTIONAL AREAS AT STA 1531 (sf)			
ELEV	1999	2004	2005
953.6	0.0	5.5	0.0
954.6	0.0	38.3	3.1
955.6	13.6	91.0	77.7
956.6	65.0	170.3	97.1
957.6	125.8	239.4	144.7
958.6	218.3	288.3	256.4
959.6	318.1	311.6	329.8
960.6	337.6	336.0	349.4
961.6	345.2	347.0	358.1
962.6	350.9	352.8	362.6
963.6	356.7	359.2	367.8
964.6	362.4	365.9	372.7
Cumulative Area	2493.7	2905.4	2719.4
