## **Appendix 5.5 (Continued)**

Hydrology (Part 8 of 15)

JOB  
**CASTAIC CREEK  
 FLUVIAL STUDY**  
 LOS ANGELES COUNTY CA

TITLE  
**HISTORICAL  
 CROSS SECTIONS  
 BY STATION**

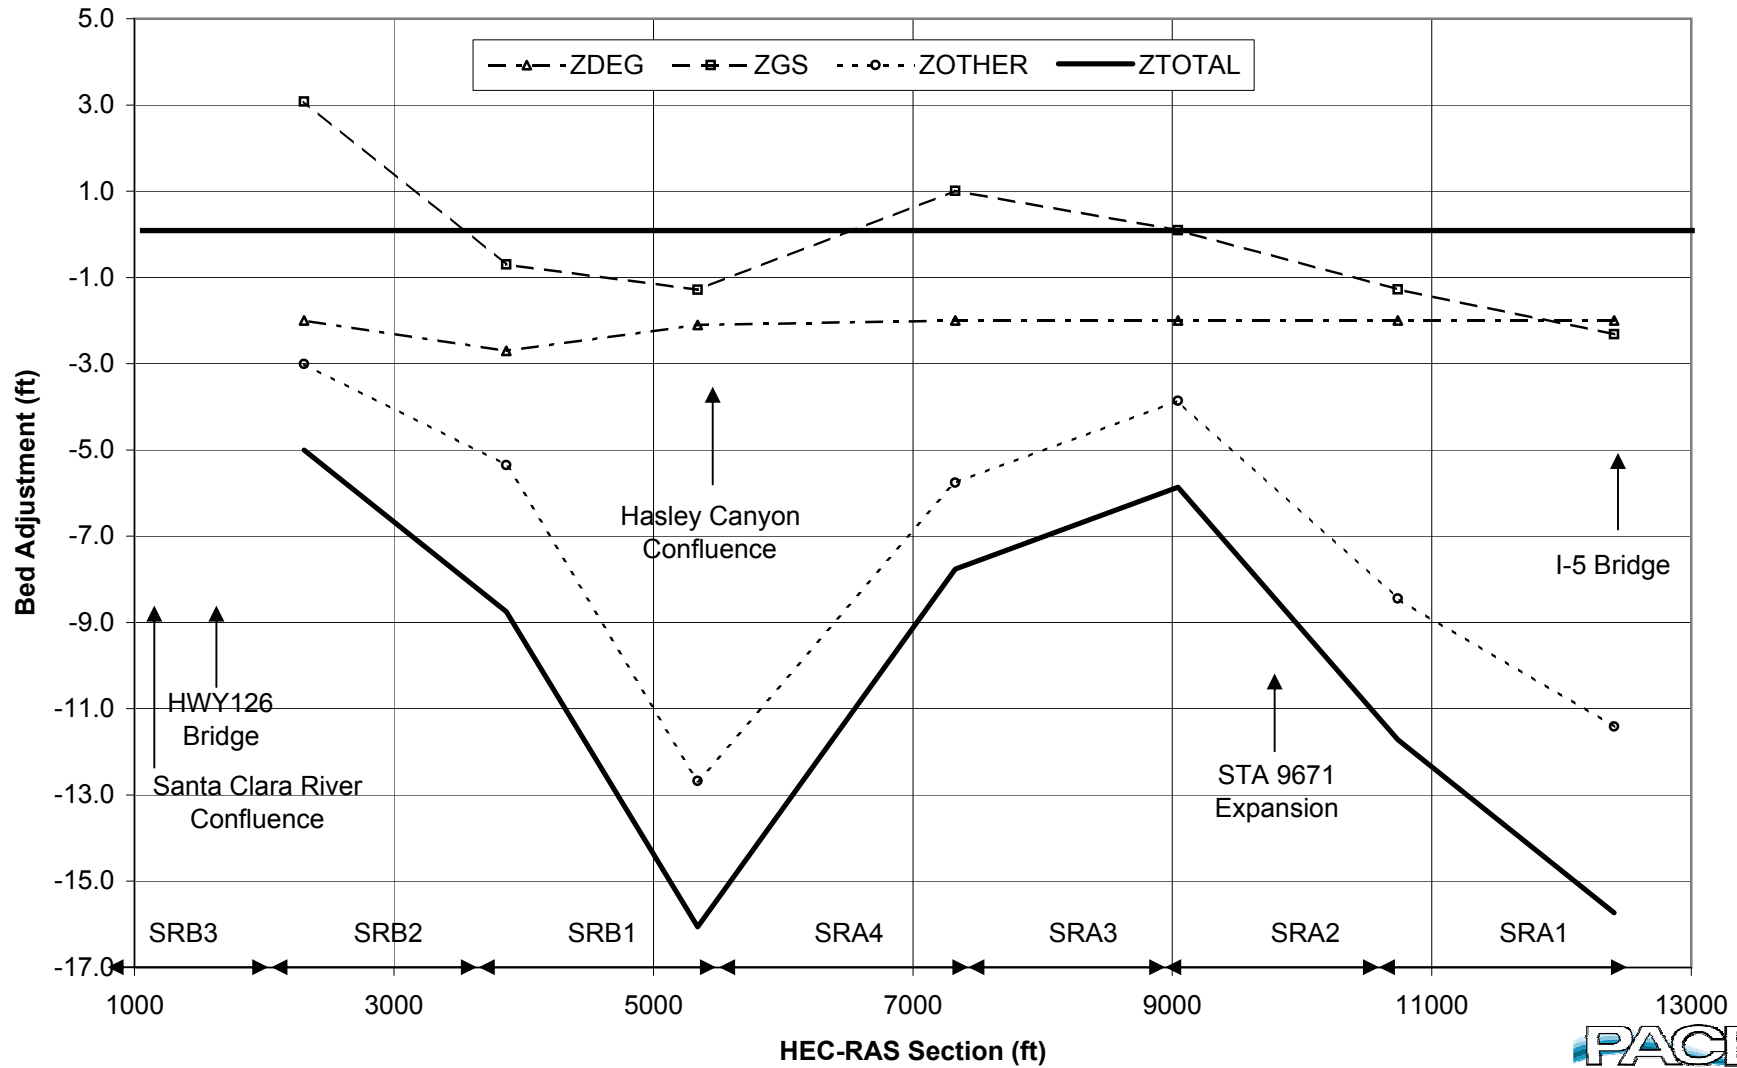
**Figure 7.1A: Castaic Creek Existing Conditions Outside Curved Reach Summary of Degradation Components**

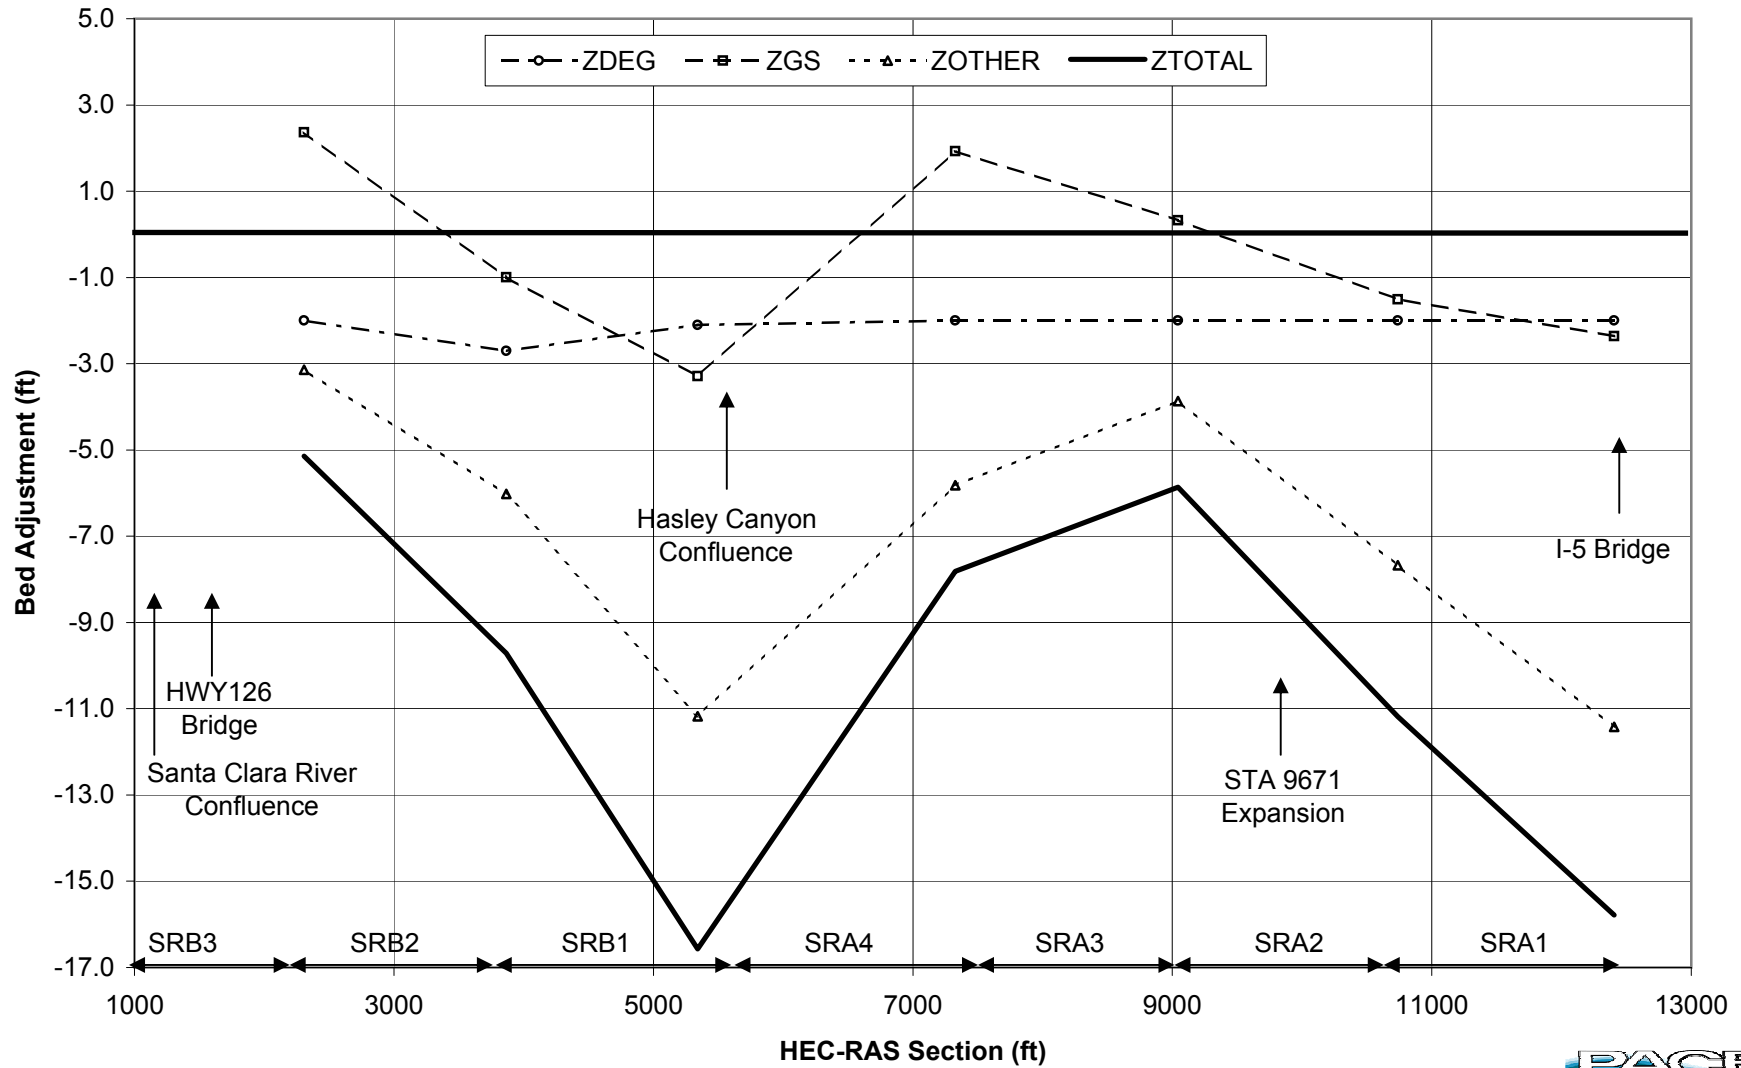
**Figure 7.1B: Castaic Creek Proposed Conditions Outside Curved Reach Summary of Degradation Components**

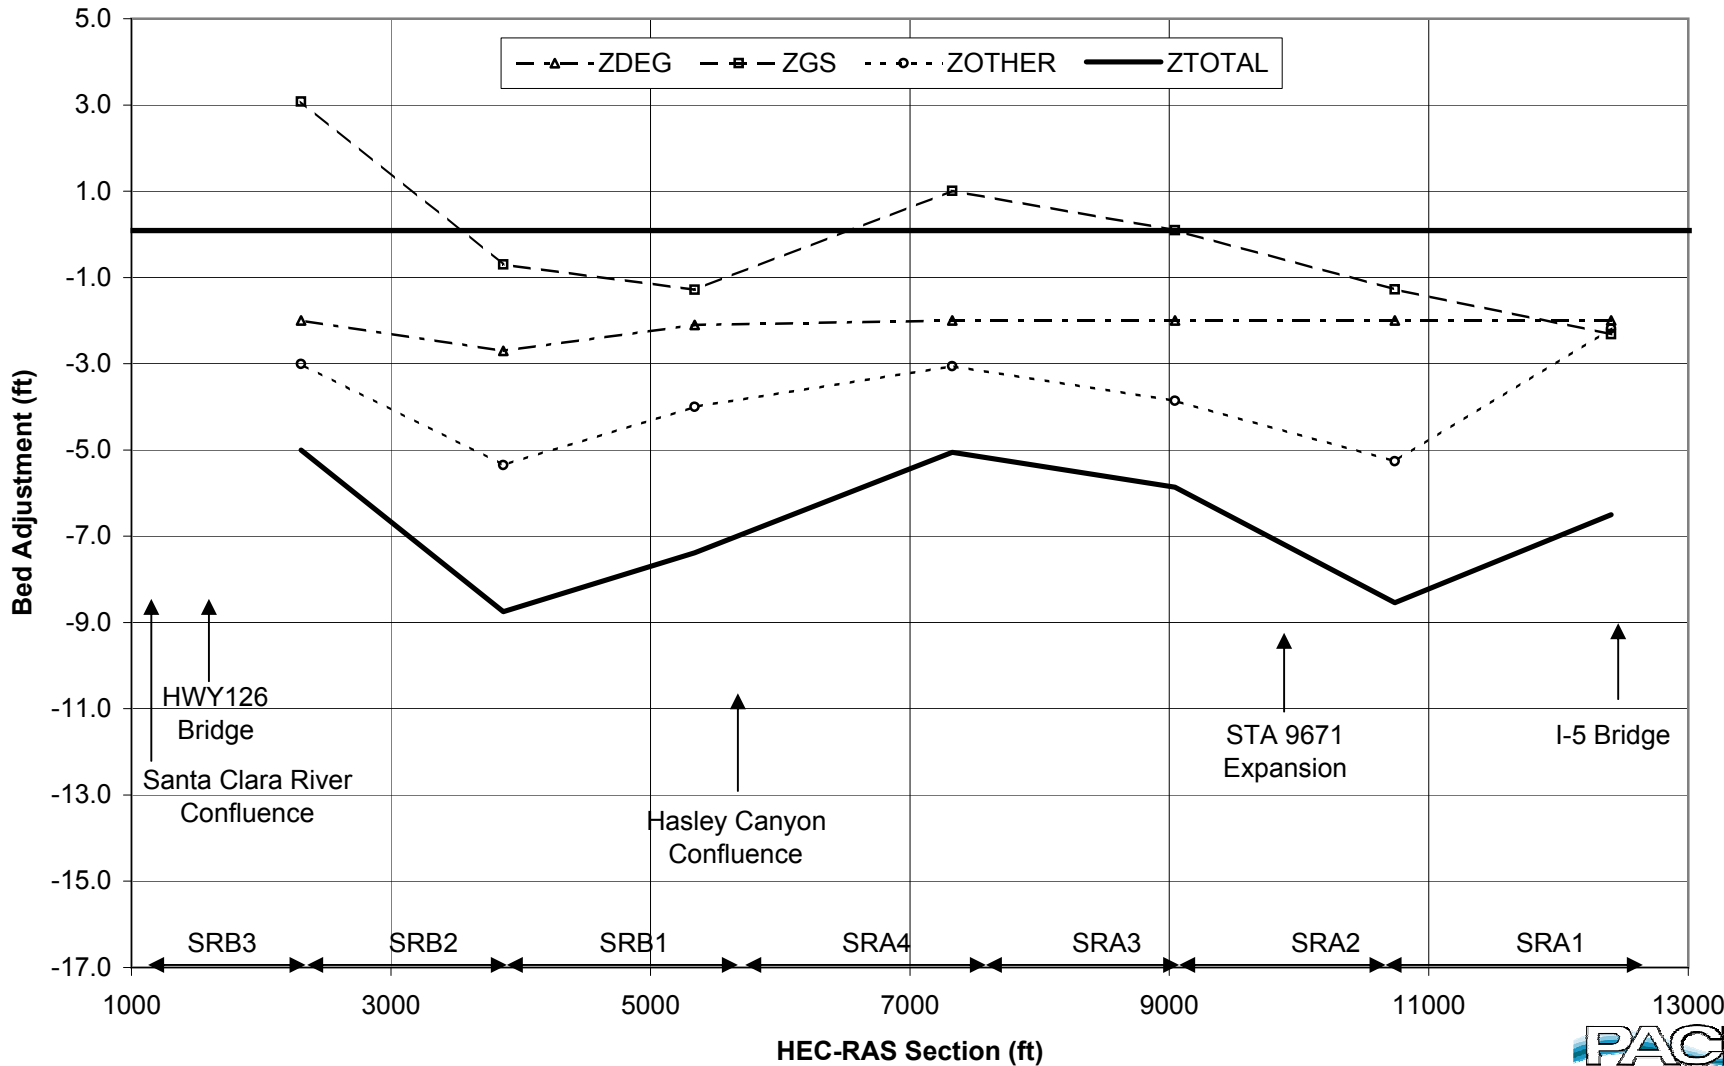
**Figure 7.1C: Castaic Creek Existing Conditions Straight-Inside Curved Reach Summary of Degradation Components**

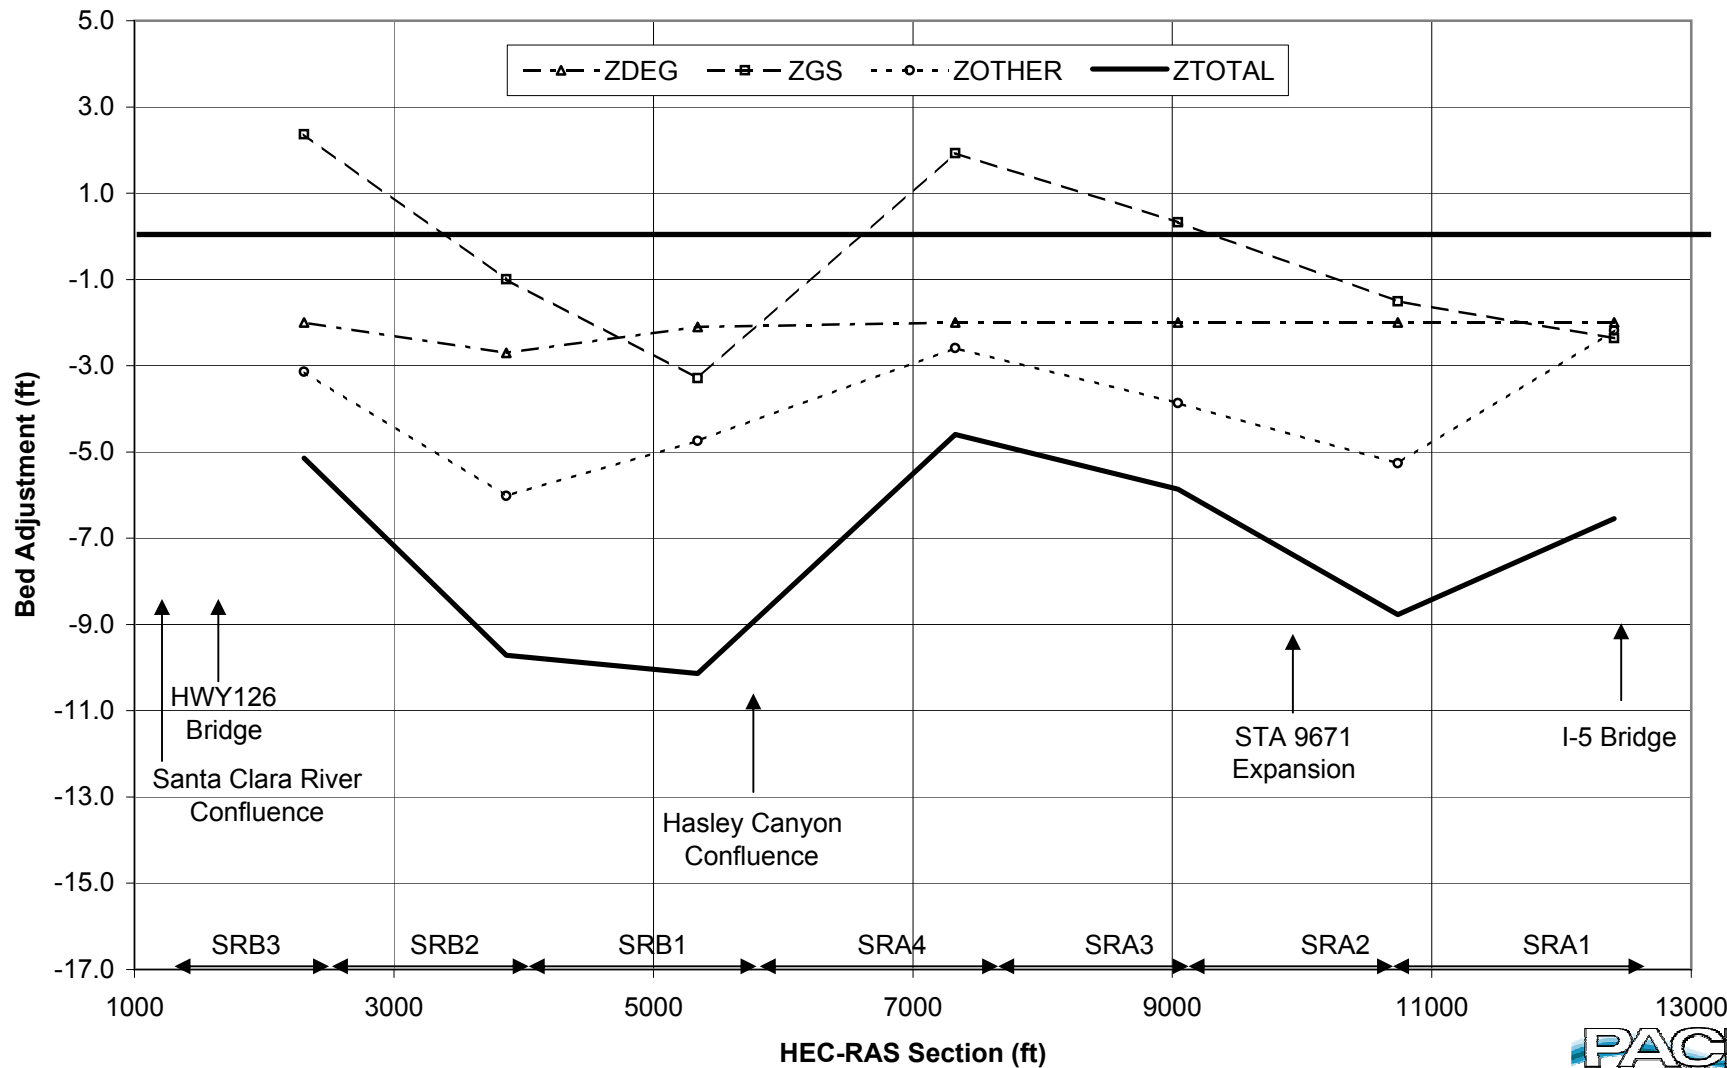
**Figure 7.1D: Castaic Creek Proposed Conditions Straight-Inside Curved Reach Summary of Degradation Components**

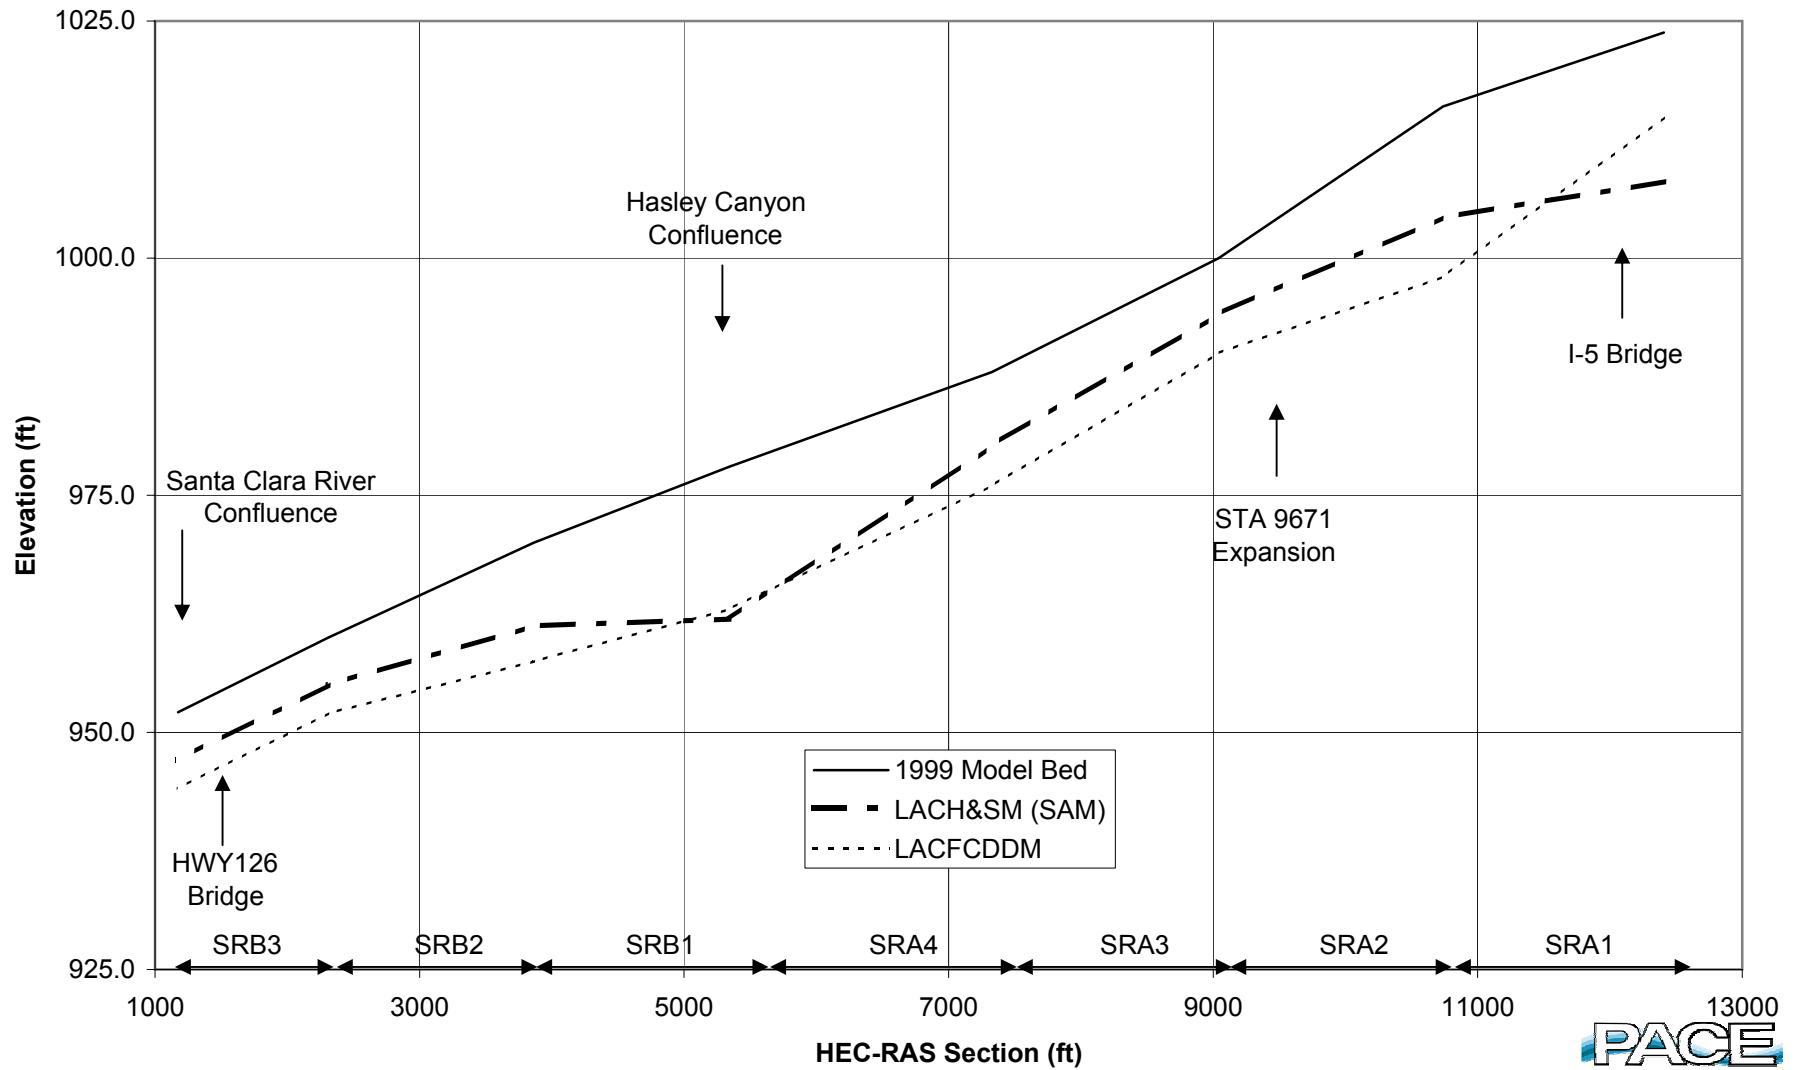
**Figure 7.2A: Castaic Creek Existing Conditions Outside Curved Reach Toe-down Depths by Methodology**

Figure 7.2A-D presents a comparison of total bed adjustment for the summed methodology, presented above, and the methodology based on the Los Angeles County Flood Control District's Design Manual (LACFCDDM), Table F-31. Calculations are shown in Table 7.2A-D. The LACFCDDM methodology is based only on velocity and does not account for any other river parameters. Generally, the LACFCDDM is the most conservative among all total scour methodologies. With the exception of the Hasley Canyon confluence where the proposed condition is more narrow than the existing condition, and at the Interstate 5 Bridge, Figure 7.2A-D shows

that the more intensive LACH&SM methodology predicts a shallower toe-down in both the existing and proposed conditions than does the LACFCDDM methodology for most sections. The LACFCDDM does not effectively account for the local degradation, therefore, the LACH&SM methodology utilizing SAM calculations predicts a deeper toe-down at some locations than does the LACFCDDM methodology. Figure 7.3A-B shows the 1999 (model) minimum bed elevation as discussed in Chapter 4, previously, and the the total toe-down expected to be needed to protect each condition. The figure shows little change between the existing and proposed conditions except in the vicinity of the proposed commerce center bridge and downstream of the Hasley Creek Confluence.

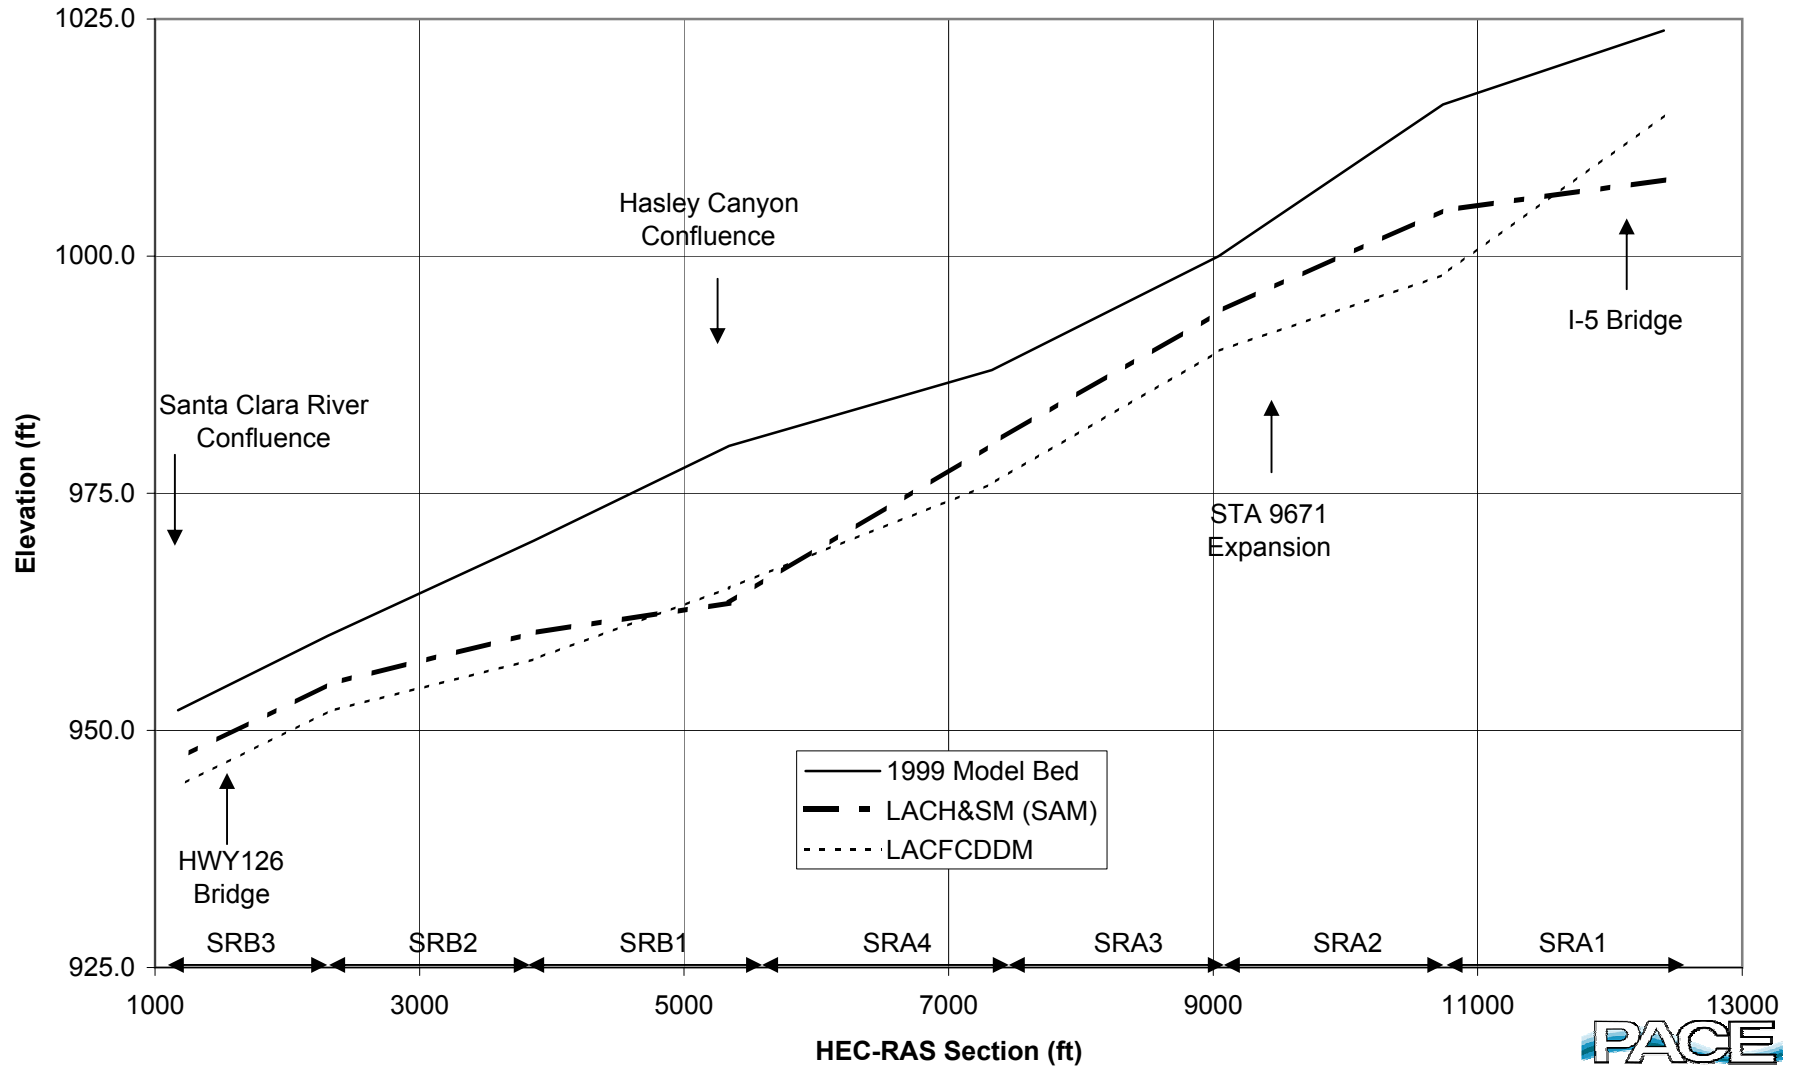
**Figure 7.2B: Castaic Creek Proposed Conditions Outside Curved Reach Toe-down Depths by Methodology**

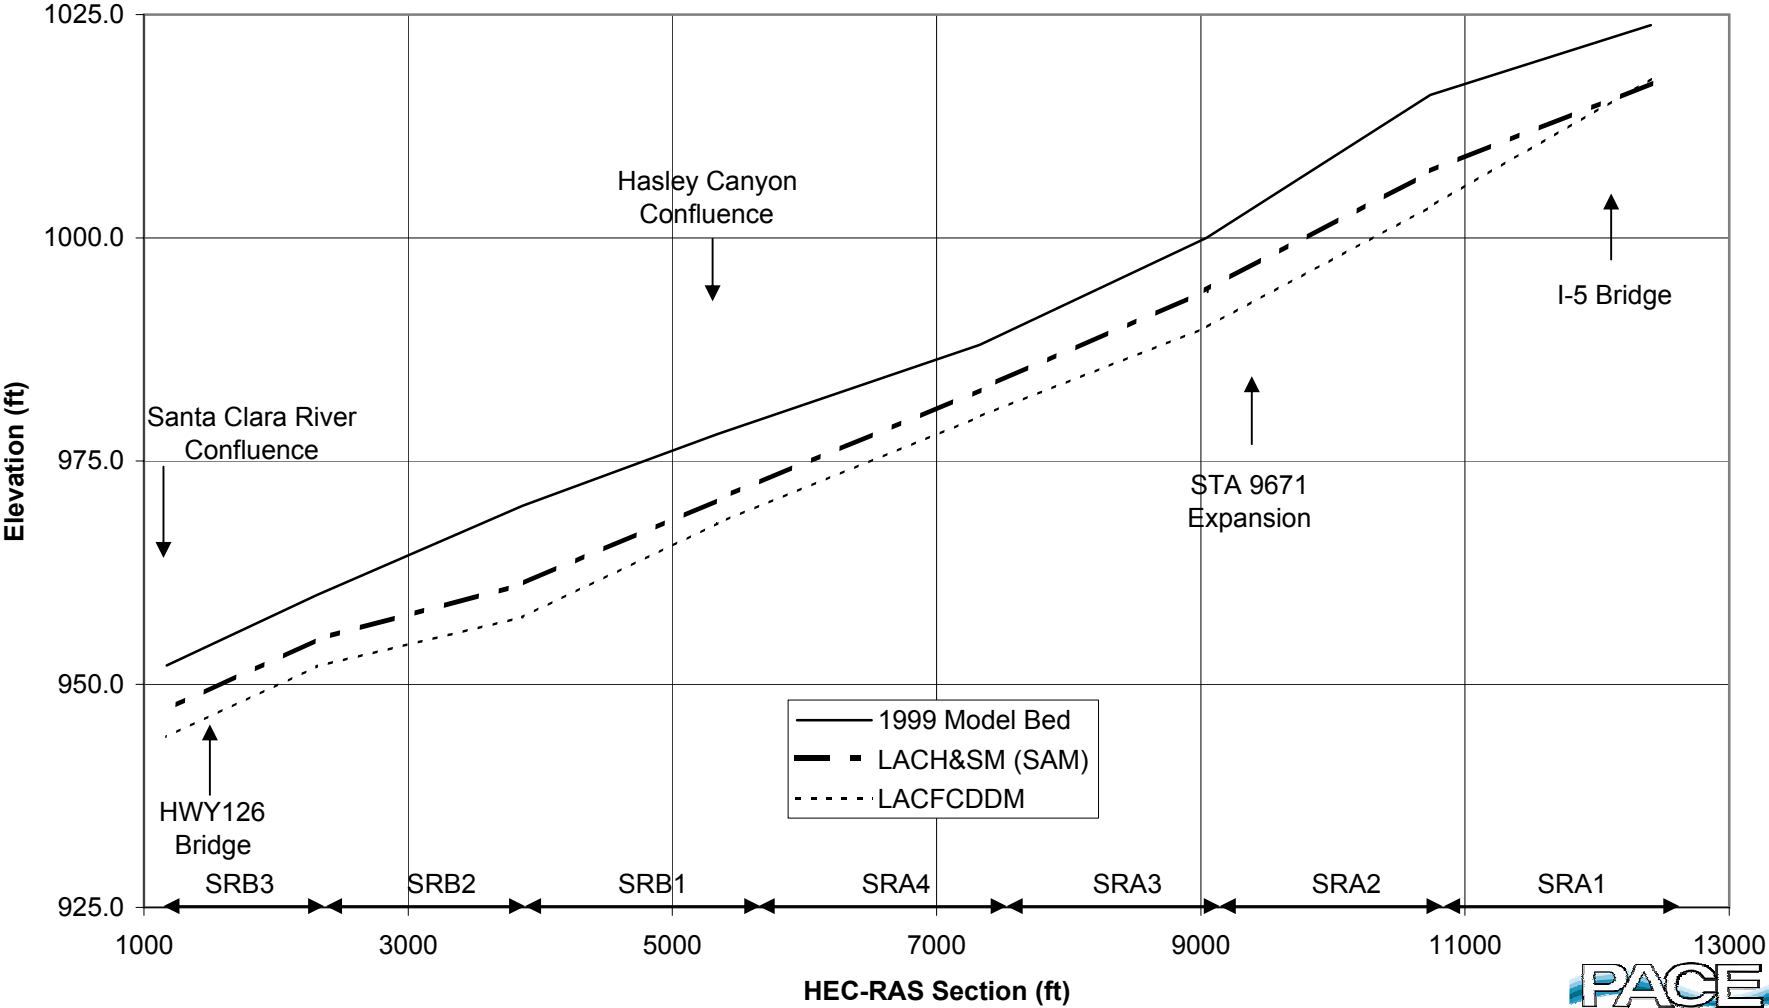
**Figure 7.2C: Castaic Creek Existing Conditions Straight-Inside Curved Reach Toe-down Depths by Methodology**

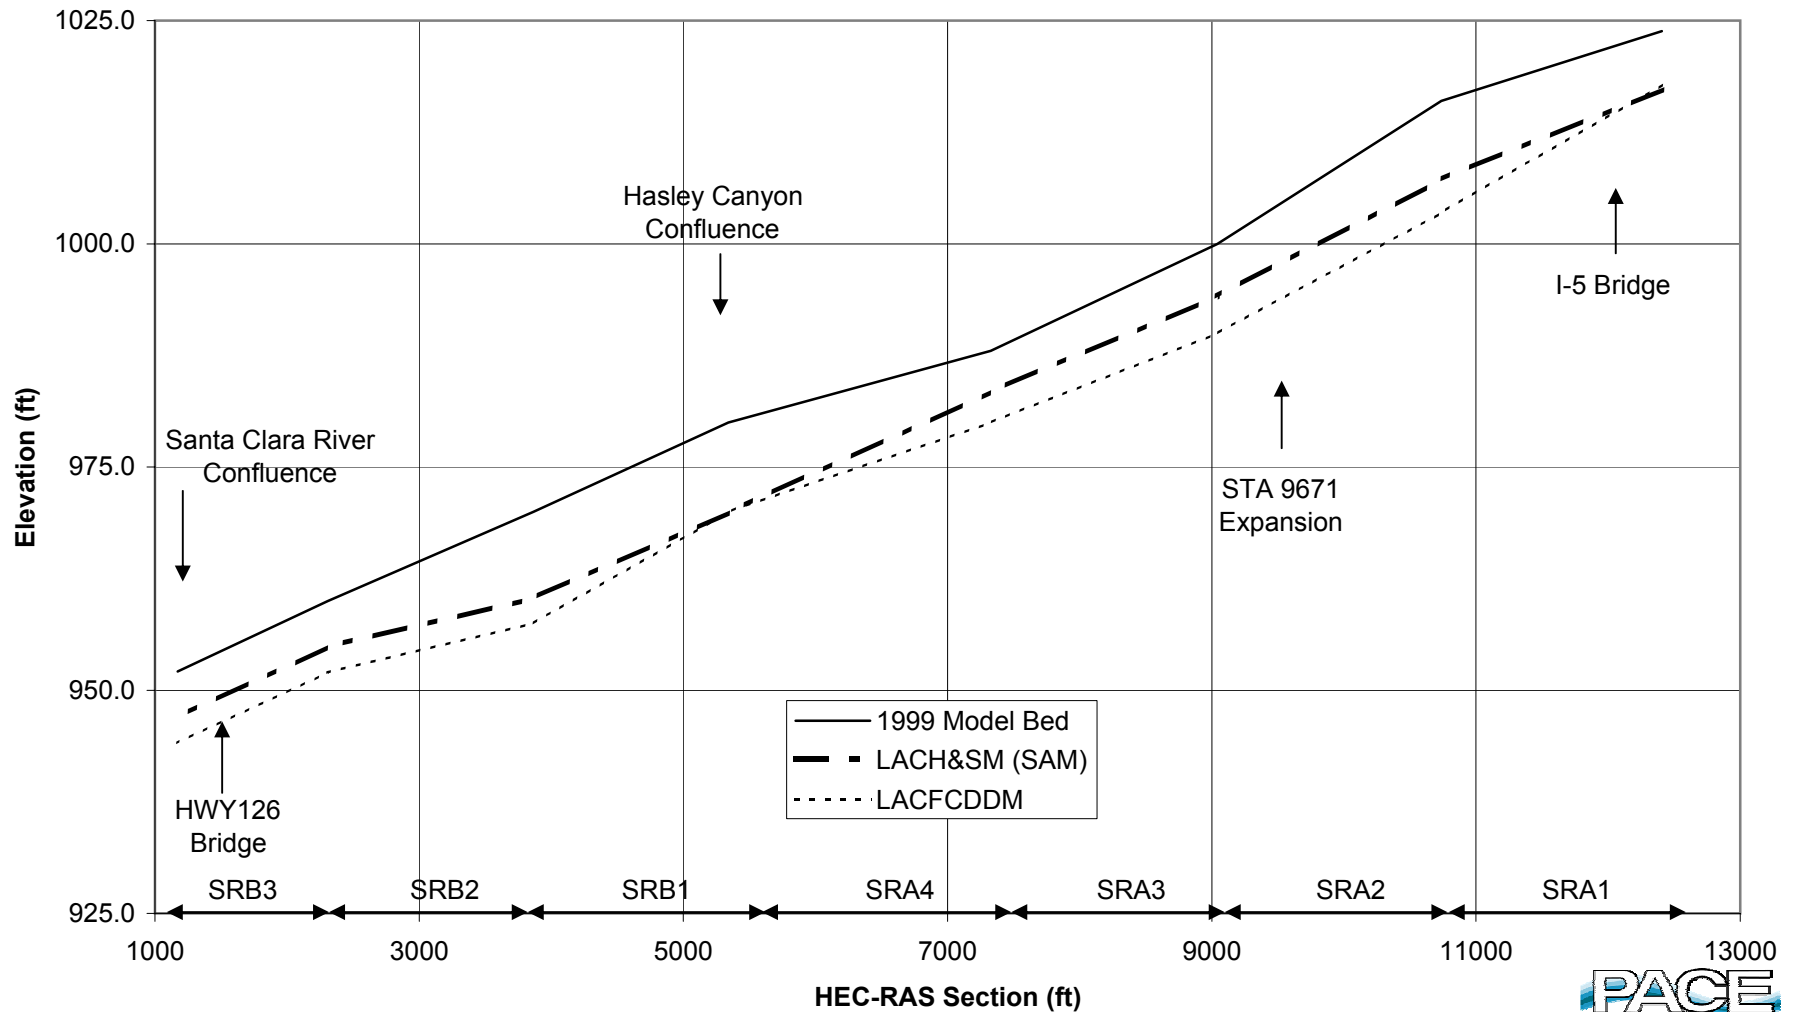
**Figure 7.2D: Castaic Creek Proposed Conditions Straight-Inside Curved Reach Toe-down  
Depths by Methodology**

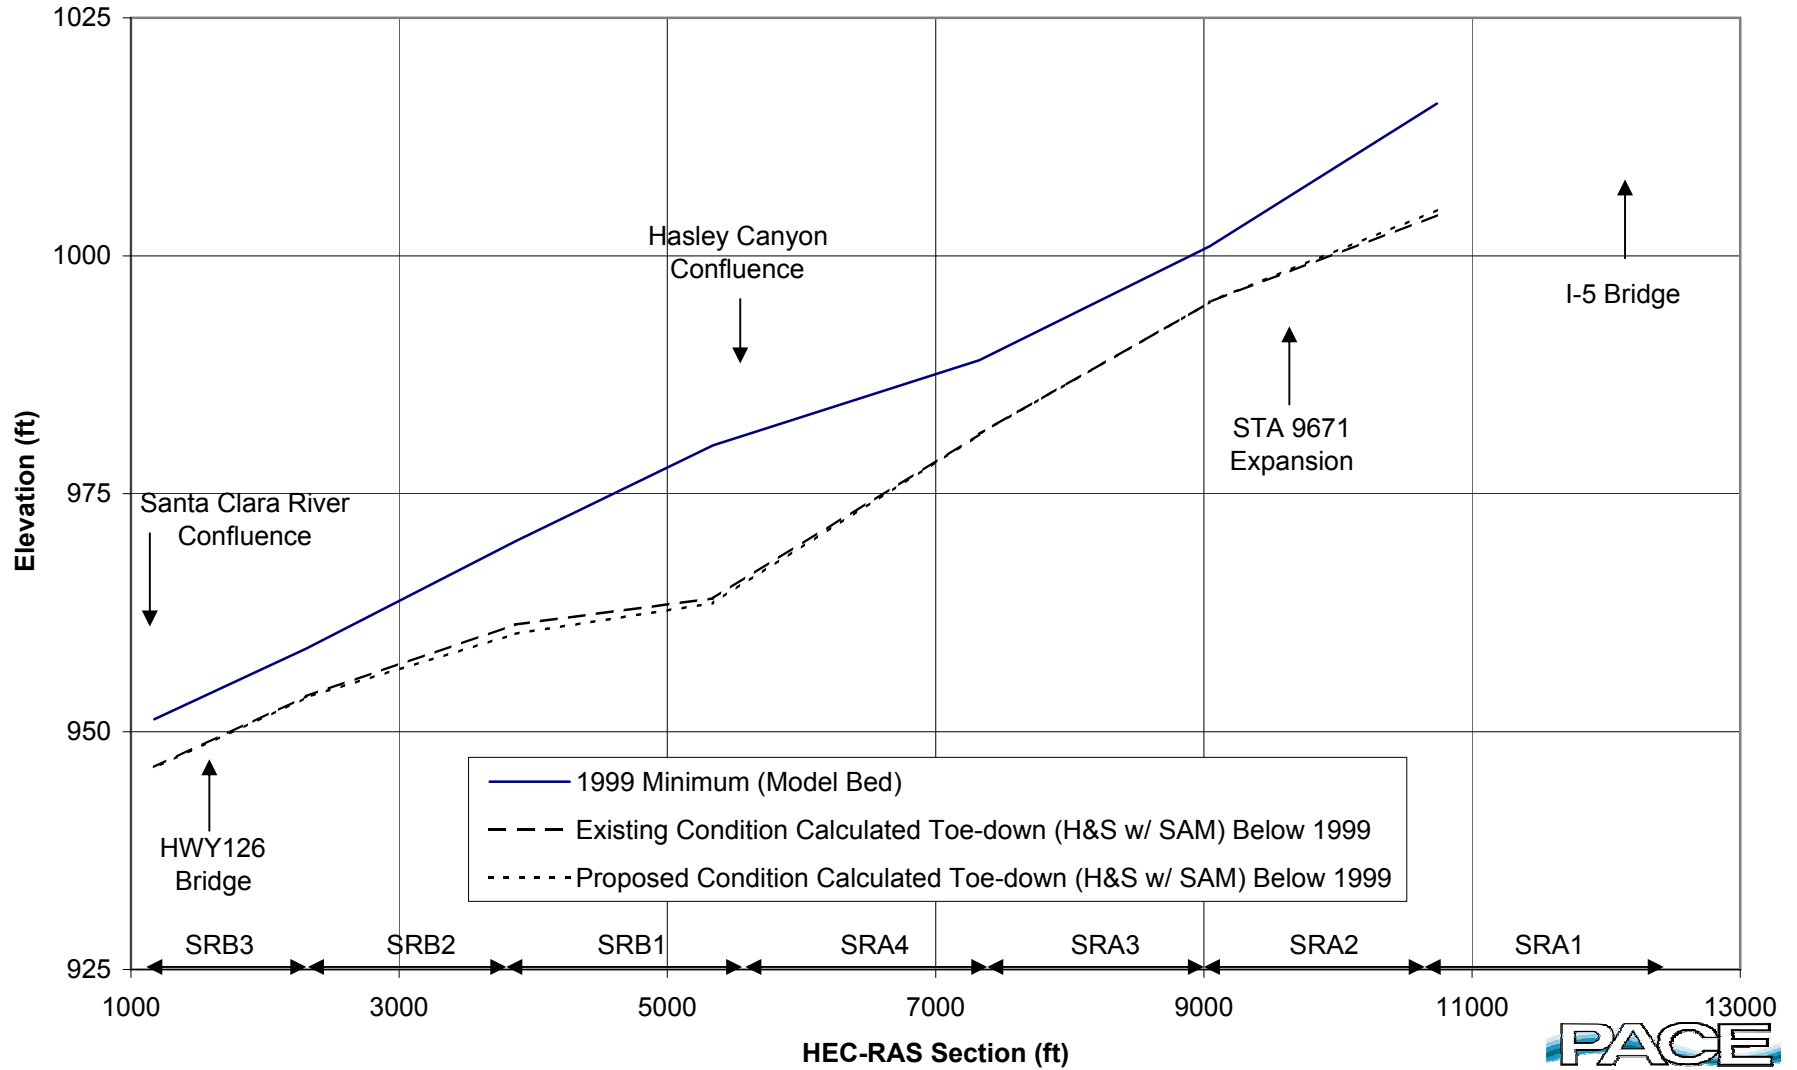
**Figure 7.3A: Castaic Creek Outside Curved Reach Model Bed and Calculated Toe-down Elevation**

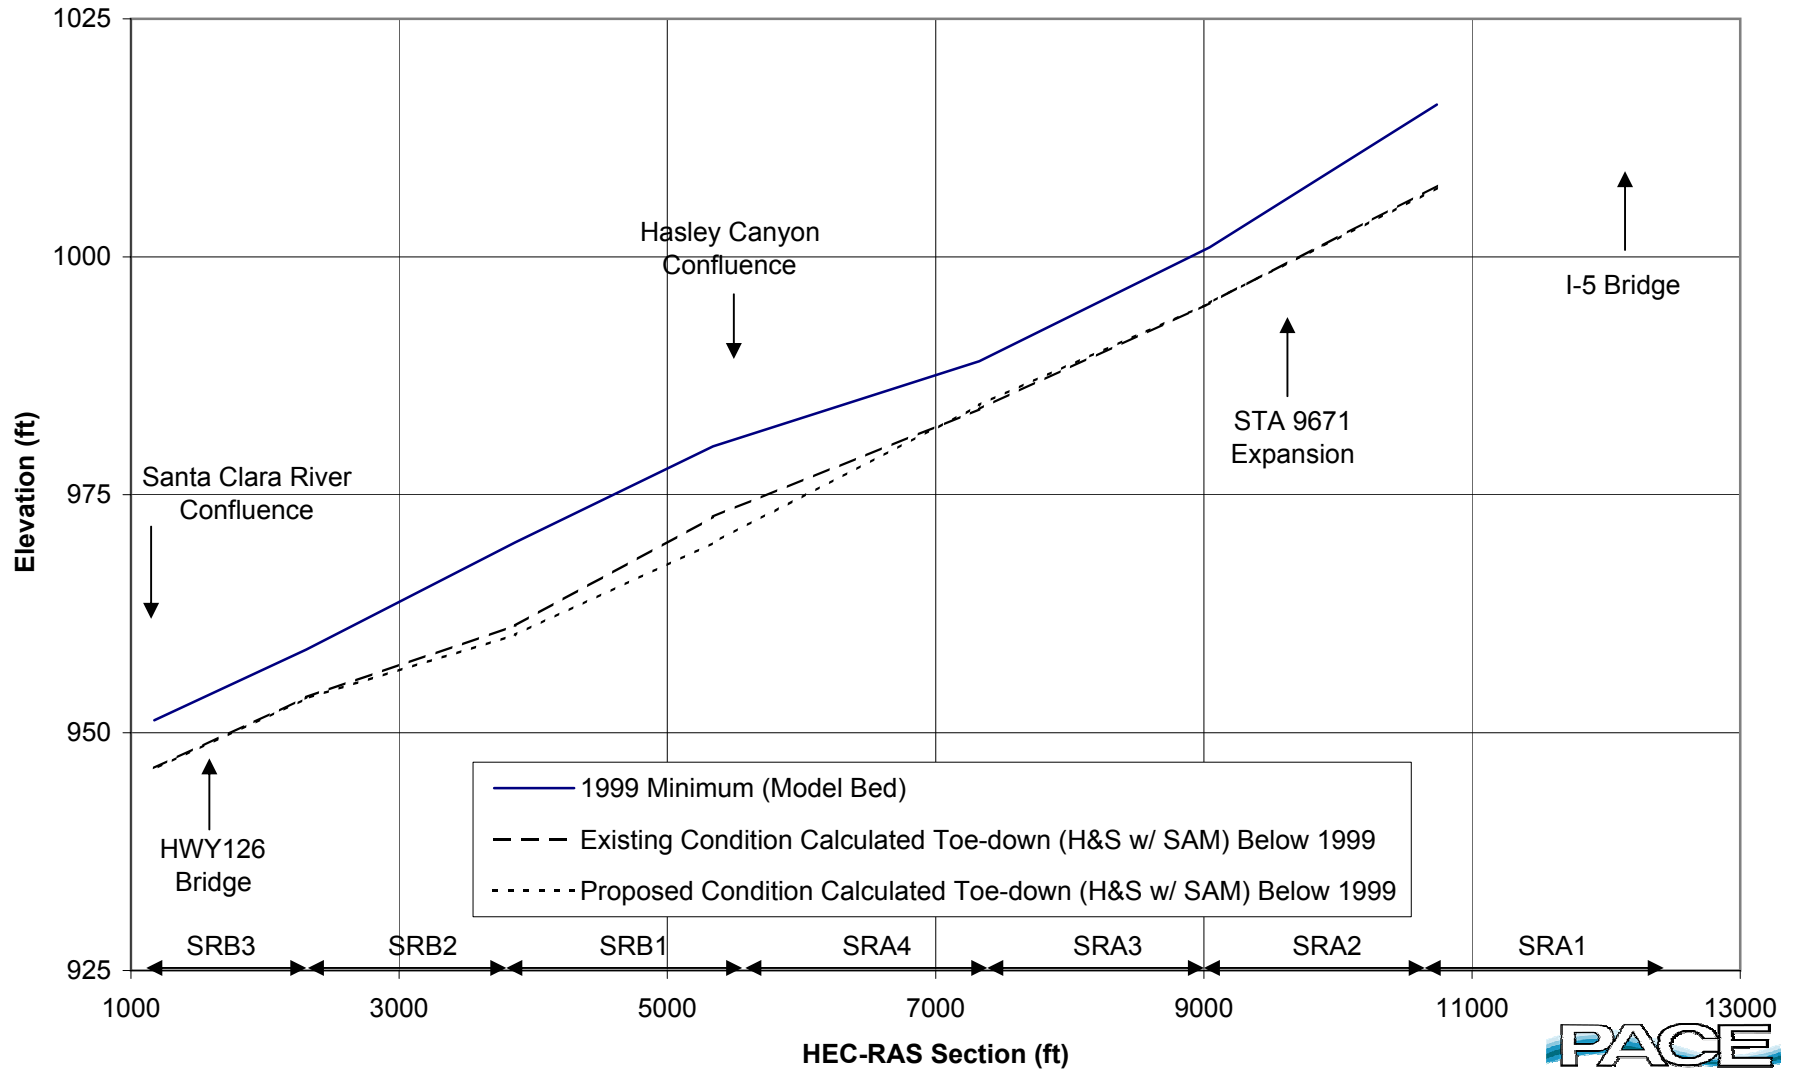
**Figure 7.3B: Castaic Creek Straight-Inside Curved Reach Model Bed and Calculated Toe-down Elevation**

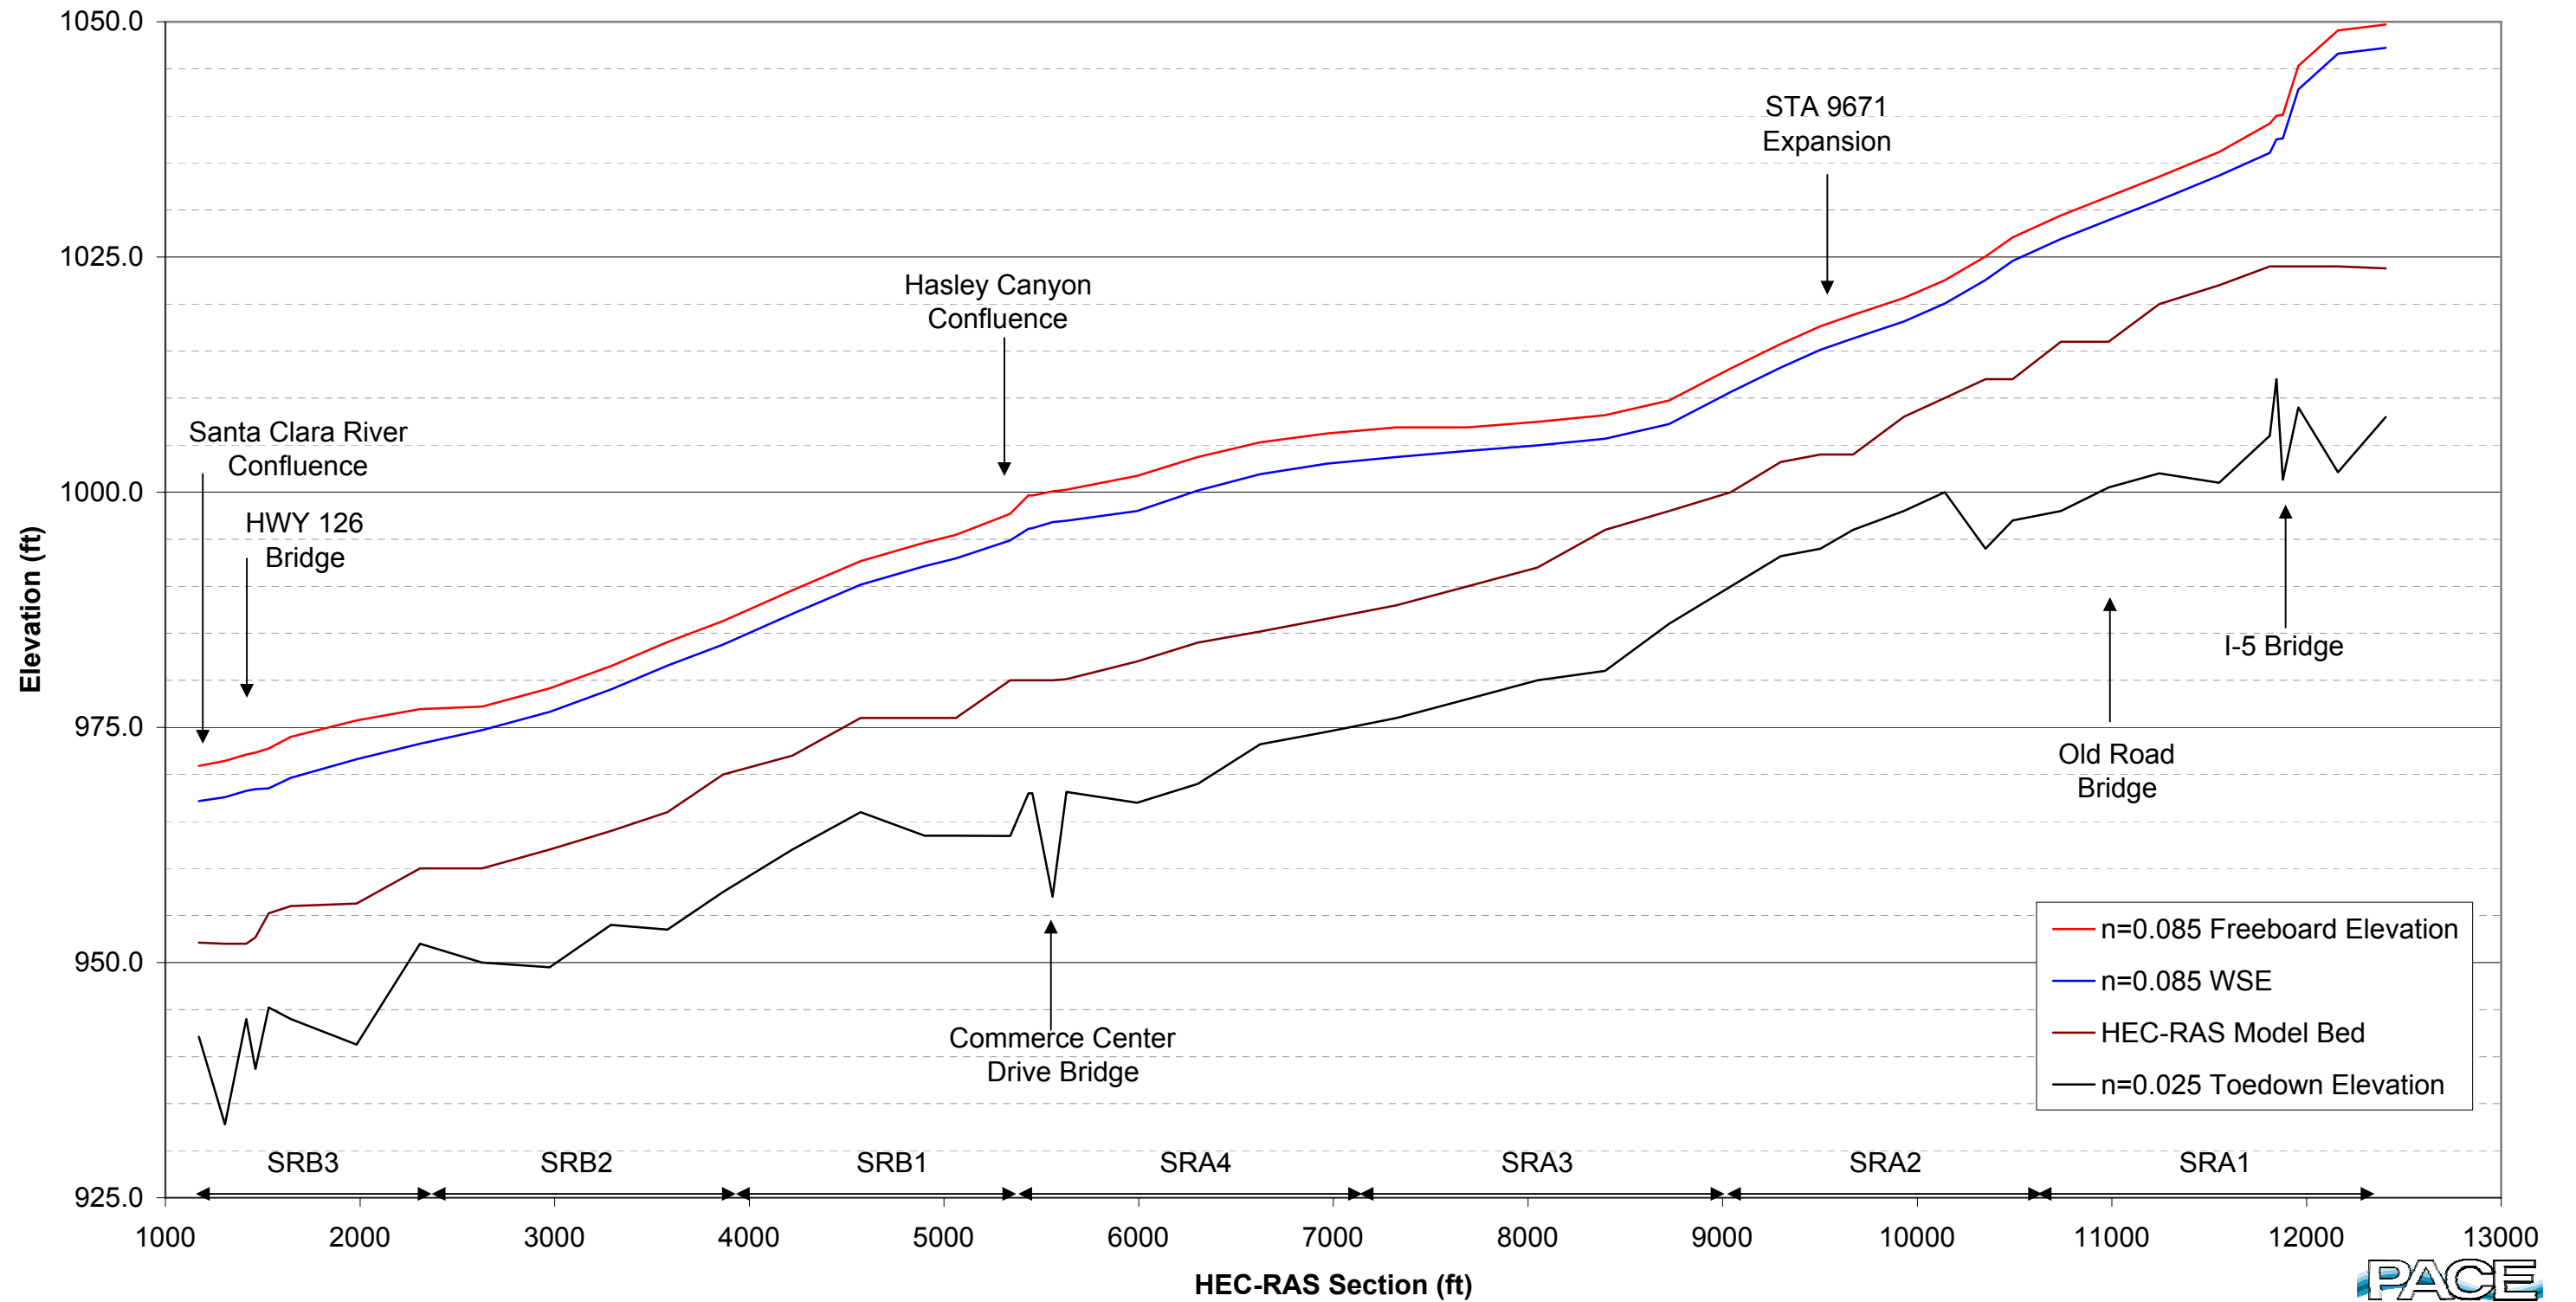
**Figure 8: Castaic Creek Proposed Conditions Outside Curved Reach Maximum Toe-down & Freeboard Summary**
