## **Appendix 5.5 (Continued)**

Hydrology (Part 8 of 15)

JOB  
**CASTAIC CREEK  
 FLUVIAL STUDY**  
 LOS ANGELES COUNTY CA

TITLE  
**HISTORICAL  
 CROSS SECTIONS  
 BY STATION**

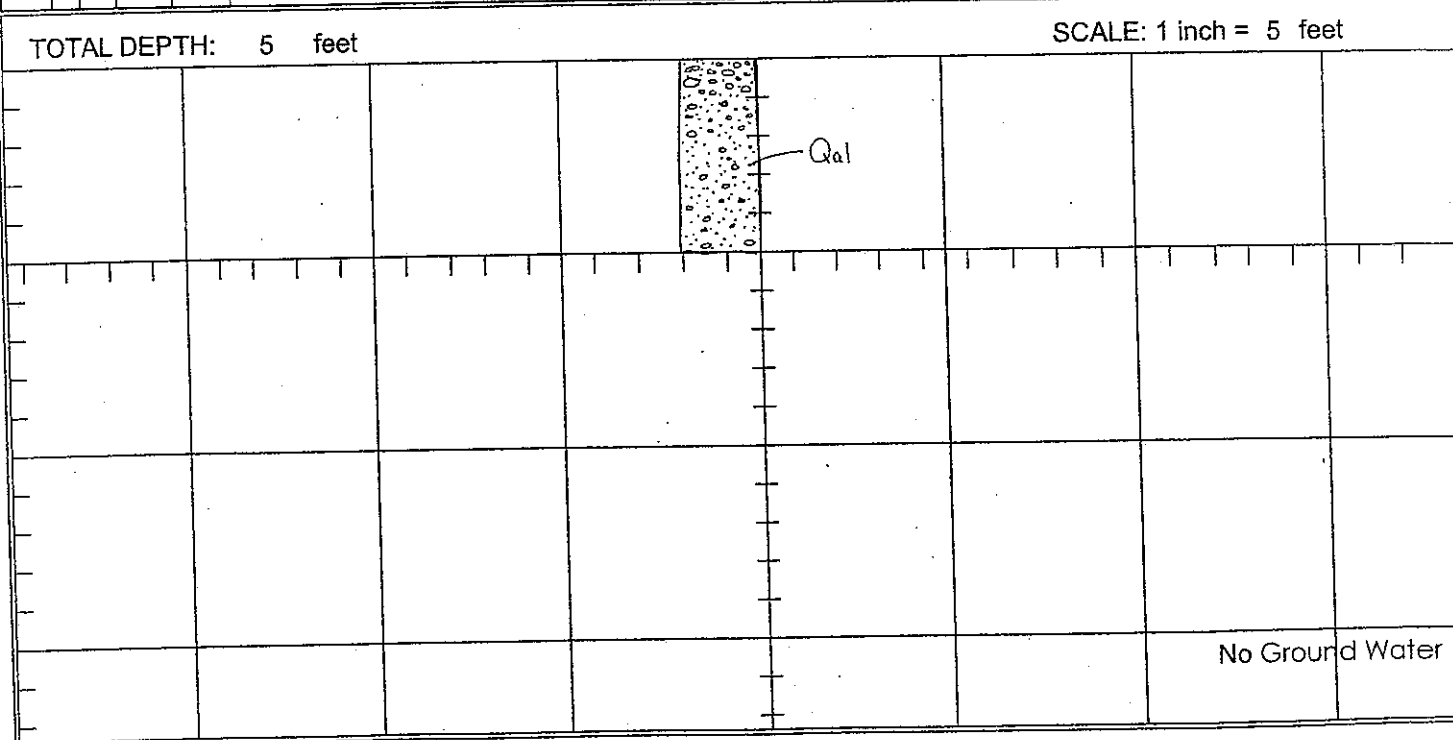
CLIENT: The Newhall Land & Farming Company	JOB NO: 05-1155BE-9 (9)	<b>TRENCH LOG NO. T-CC-3</b>
PROJECT: Alluvial Sediment Sampling Castaic Creek	DATE: 9/15/05	
	LOGGED BY: JH	
	EXCAVATED: 9/1/05	
EXCAVATION METHOD: Hand Labor	ELEVATION: 980'

DEPTH (feet)	SAMPLE TYPE	SAMPLE NUMBER	GRAPHIC LOG	USCS SYMBOL	DESCRIPTION	ATTITUDES	LABORATORY TESTS		
							Moisture Content (%)	Dry Density (pcf)	Other Tests
0				GP	<b>ALLUVIUM; Qal (0 - 5')</b> @ 0' Light-gray, poorly graded GRAVEL with sand; friable; dry @ 1' -damp @ 2' Pale-brown, poorly graded SAND with gravel and local cobbles @ 3' -no cobbles  <u>COMMENTS:</u> Bulk sample @ 0-5' (750 lbs total)			Gradation % fines=1.0	
5				SP					
10									
15									
20

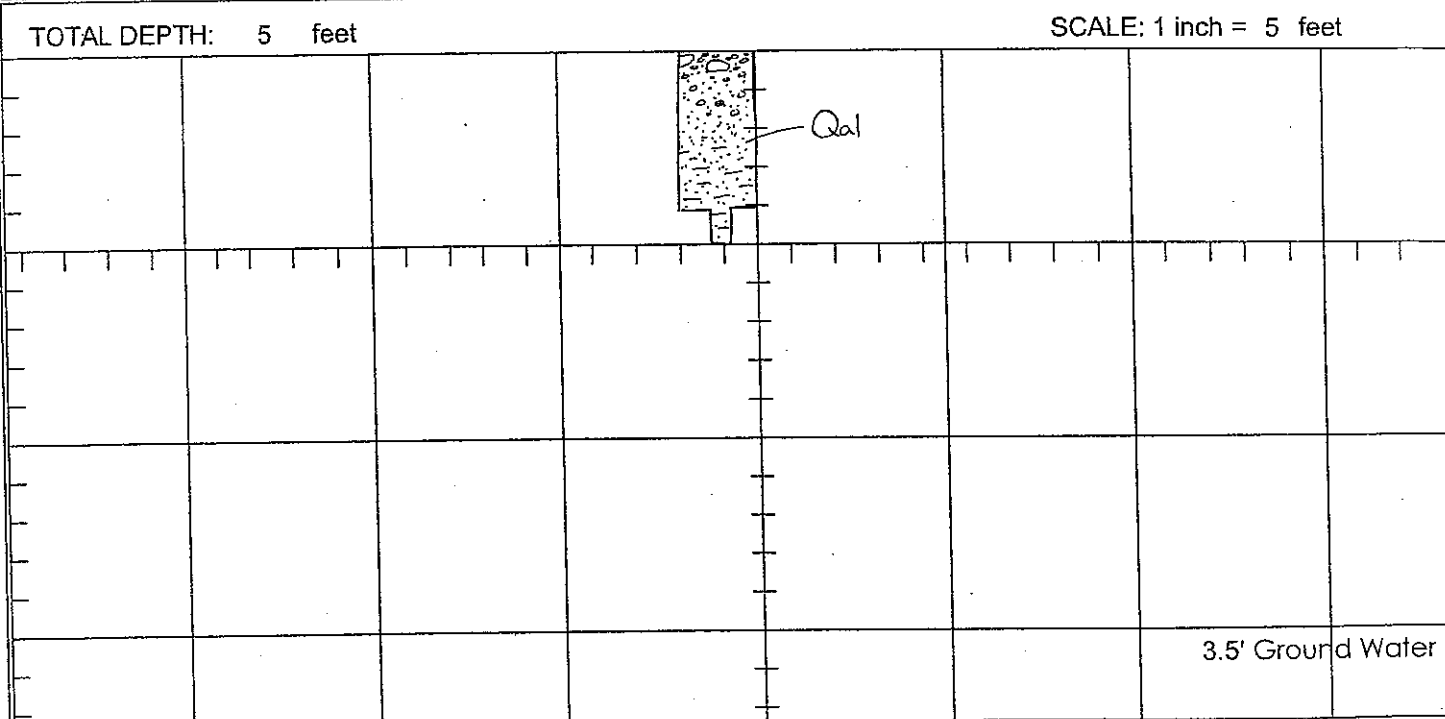
CLIENT: The Newhall Land & Farming Company	JOB NO: 05-1155BE-9 (9)	<b>TRENCH LOG NO. T-CH-1</b>
PROJECT: Alluvial Sediment Sampling Castaic Creek	DATE: 9/15/05	
	LOGGED BY: JH	
	EXCAVATED: 9/2/05	
EXCAVATION METHOD: Hand Labor	ELEVATION: 969'

GP SP SW SM	<b>ALLUVIUM; Qal (0 - 5')</b> @ 0' Light-gray, poorly graded GRAVEL with sand and local cobbles; friable; dry @ 1' Pale-brown, poorly graded SAND with gravel; damp @ 2' Light yellowish-brown, well-graded SAND; damp @ 2.5' Dark-brown, silty SAND with local cobbles; damp @ 3.5' -wet  <b>COMMENTS:</b> Bulk sample @ 0-5' (392 lbs total) Sample hand-augered from 4 to 5' due to ground water			Gradation % fines=3.1	
5									
10									
15									
20

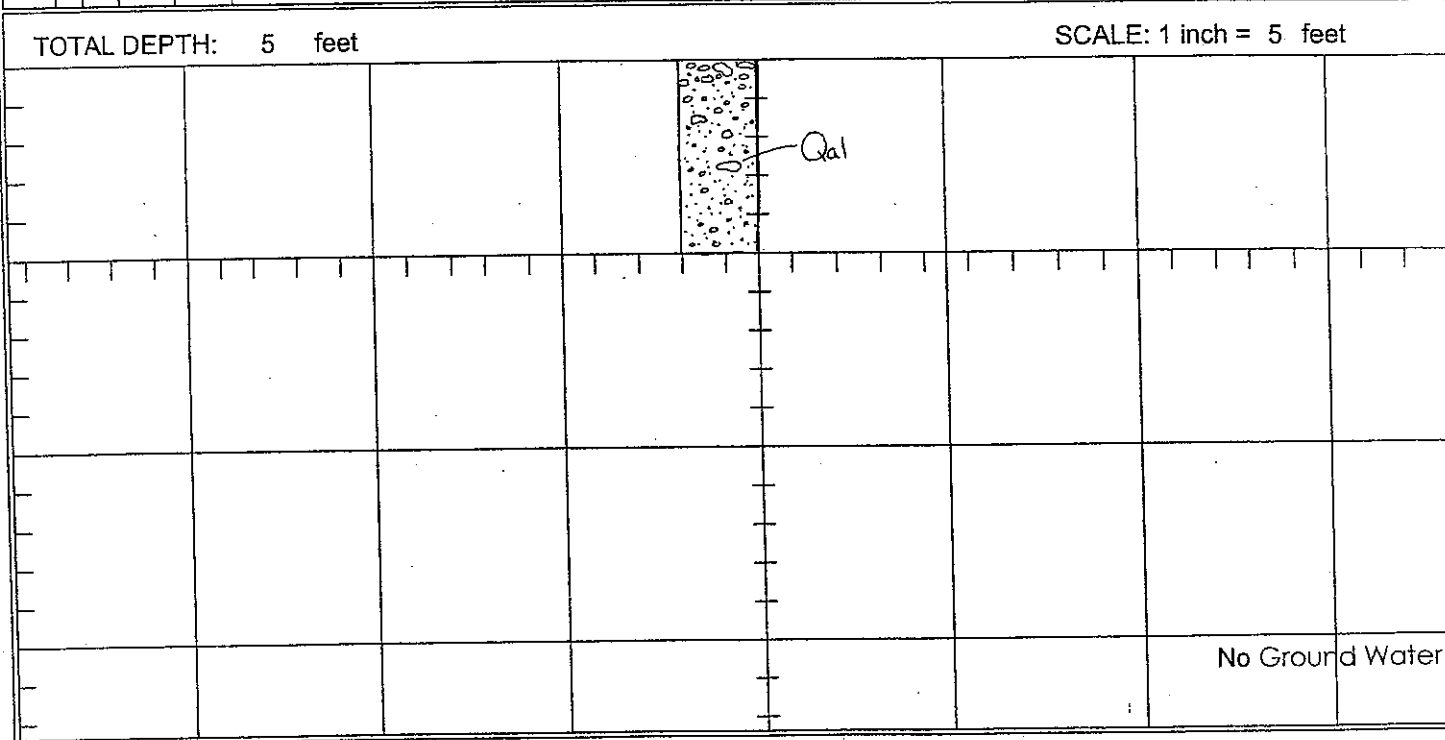
CLIENT: The Newhall Land & Farming Company	JOB NO: 05-1155BE-9 (9)	<b>TRENCH LOG NO. T-CH-3</b>
PROJECT: Alluvial Sediment Sampling Castaic Creek	DATE: 9/15/05	
	LOGGED BY: JH	
	EXCAVATED: 9/2/05	
EXCAVATION METHOD: Hand Labor	ELEVATION: 970'

GP SP	<b>ALLUVIUM; Qal (0 - 5')</b> @ 0' Light-gray, poorly graded GRAVEL with sand and cobbles; friable; dry @ 1' Pale-brown, poorly graded SAND with gravel and local cobbles; damp @ 2' -no cobbles @ 3' -local cobbles  <u>COMMENTS:</u> Bulk sample @ 0-5' (732 lbs total)			Gradation % fines=0.8	
5									
10									
15									
20

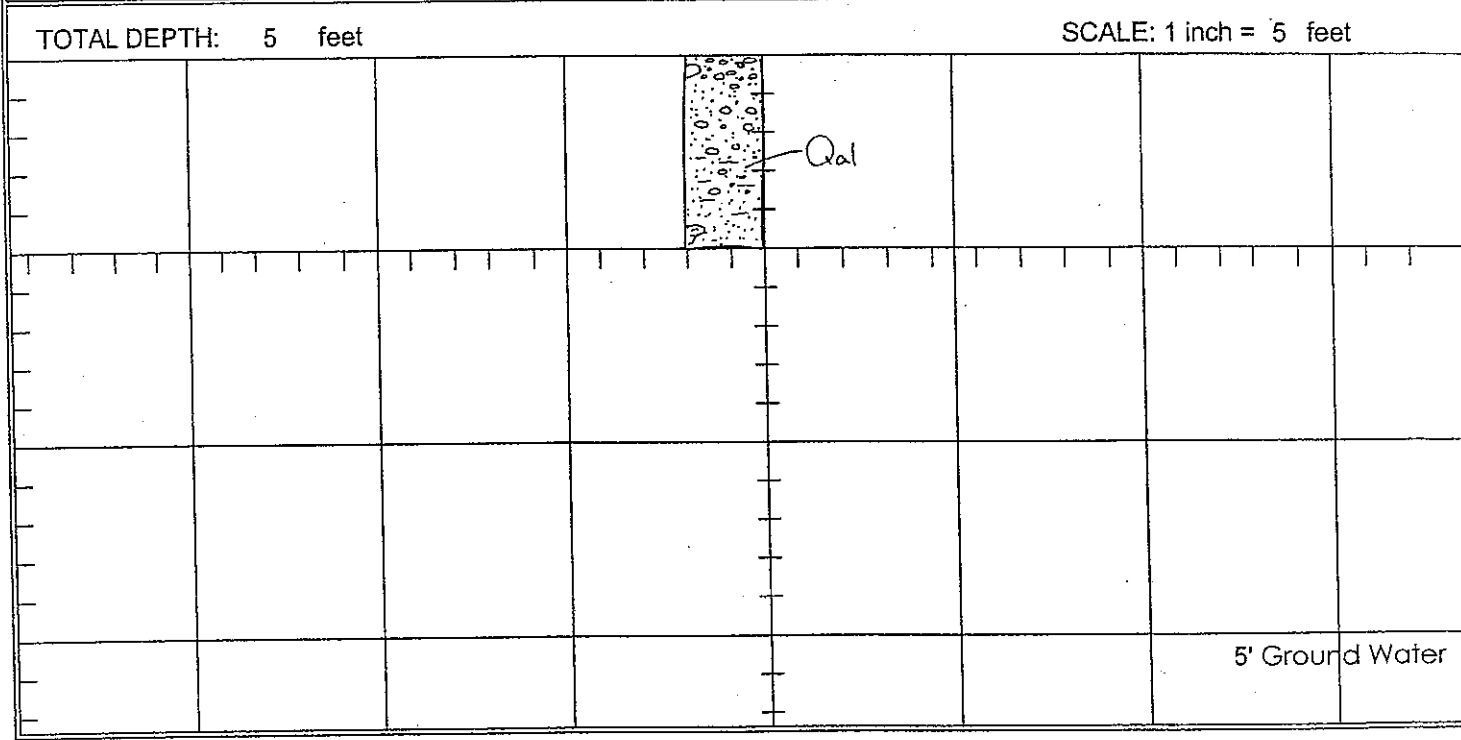
CLIENT: The Newhall Land & Farming Company	JOB NO: 05-1155BE-9 (9)	<b>TRENCH LOG NO. T-HS-1</b>
PROJECT: Alluvial Sediment Sampling Castaic Creek	DATE: 9/15/05	
	LOGGED BY: JH	
	EXCAVATED: 9/6/05	
EXCAVATION METHOD: Hand Labor	ELEVATION: 943'

DEPTH (feet)	SAMPLE TYPE	SAMPLE NUMBER	GRAPHIC LOG	USCS SYMBOL	DESCRIPTION	ATTITUDES	LABORATORY TESTS		
							Moisture Content (%)	Dry Density (pcf)	Other Tests
0				GP SP	<b>ALLUVIUM; Qal (0 - 5')</b> @ 0' Light yellowish-brown, poorly graded GRAVEL with sand and local cobbles; friable; dry			Gradation % fines=2.3	
0.5				SW-SM	@ 0.5' Yellowish-brown, poorly graded SAND with gravel; damp @ 2' -dark grayish-brown; moist @ 2.5' Dark grayish-brown, well-graded SAND with silt and gravel; moist @ 4.5' -local rip-up clasts of silt and clay @ 5' -local cobbles; wet				
5					<b>COMMENTS:</b> Bulk sample @ 0-5' (561 lbs total)				
10									
15									
20
