Habitat Restoration Plan

23333
Saddle Peak Road
County of Los Angeles

August 2022
Revised March 2023

HABITAT RESTORATION PLAN

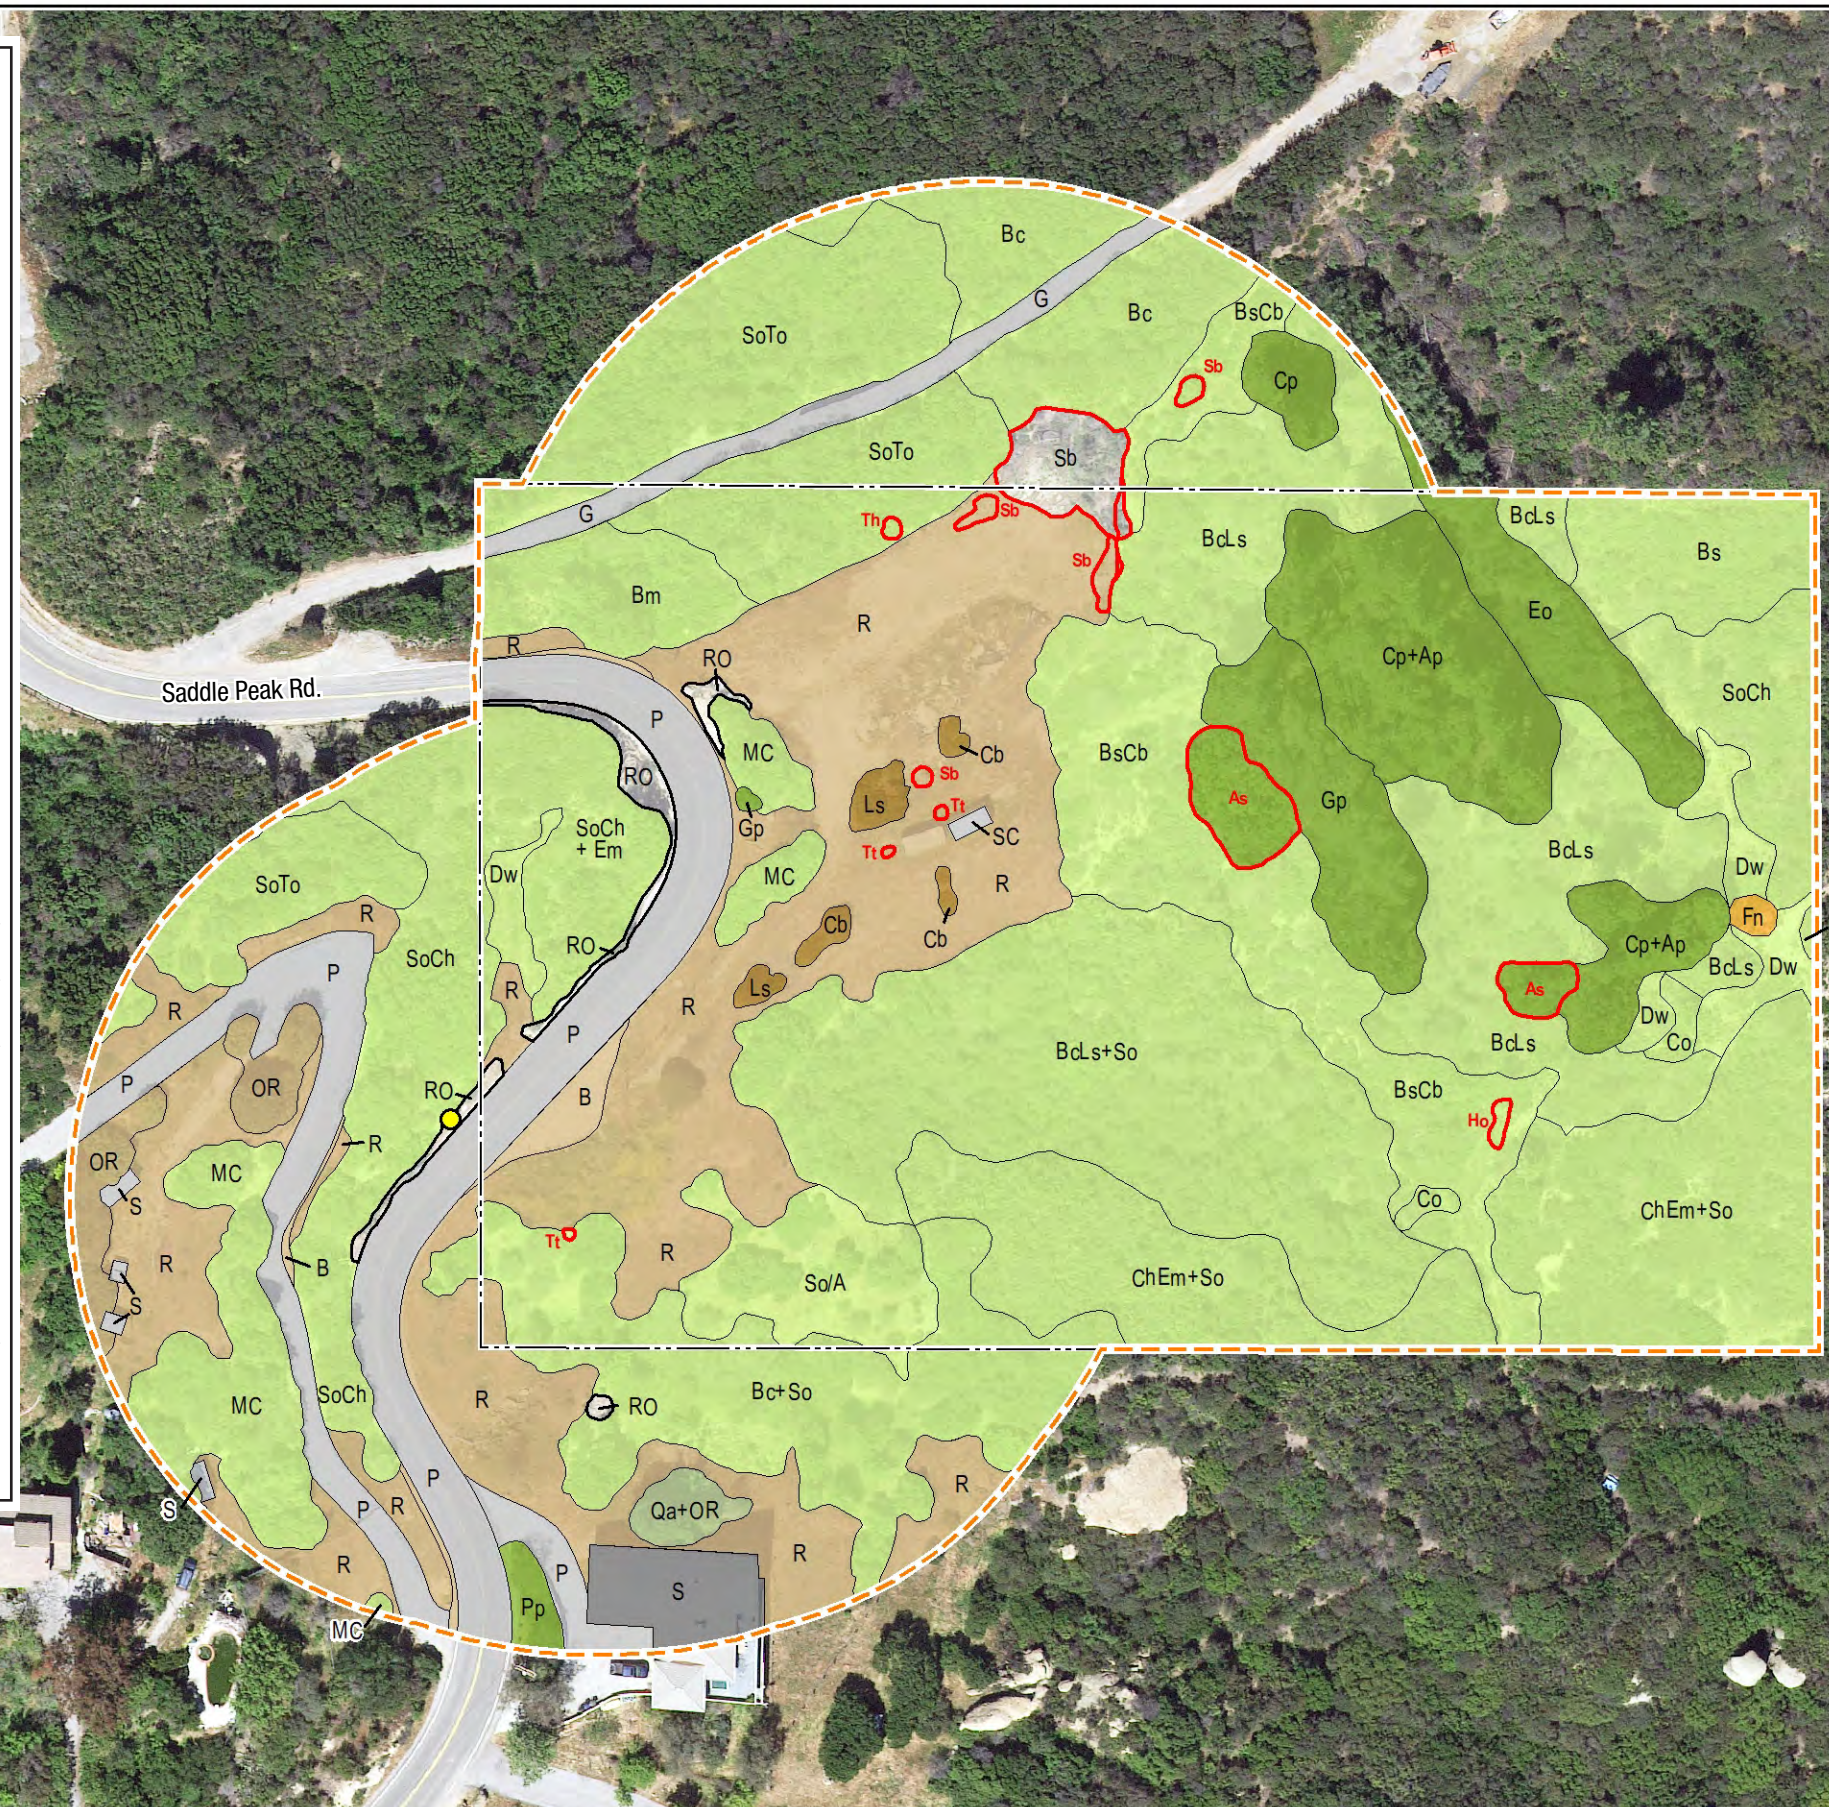
The vegetation at the site is shown on **Figure 2, Vegetation Map**, which as stated consists predominately of chaparral, stands of introduced trees, and disturbed areas containing non-native grasses and forbs. The chaparral at the site consists primarily of big-pod ceanothus (*Ceanothus megacarpus*), scrub oak (*Quercus berberidifolia*), laurel sumac (*Malosma laurina*), toyon (*Heteromeles arbutifolia*), and chamise (*Adenostoma fasciculatum*). California buckwheat (*Eriogonum fasciculatum*) and black sage (*Salvia mellifera*) are common in chaparral openings and along the margins of the chaparral. There are stands of introduced native and non-native trees including pine (*Pinus halepensis*, *coulteri*, *sabiniana*), African sumac (*Saersia lancea*), and European olive (*Olea europaea*) in the northeastern portion of the property. Previously cleared and disturbed areas are dominated by non-native herbs such as tocalote (*Centaurea melitensis*), annual brome grasses (*Bromus* spp.), wild oats (*Avena barbata*, *A. fatua*), and hoary mustard (*Hirschfeldia incana*). A few native shrubs such as deerweed (*Acmispon glaber*) and sawtooth goldenbush (*Hazardia squarrosa* var. *grindelioides*) also occur in disturbed areas. A few invasive plant species with California Invasive Plant Council (Cal-IPC) “moderate” and “high” invasiveness ratings occur at the site, Spanish broom (*Spartium junceum*), tree tobacco (*Nicotiana glauca*), and tree of heaven (*Ailanthus altissima*).

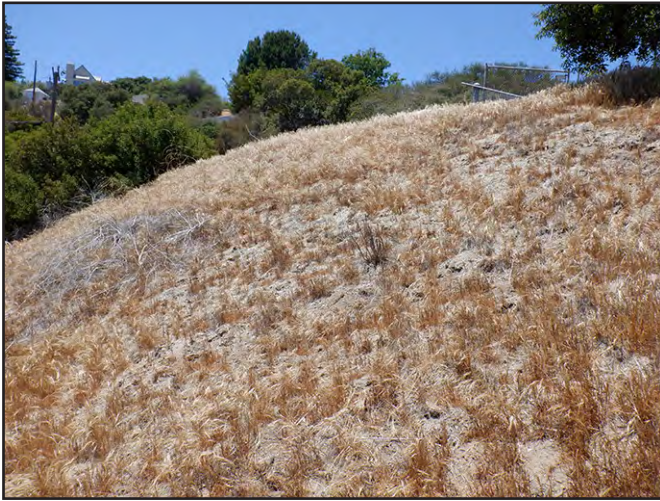
Photo 1 – The undocumented fill at the entrance slope is shown. View faces west.

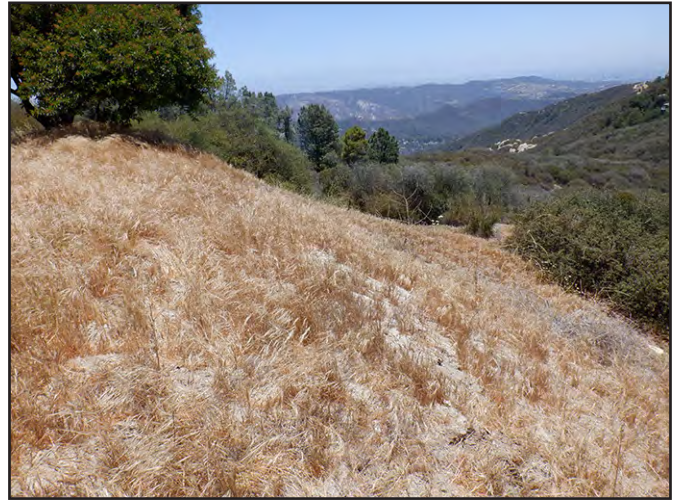
Photo 2 – Another view of the entrance slope, facing east.

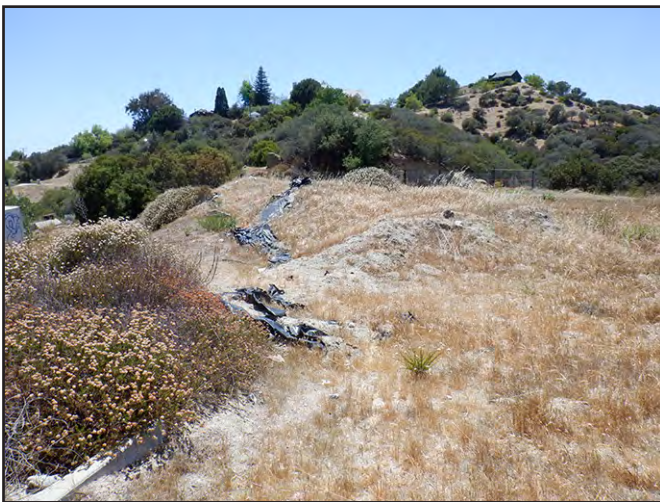
Photo 3 – The small stockpile of undocumented fill at the graded pad is shown. View faces southwest.

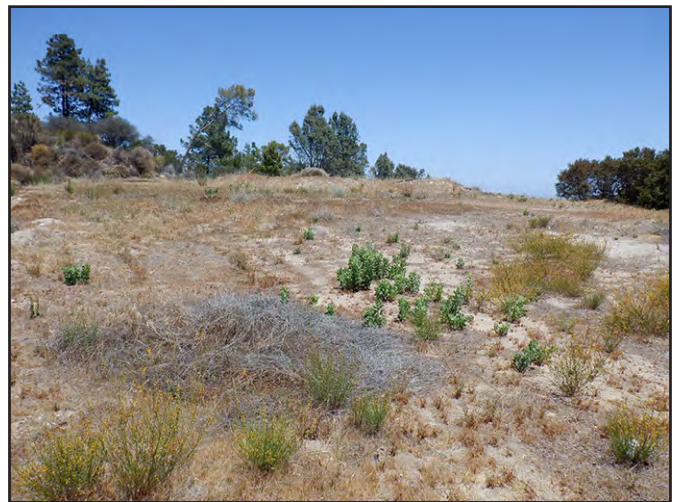
Photo 4 – The graded pad is shown. The undocumented fill to be removed is visible on the pad in the background. View faces northeast.

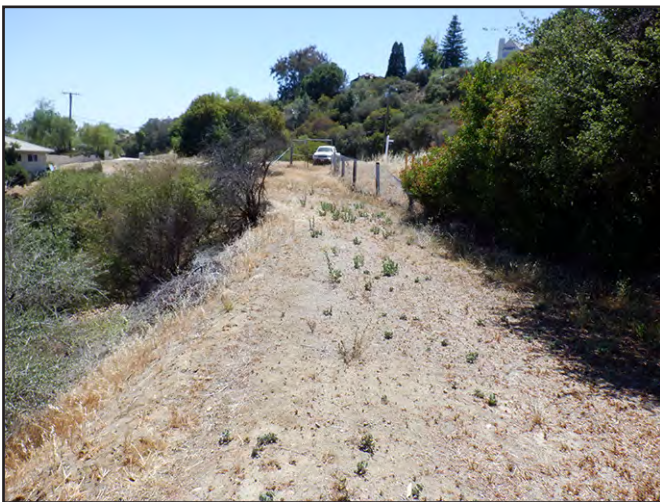
Photo 5 – This photo shows the southern access including gate and unimproved dirt road. View faces southwest.

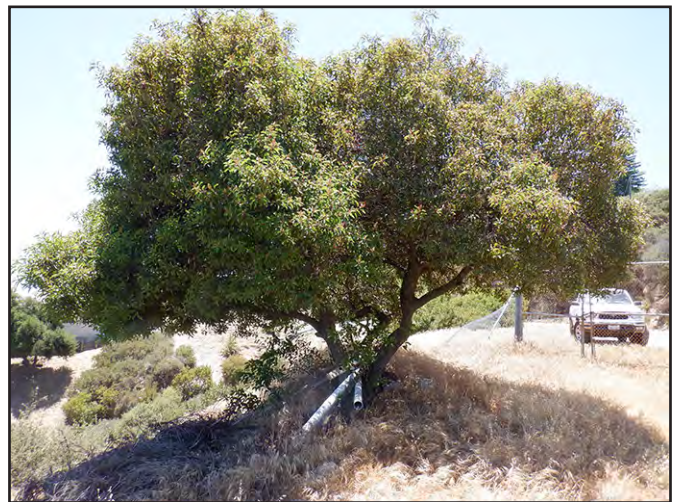
Photo 6 – A laurel sumac (*Malosma laurina*) located at the northern margin of the entrance slope is shown, which qualifies as a Los Angeles County protected tree. This is the only protected tree that was encroached upon by the placement of undocumented fill at the site.

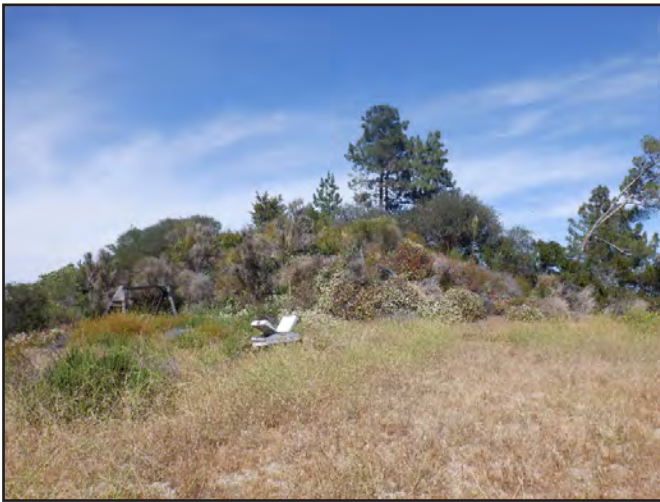
Photo 1 – A small hill with several invasive Spanish broom (*Spartium junceum*) plants at the northern end of the graded pad is shown. The Spanish broom will be removed as part of the restoration project. View faces north.

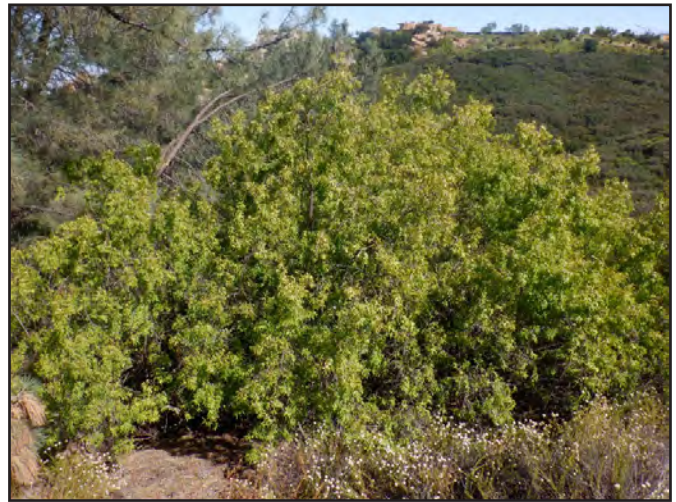
Photo 2 – This photo shows one of the two patches of invasive African sumac (*Searsia lancea*) at the site. The African sumac will also be removed as part of the restoration project.

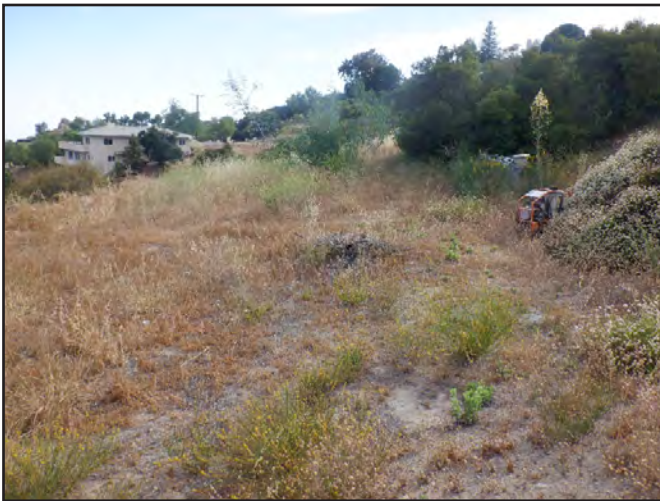
Photo 3 – This photo shows the disturbed area to be restored south of the graded pad. A few non-native tree tobacco (*Nicotiana glauca*) plants are visible in the background in the center of the photo, which will also be removed.

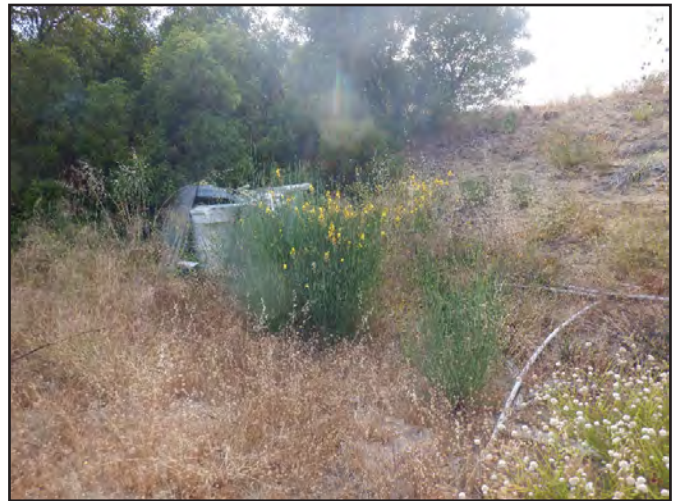
Photo 4 – A few Spanish broom plants in the disturbed area to the south of the graded pad are shown. Disturbed areas such as this area and the graded pad will be restored to native habitat.

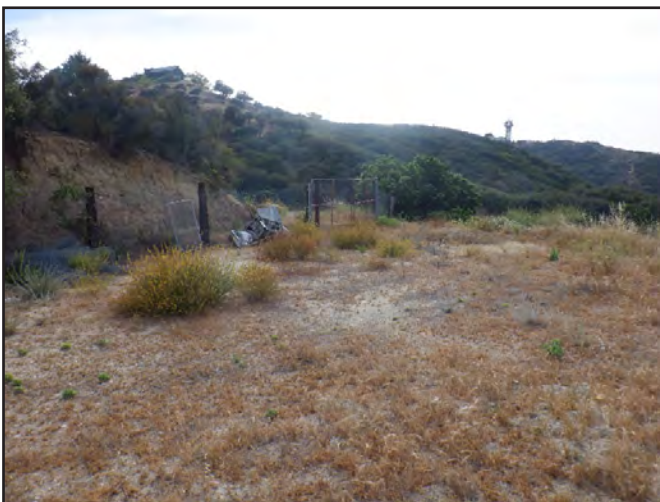
Photo 5 – This photo shows the western end of the graded pad near the north entrance. The entrance gate and chain link fence that runs along the western margin of the graded pad and dirt access road (see Figure 4, Photo 5) are also visible.

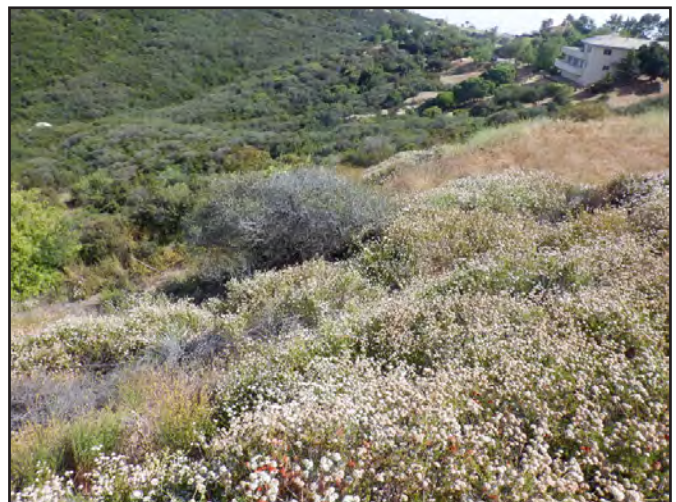
Photo 6 – Native coastal scrub is shown in the foreground. Coastal scrub occurs at the site in previously disturbed areas that have recovered naturally to native habitat. The chaparral habitats that covered the entire property prior to site disturbances are visible in the background.
