## REPORT TO THE HEARING OFFICER

DATE ISSUED: February 15, 2024  
HEARING DATE: February 27, 2024 AGENDA ITEM: 9  
PROJECT NUMBER: PRJ2023-003125-(5)  
PERMIT NUMBER(S): Oak Tree Permit ("OTP") RPPL2023004582  
SUPERVISORIAL DISTRICT: 5  
PROJECT LOCATION: 4010 Fair Oaks Avenue, Altadena  
OWNER: Alan Zorthian  
APPLICANT: Alan Zorthian  
CASE PLANNER: Sean Donnelly, Senior Planner  
sdonnelly@planning.lacounty.gov

REPAIR OF EXISTING WOOD BRIDGE

BRIDGE REPAIR  
3697 NORTH FAIR OAKS AVENUE  
ALTADENA, CA 91001

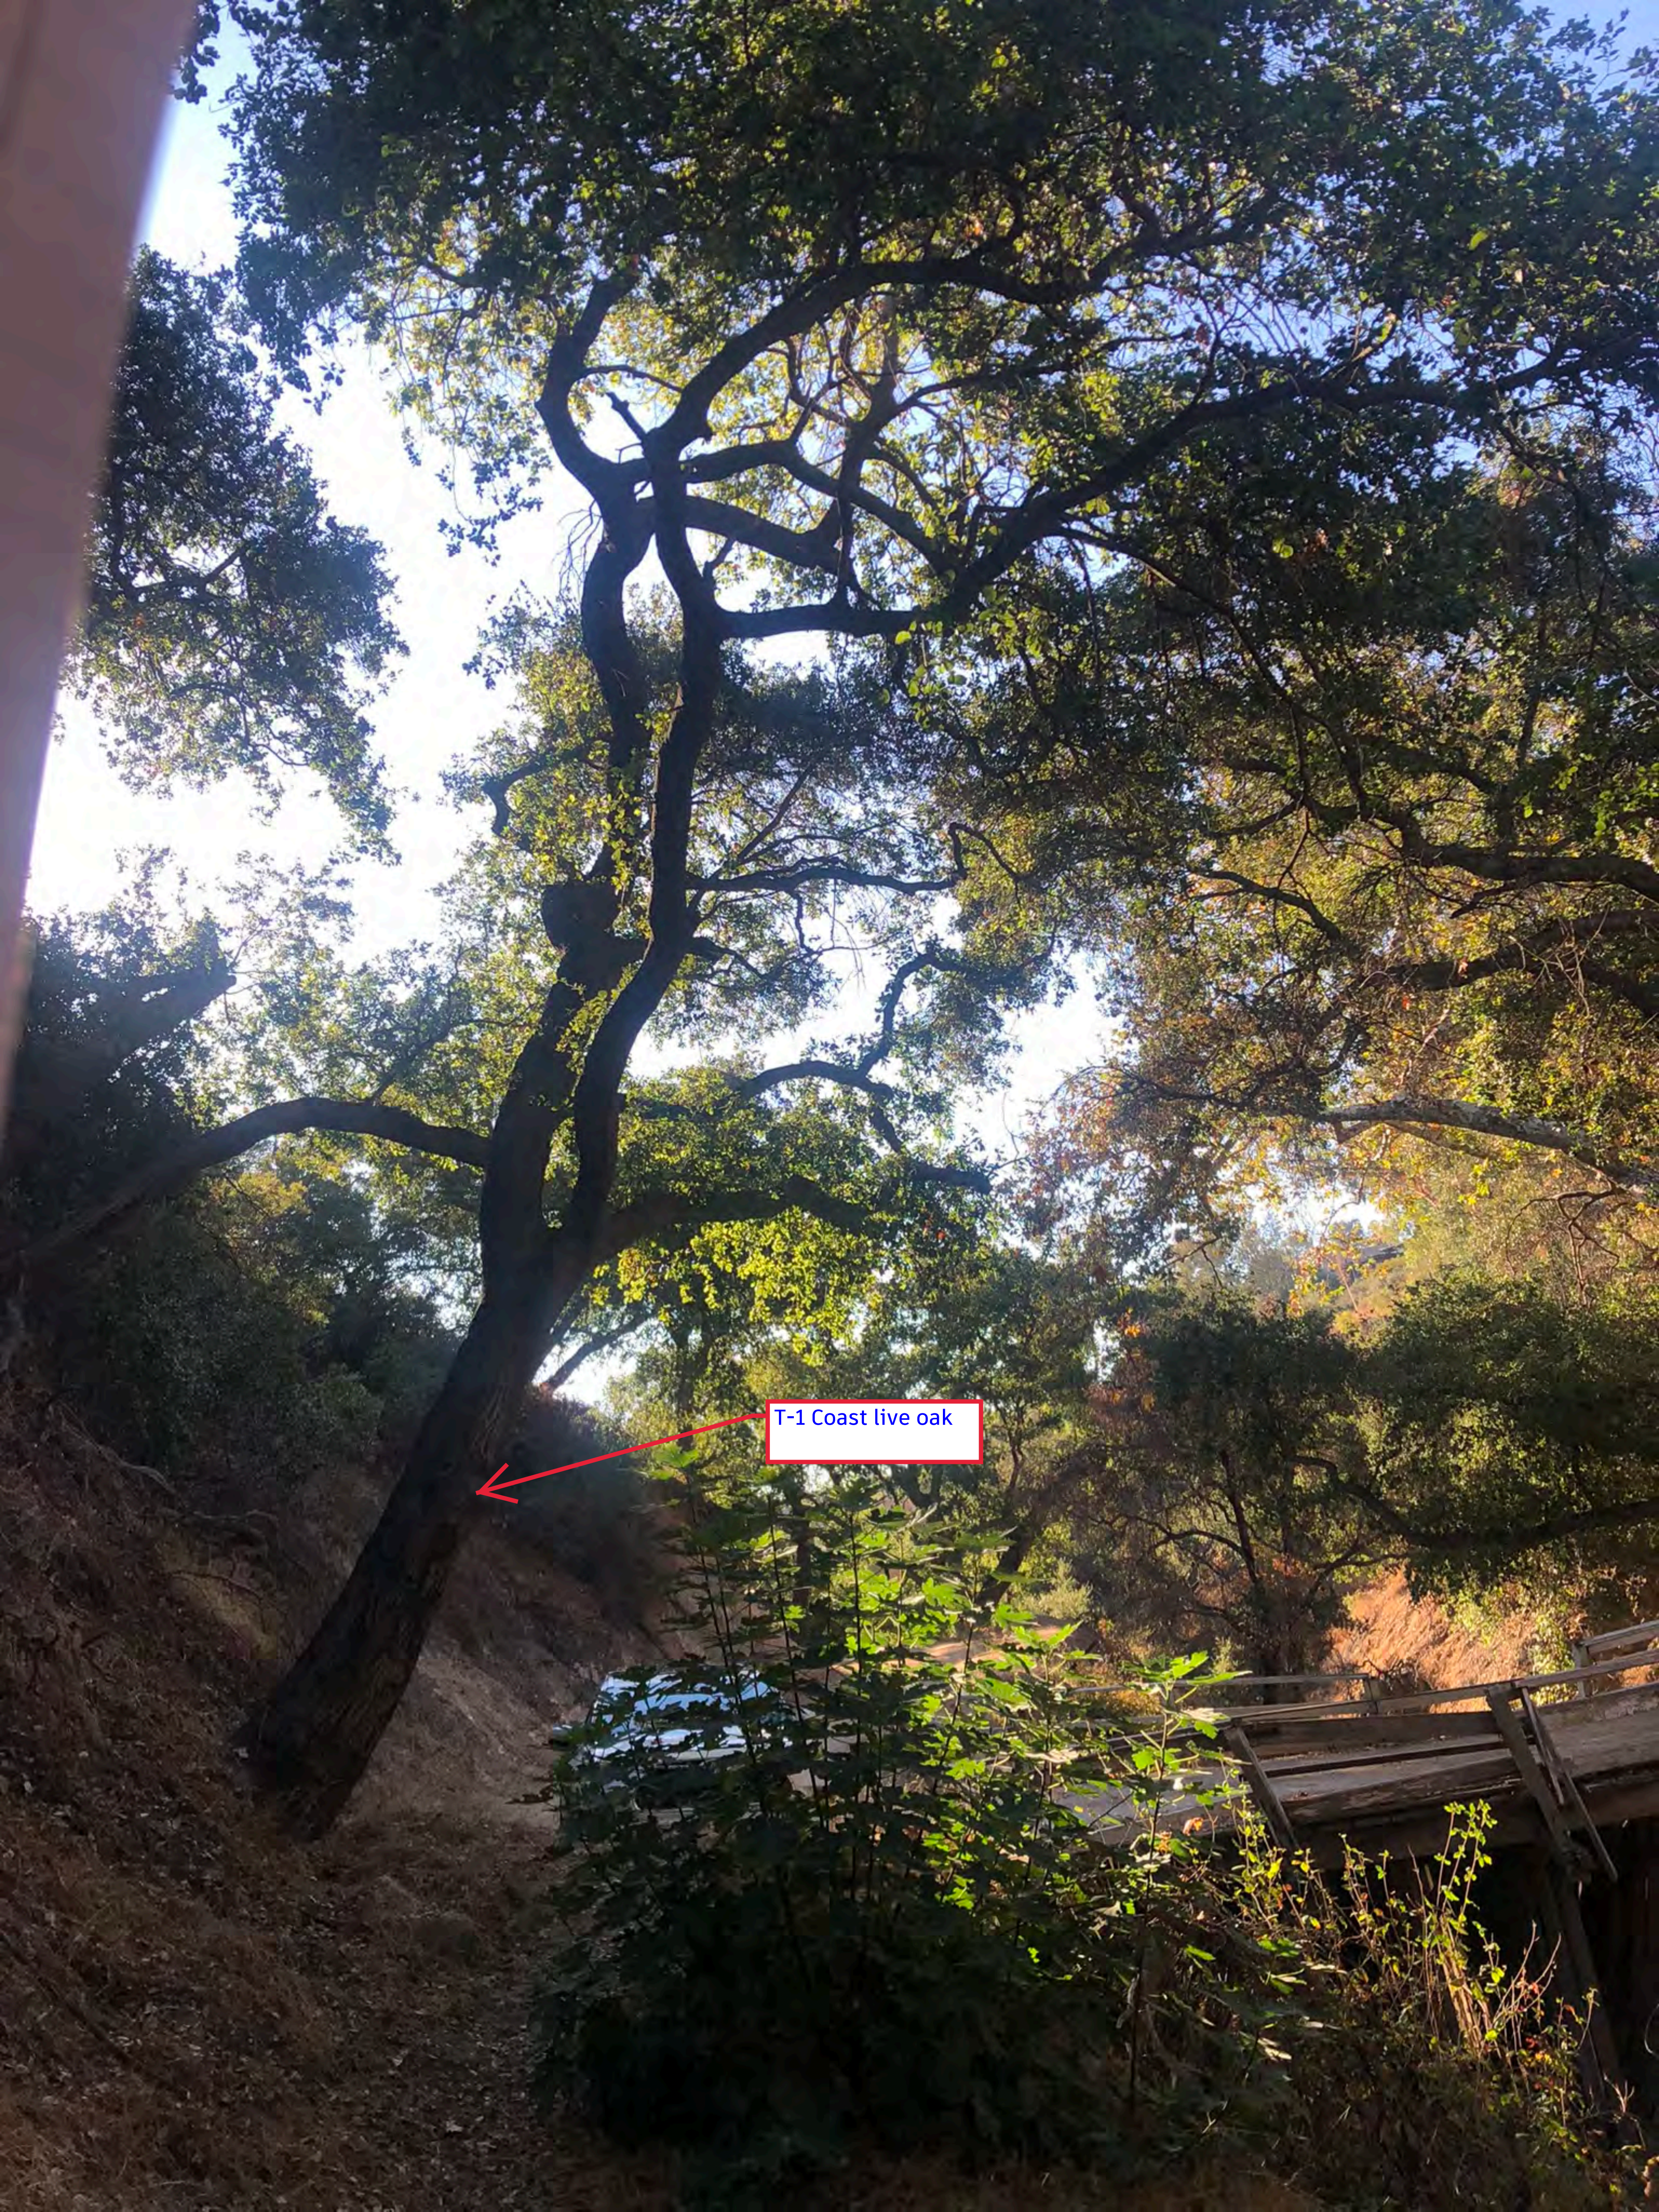
T-1 Coast live oak

| <u>Oak Tree</u> | <u>DBH<br/>(Diameter at<br/>Breast<br/>Height in<br/>Inches)</u> | <u>Height (in<br/>feet)</u> | <u>Health</u> |
|---|--|---|---|
| T-1 | 23 | 40 | Good, 35<br>degree lean<br>northwest |

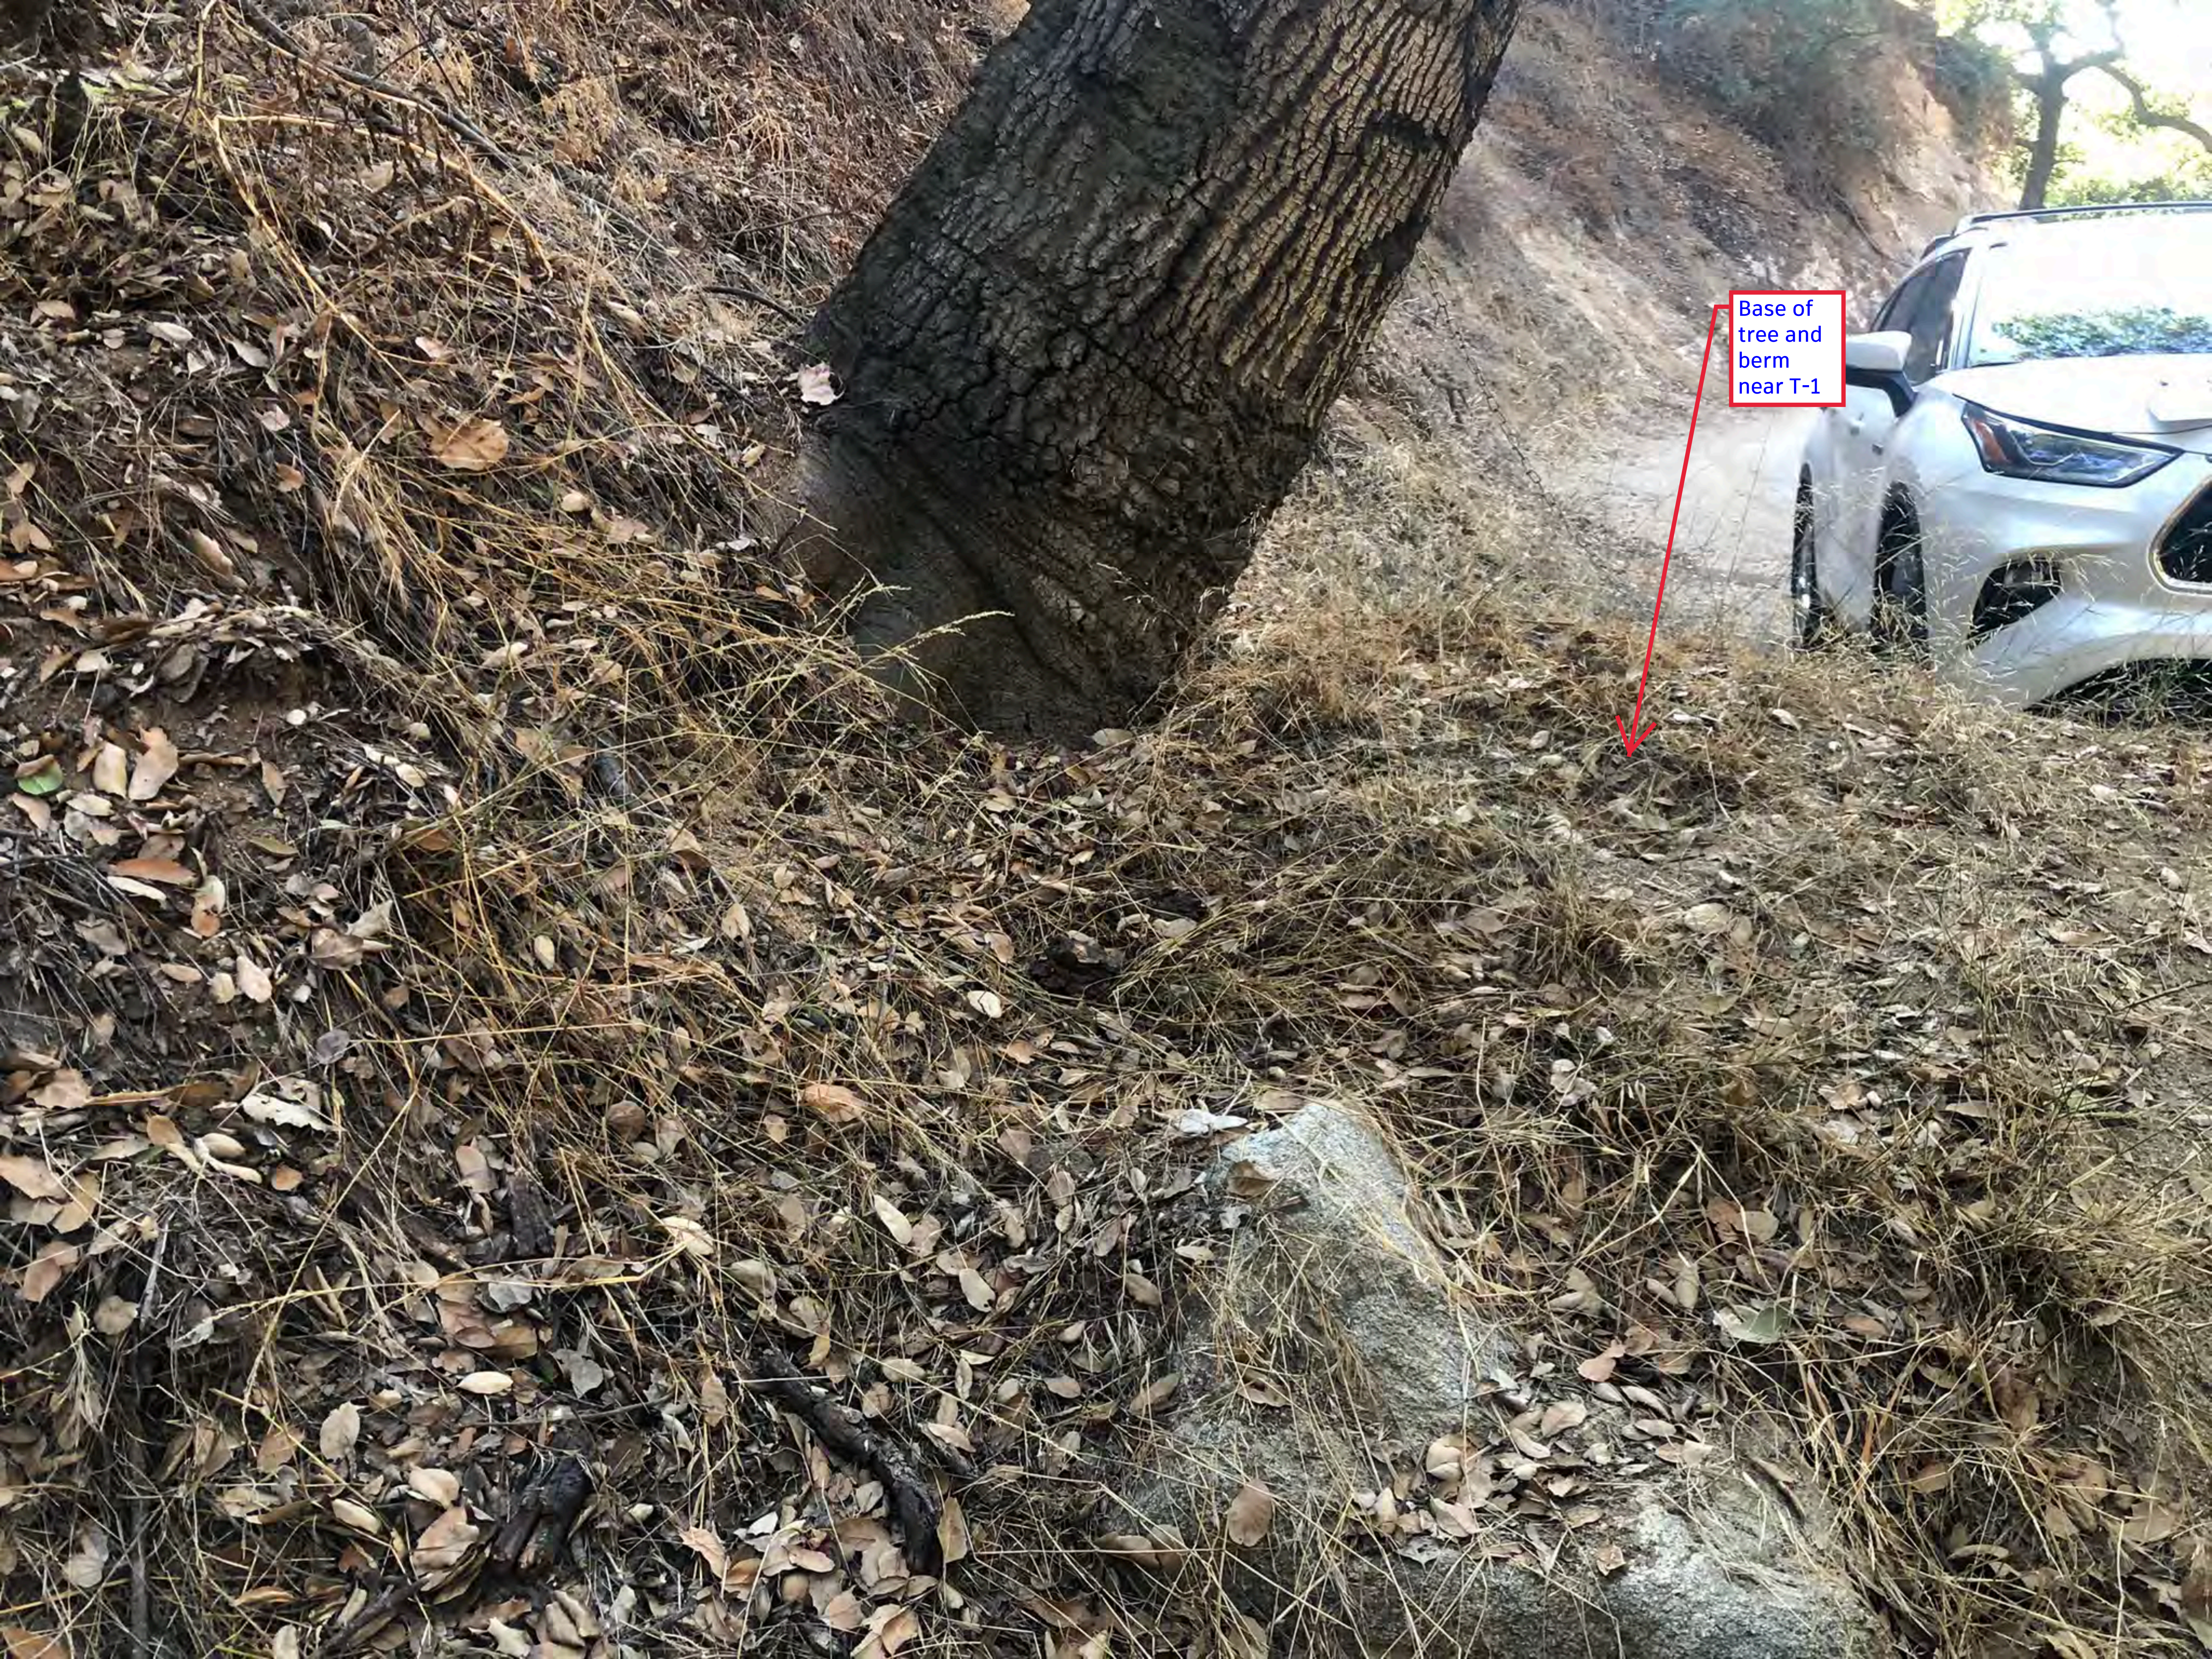
Base of  
tree and  
berm  
near T-1

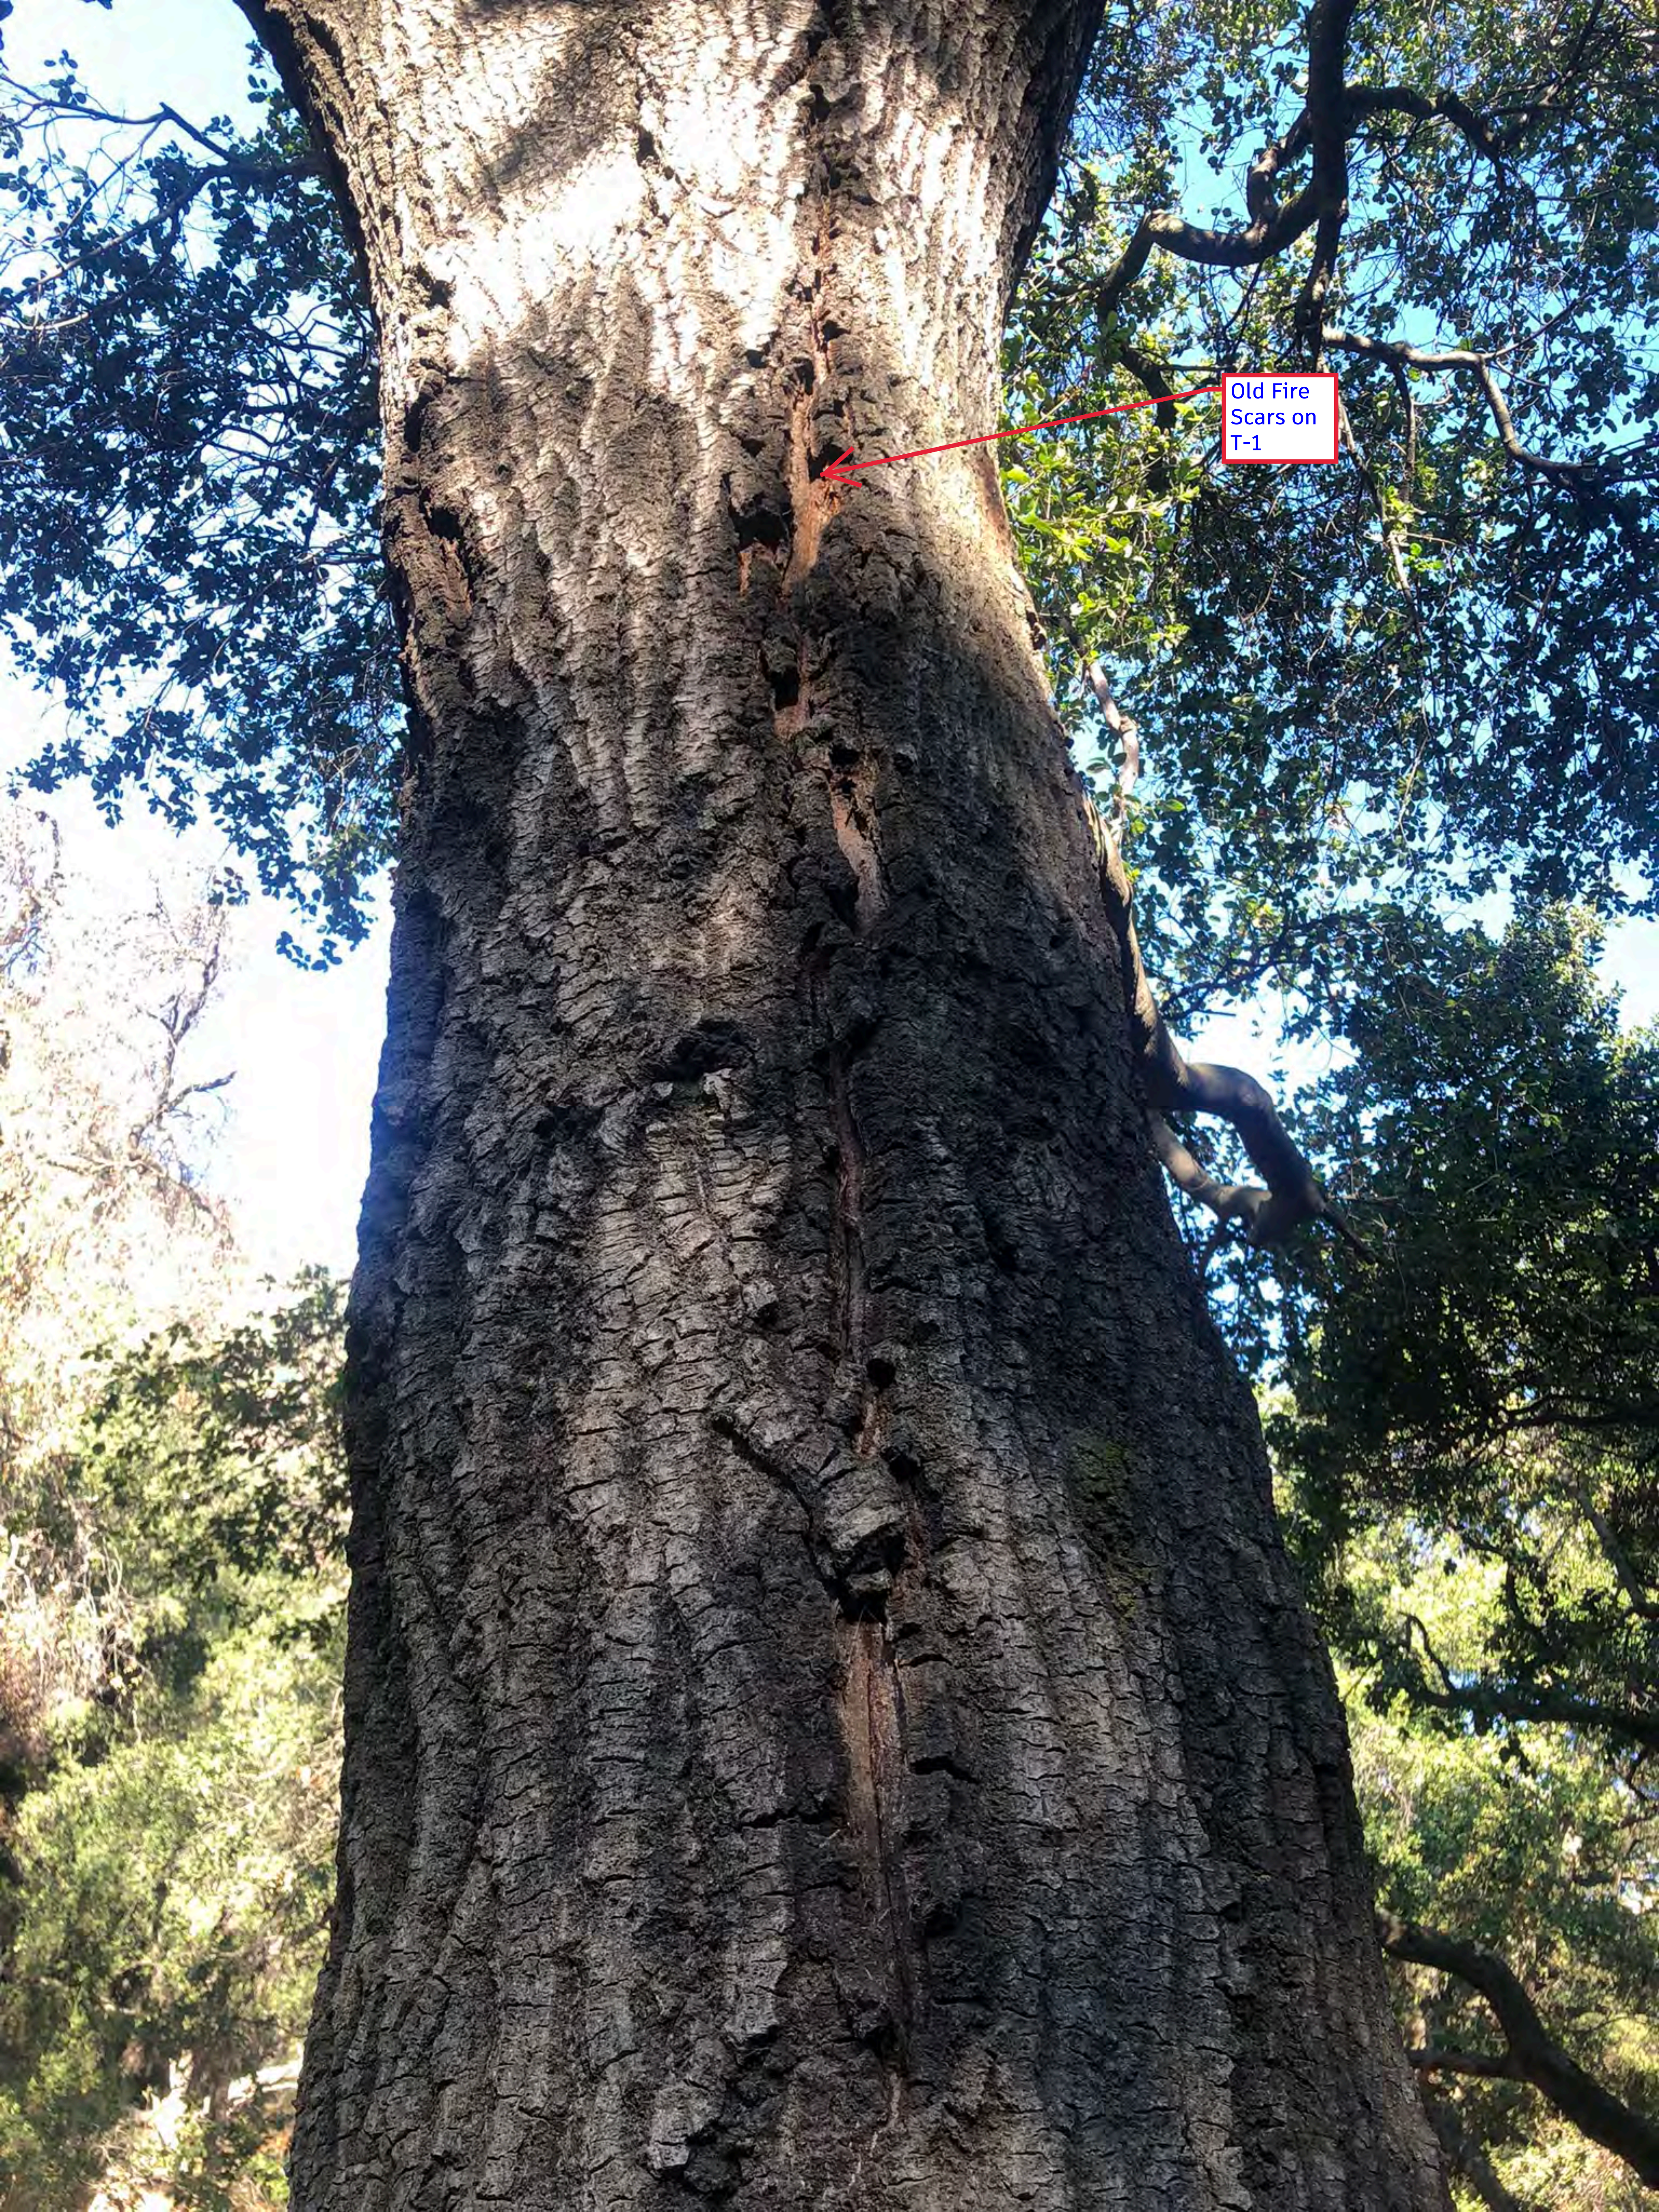
Old Fire  
Scars on  
T-1

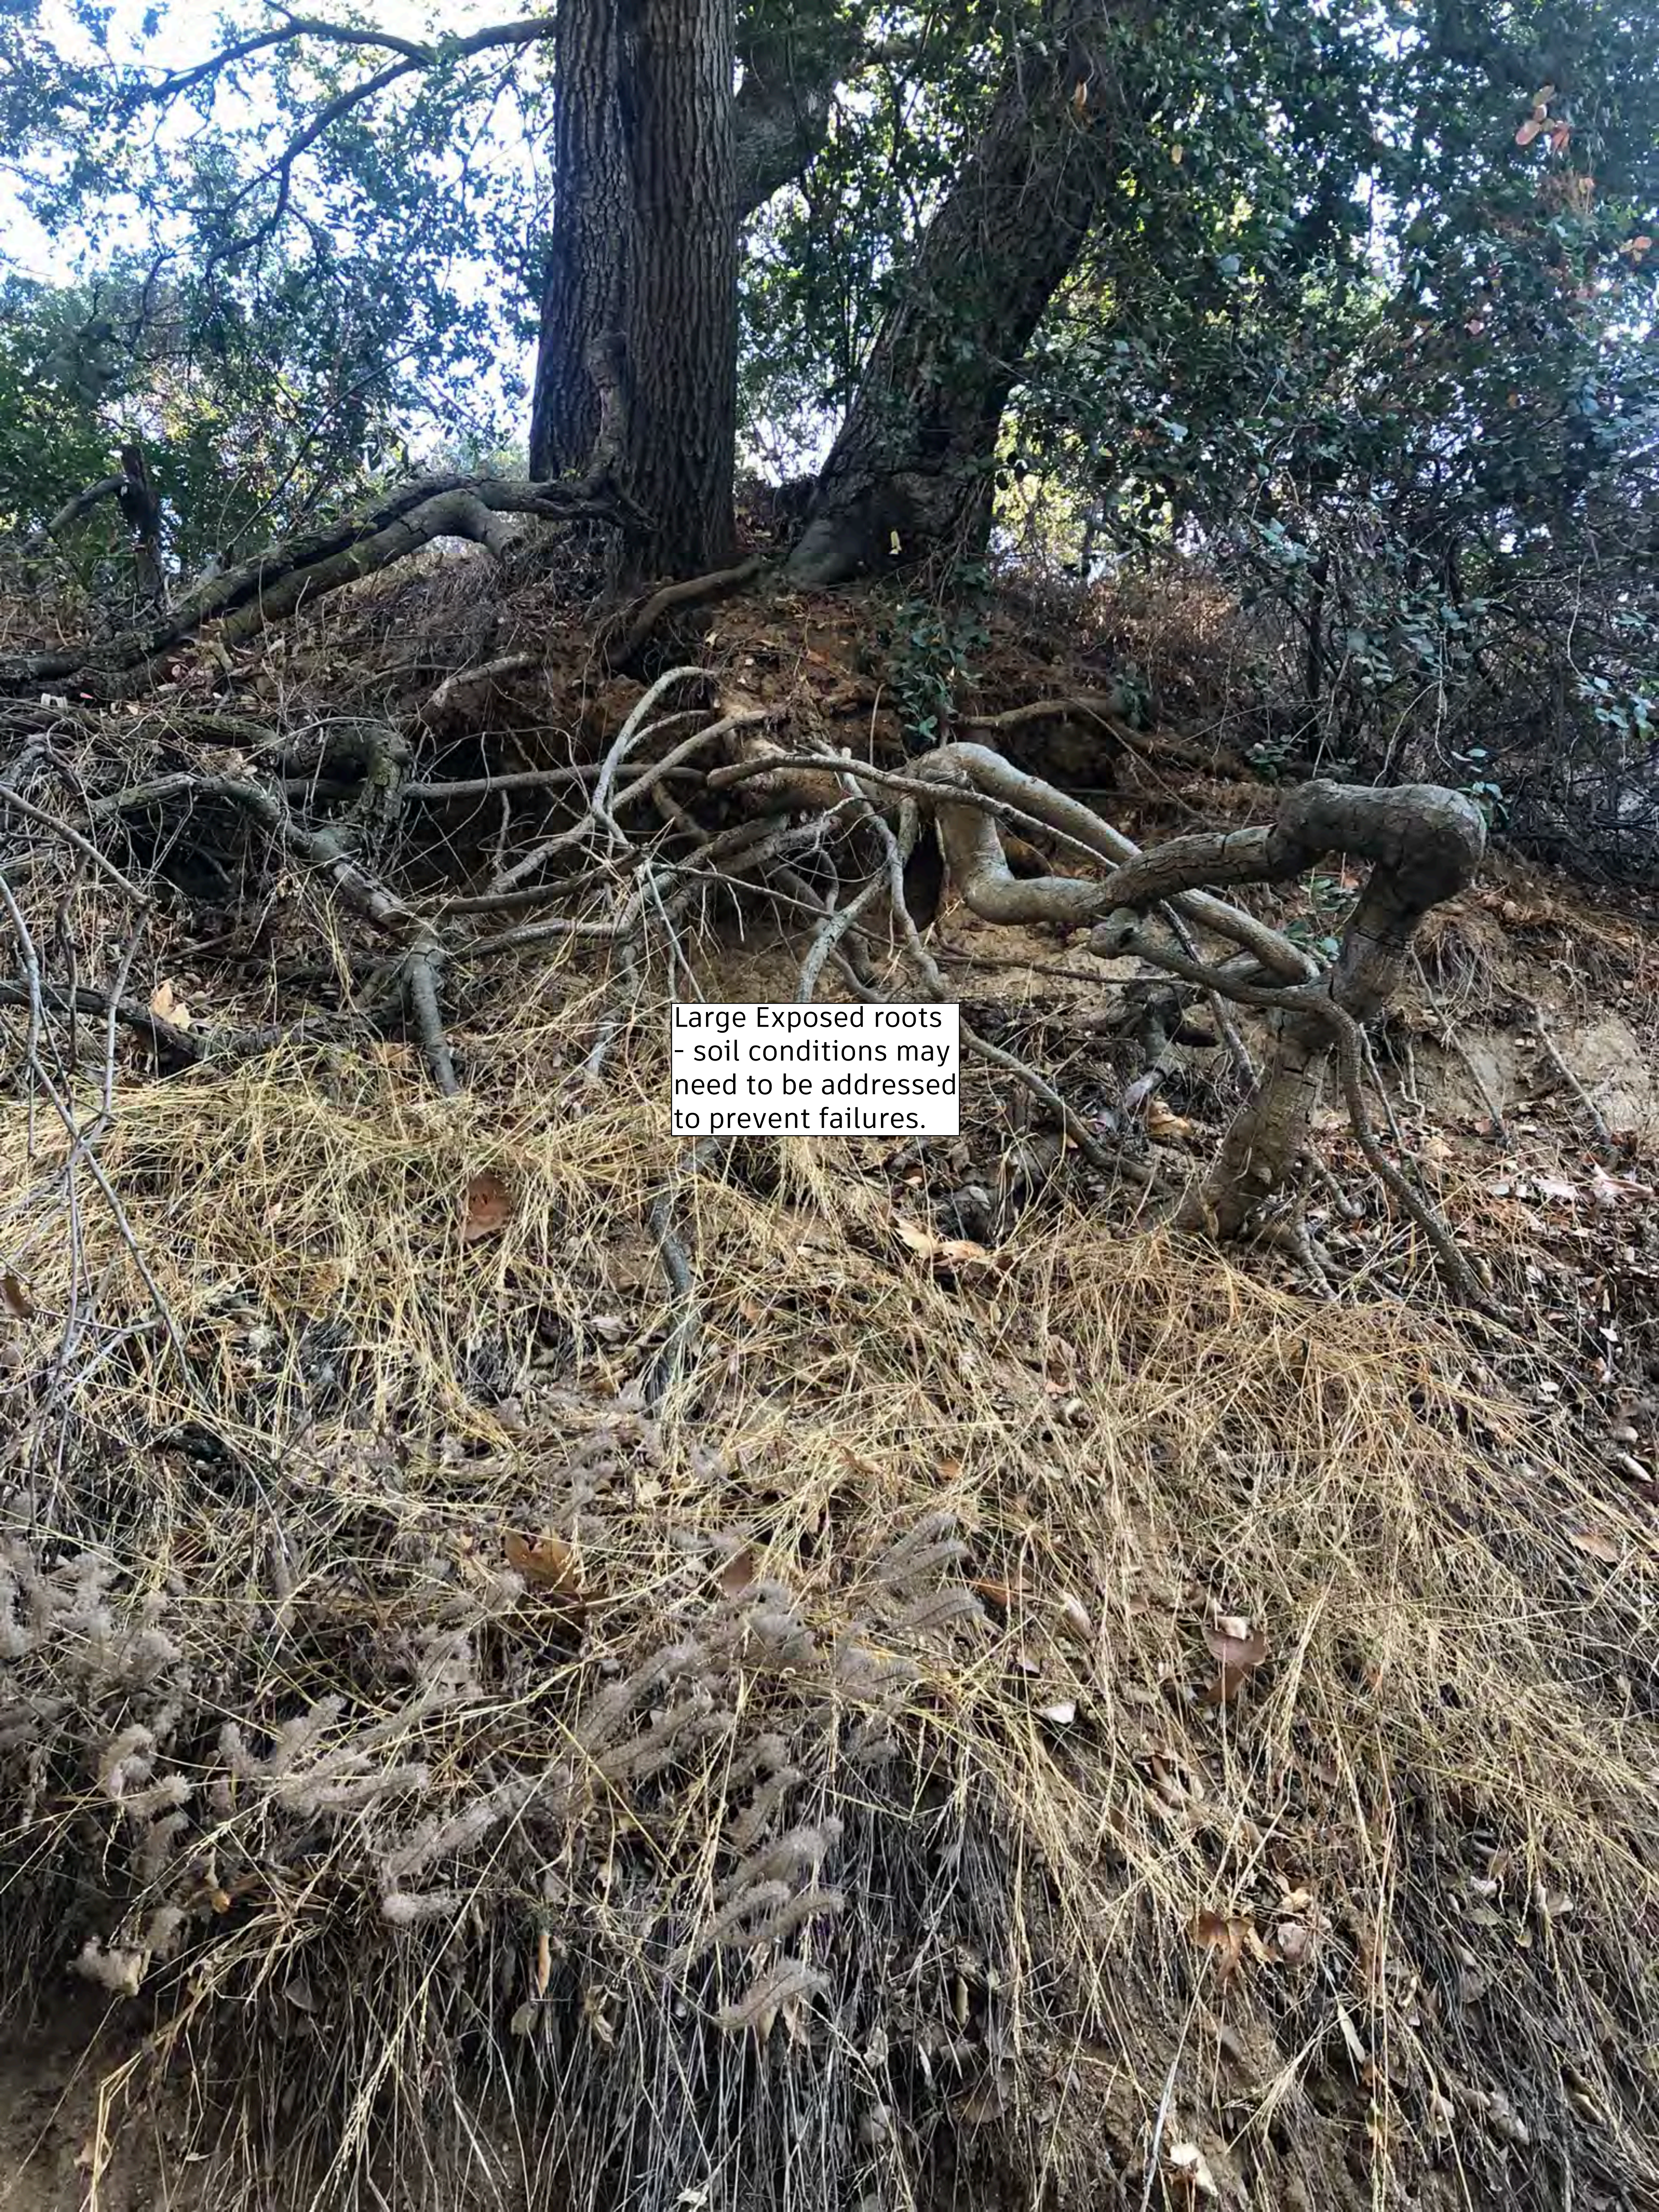
Exposed roots by roadway

Large Exposed roots  
- soil conditions may  
need to be addressed  
to prevent failures.

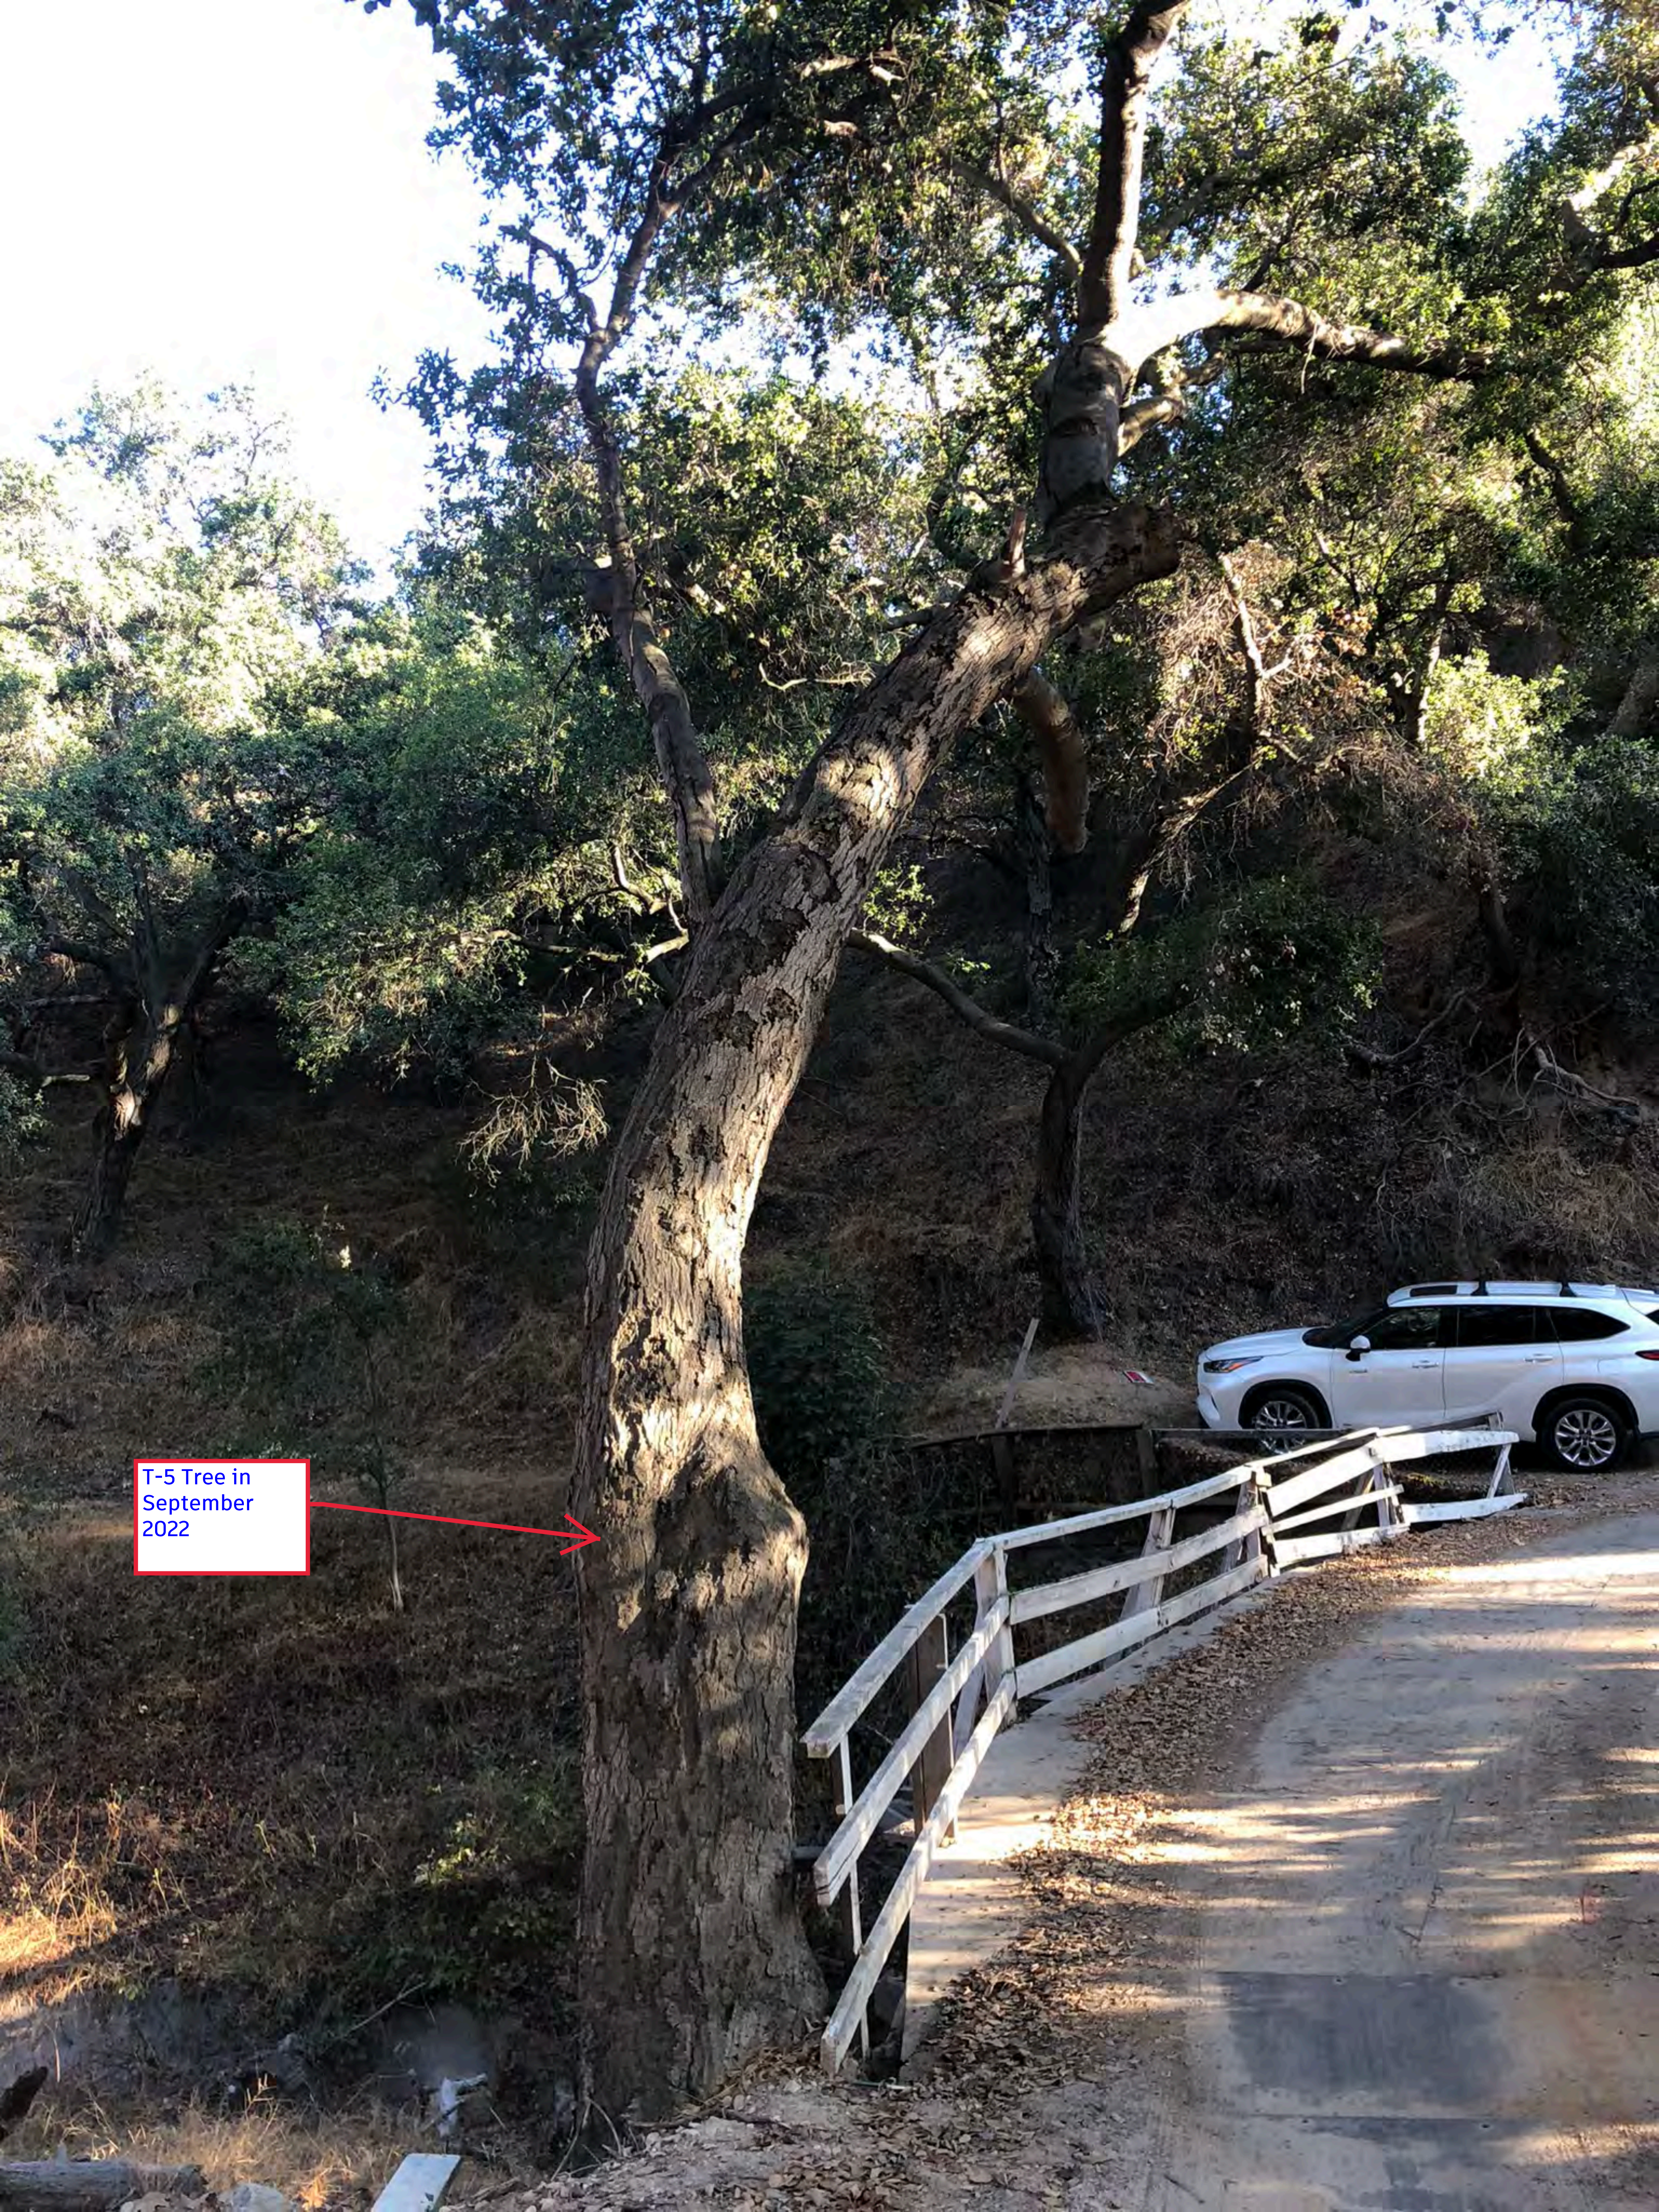
T-5 Tree in  
September  
2022

After November - T-5 failed.

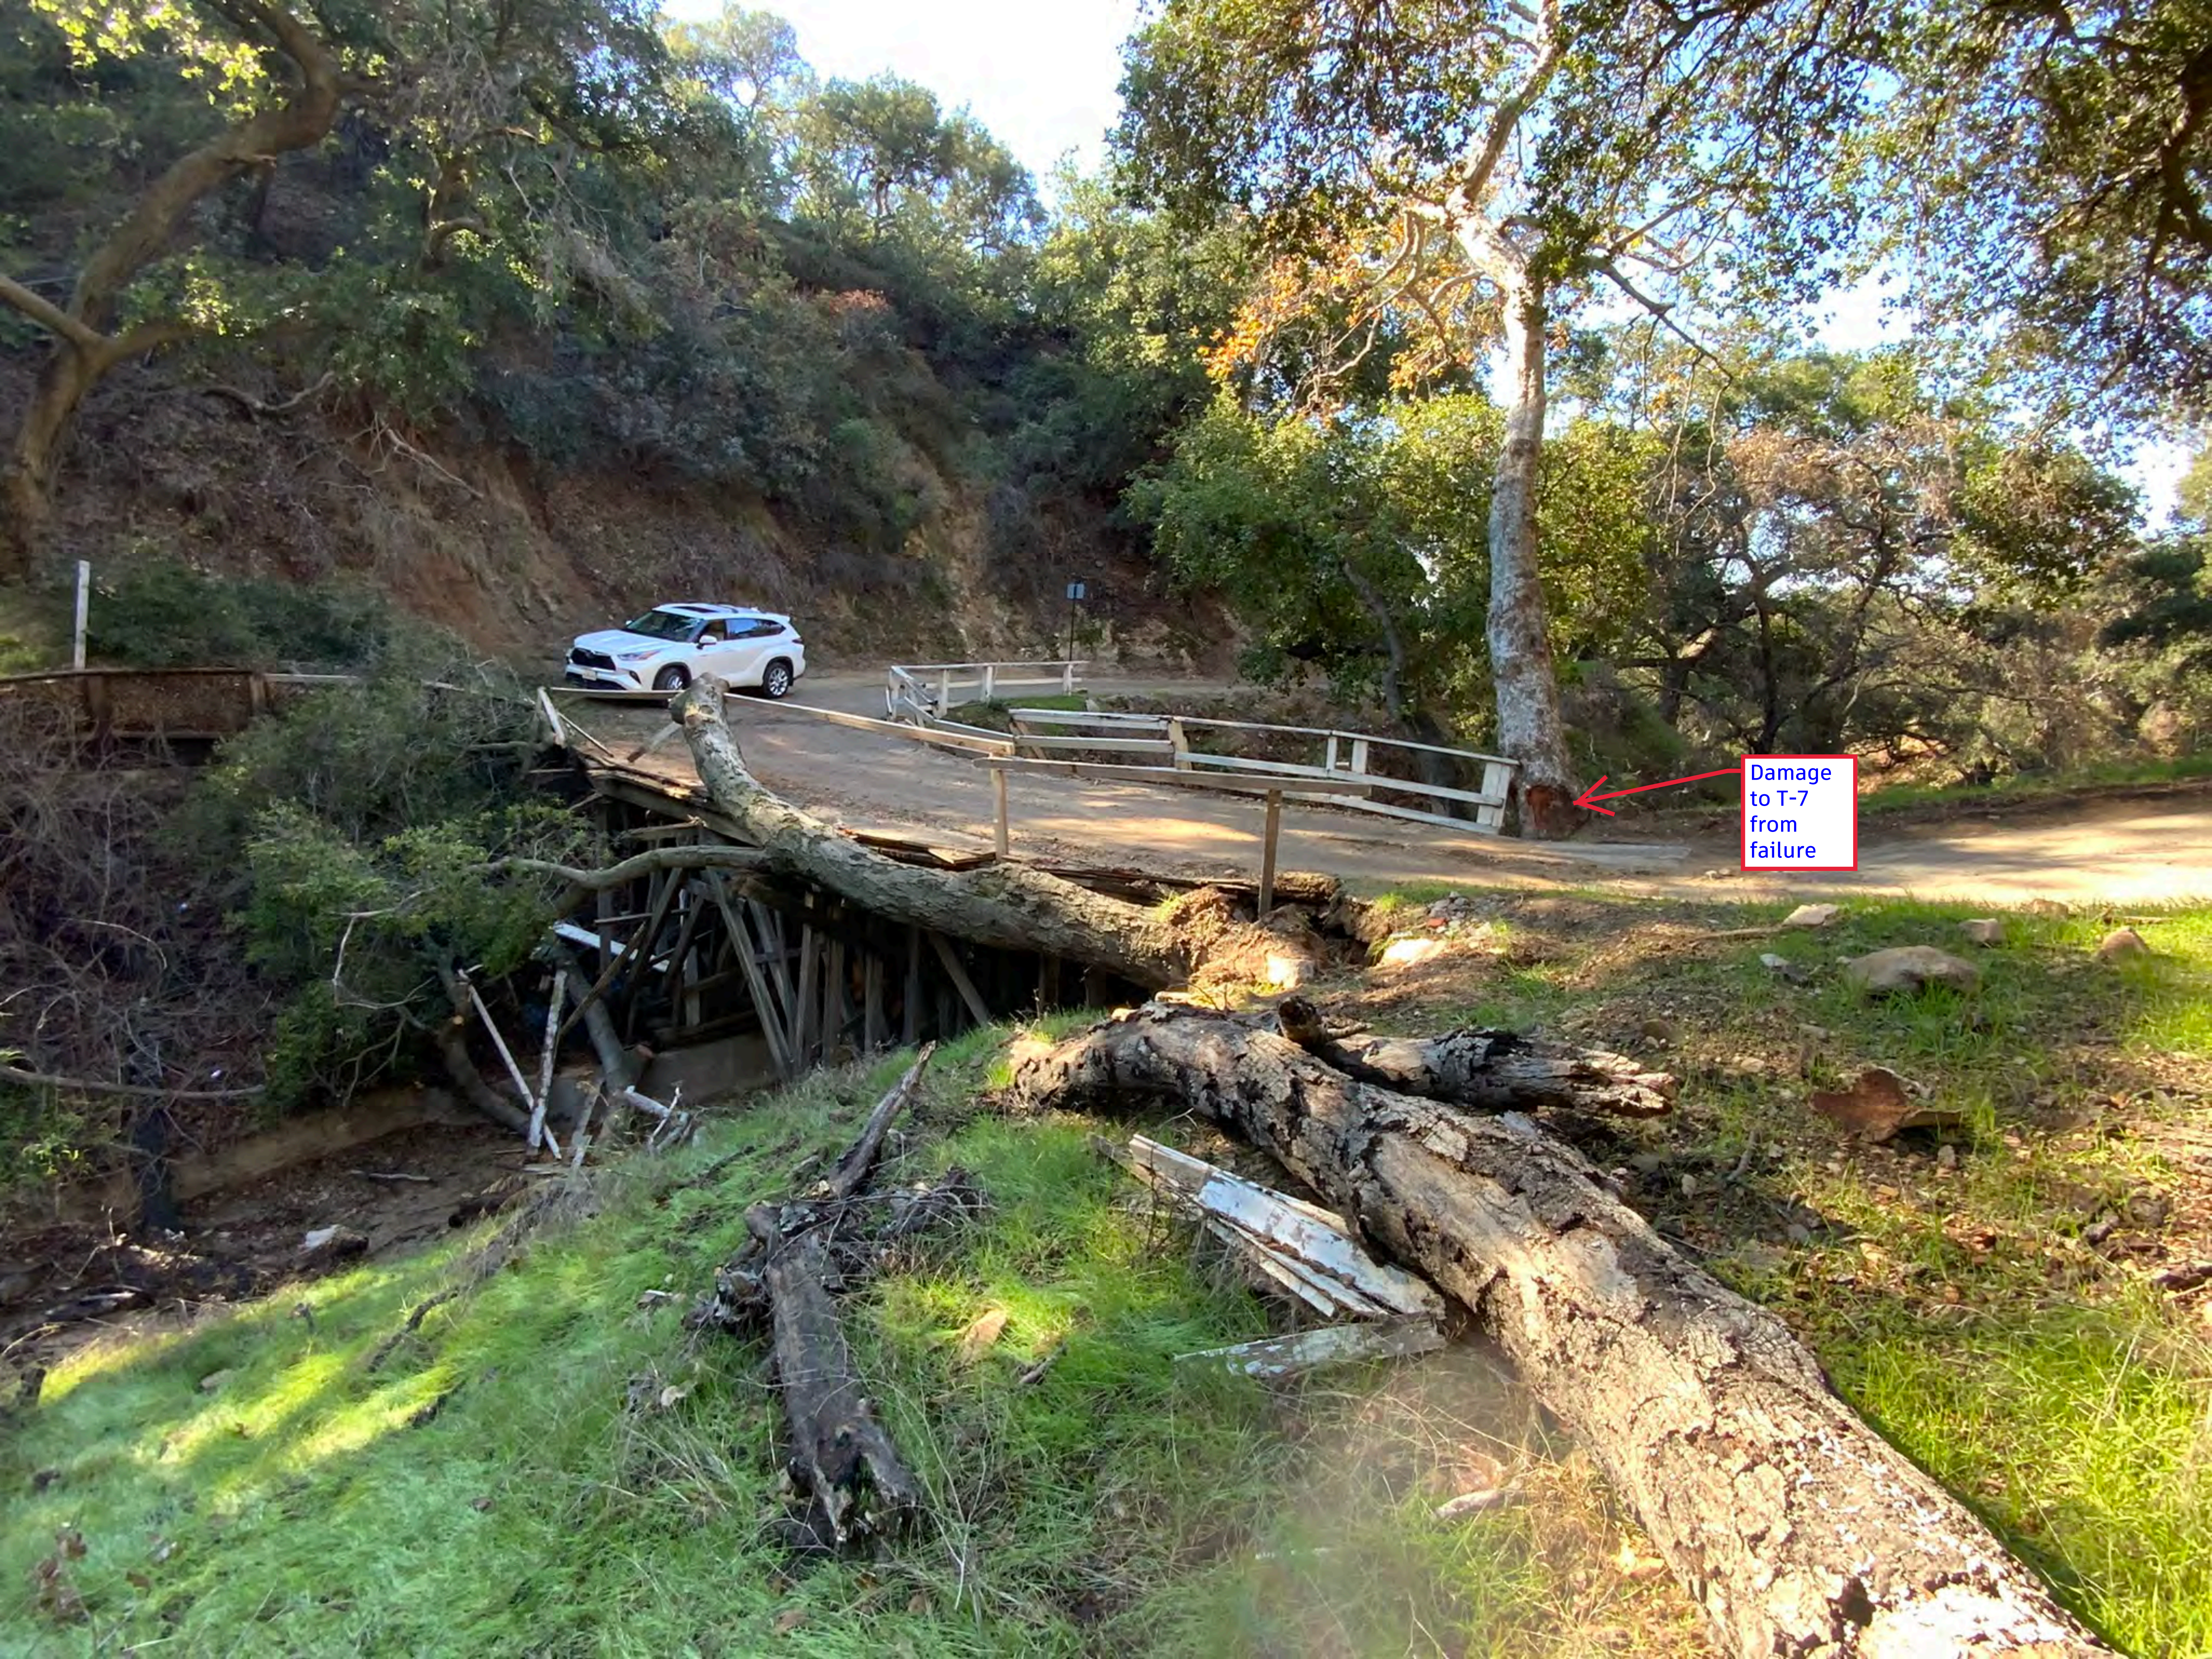
Damage  
to T-7  
from  
failure
