## REPORT TO THE HEARING OFFICER

DATE ISSUED: February 15, 2024  
HEARING DATE: February 27, 2024 AGENDA ITEM: 9  
PROJECT NUMBER: PRJ2023-003125-(5)  
PERMIT NUMBER(S): Oak Tree Permit ("OTP") RPPL2023004582  
SUPERVISORIAL DISTRICT: 5  
PROJECT LOCATION: 4010 Fair Oaks Avenue, Altadena  
OWNER: Alan Zorthian  
APPLICANT: Alan Zorthian  
CASE PLANNER: Sean Donnelly, Senior Planner  
sdonnelly@planning.lacounty.gov

REPAIR OF EXISTING WOOD BRIDGE

BRIDGE REPAIR  
3697 NORTH FAIR OAKS AVENUE  
ALTADENA, CA 91001

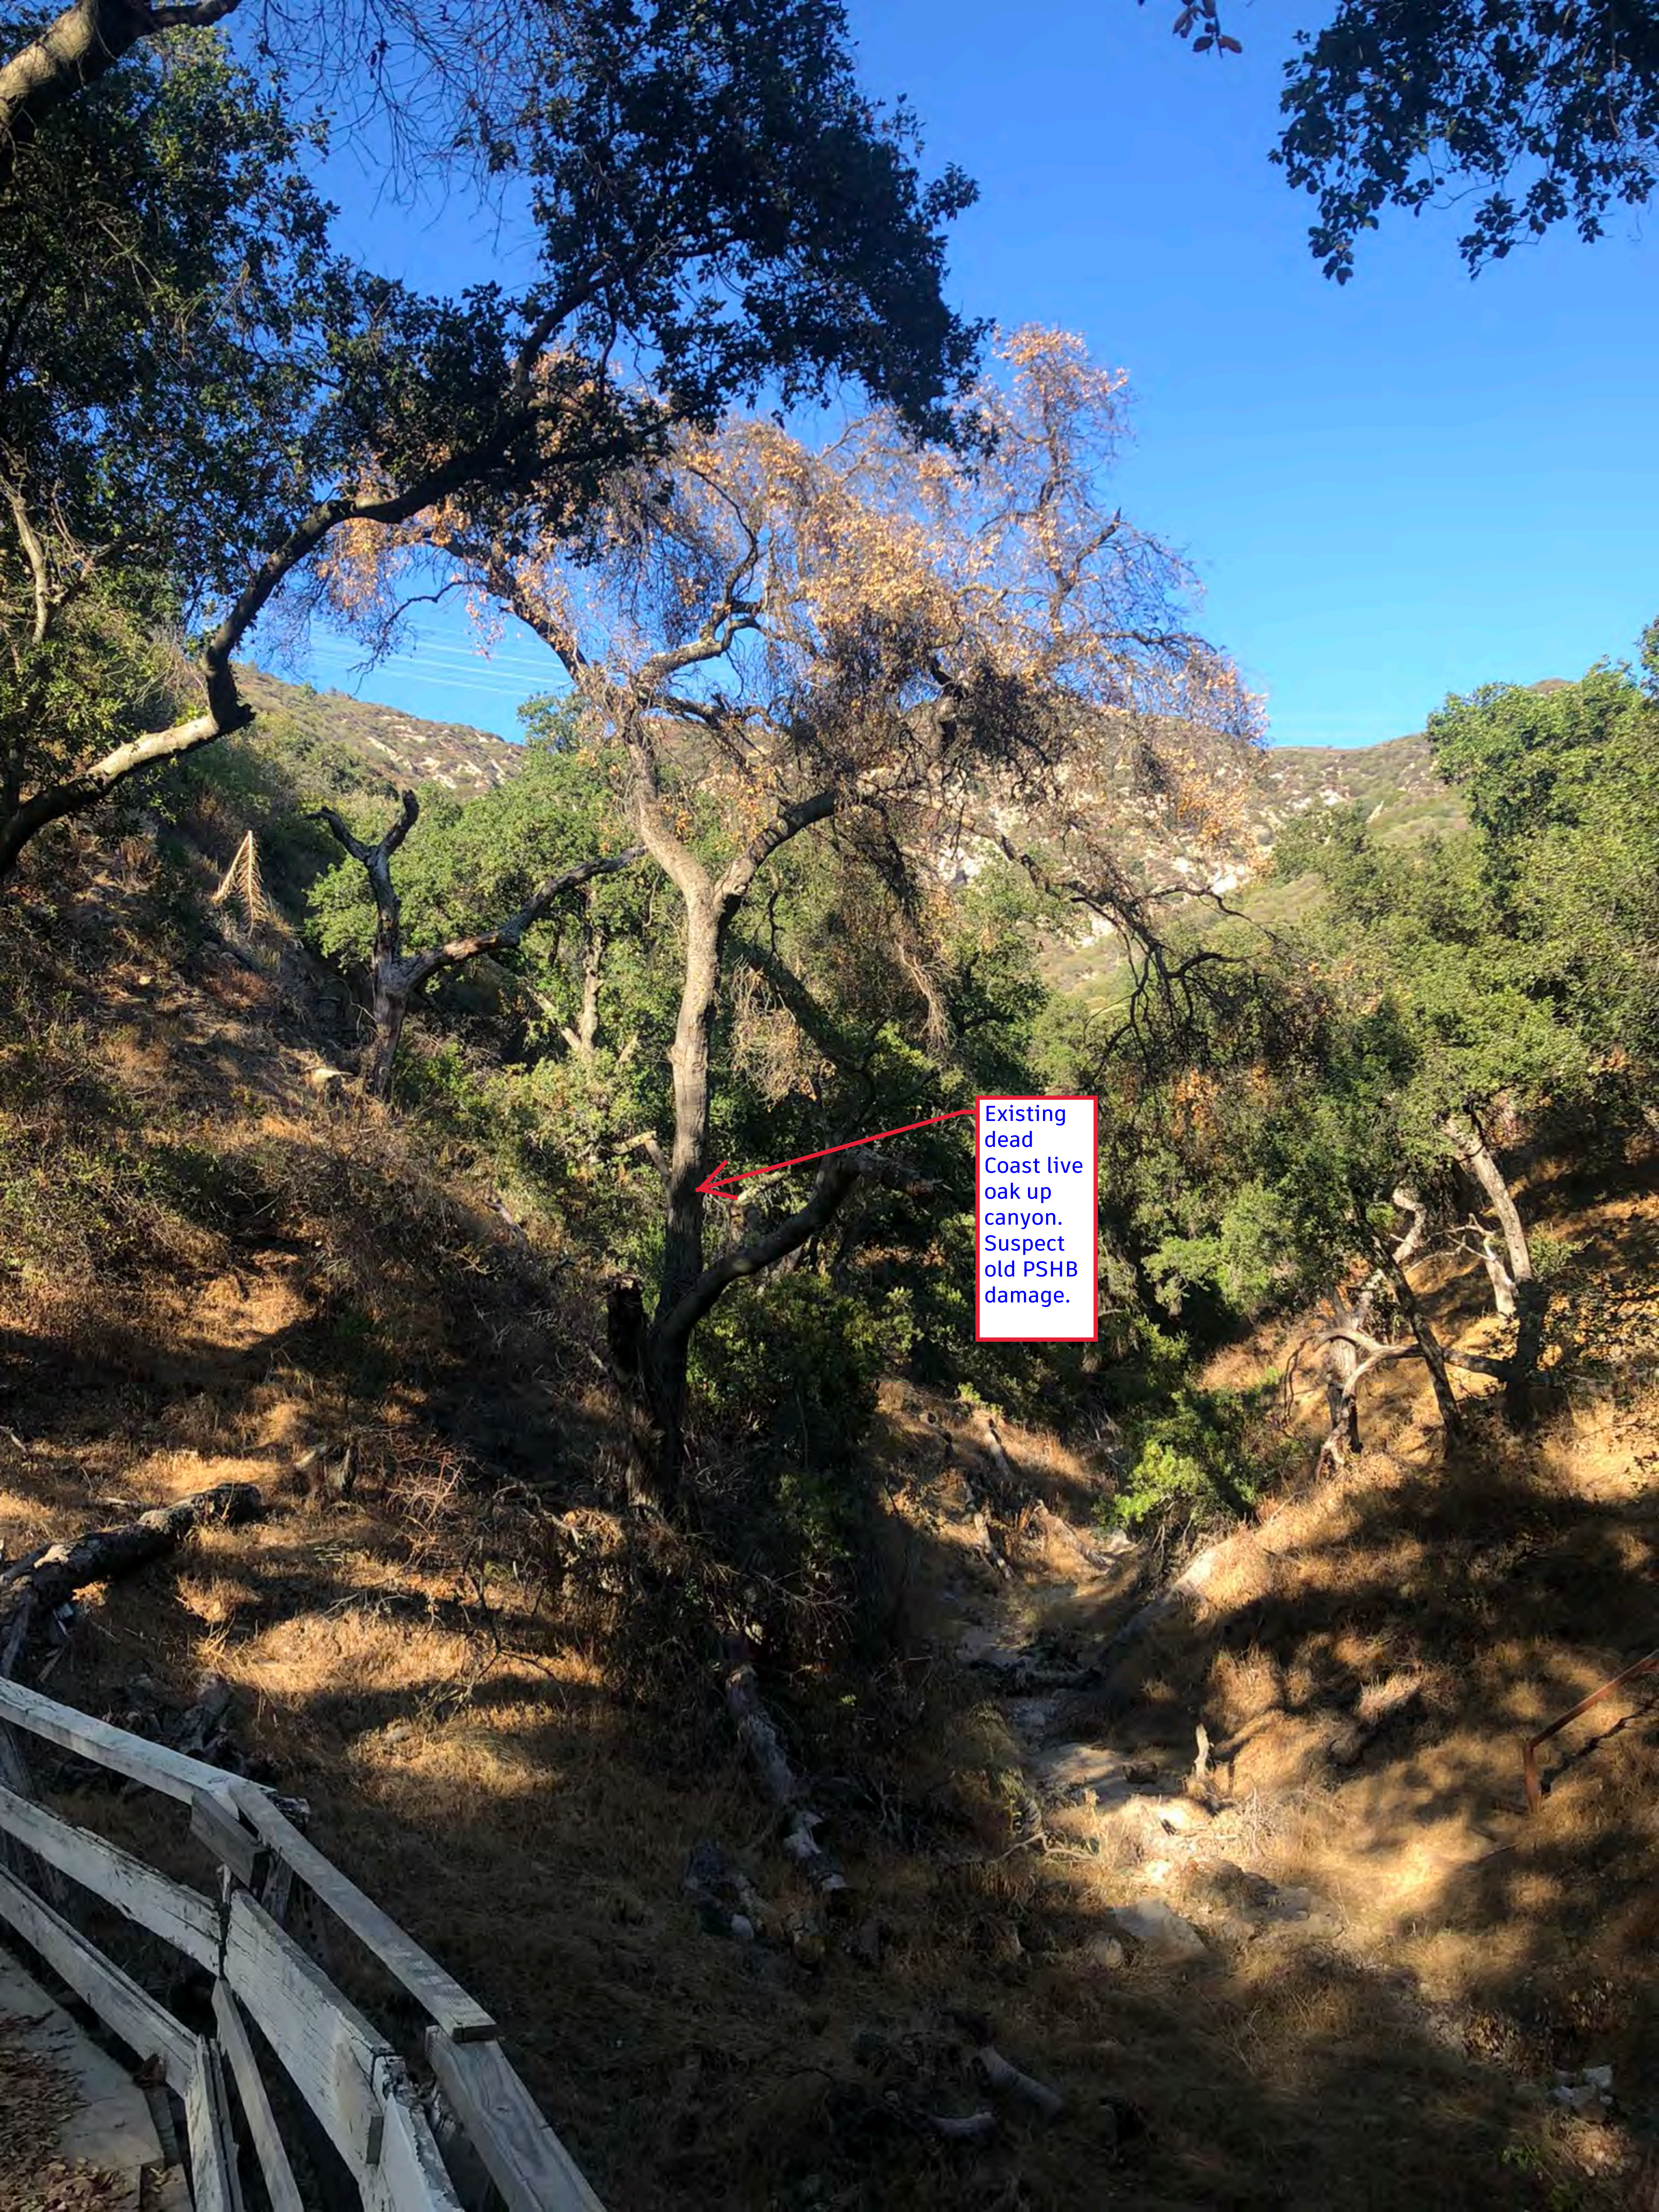
Existing  
dead  
Coast live  
oak up  
canyon.  
Suspect  
old PSHB  
damage.

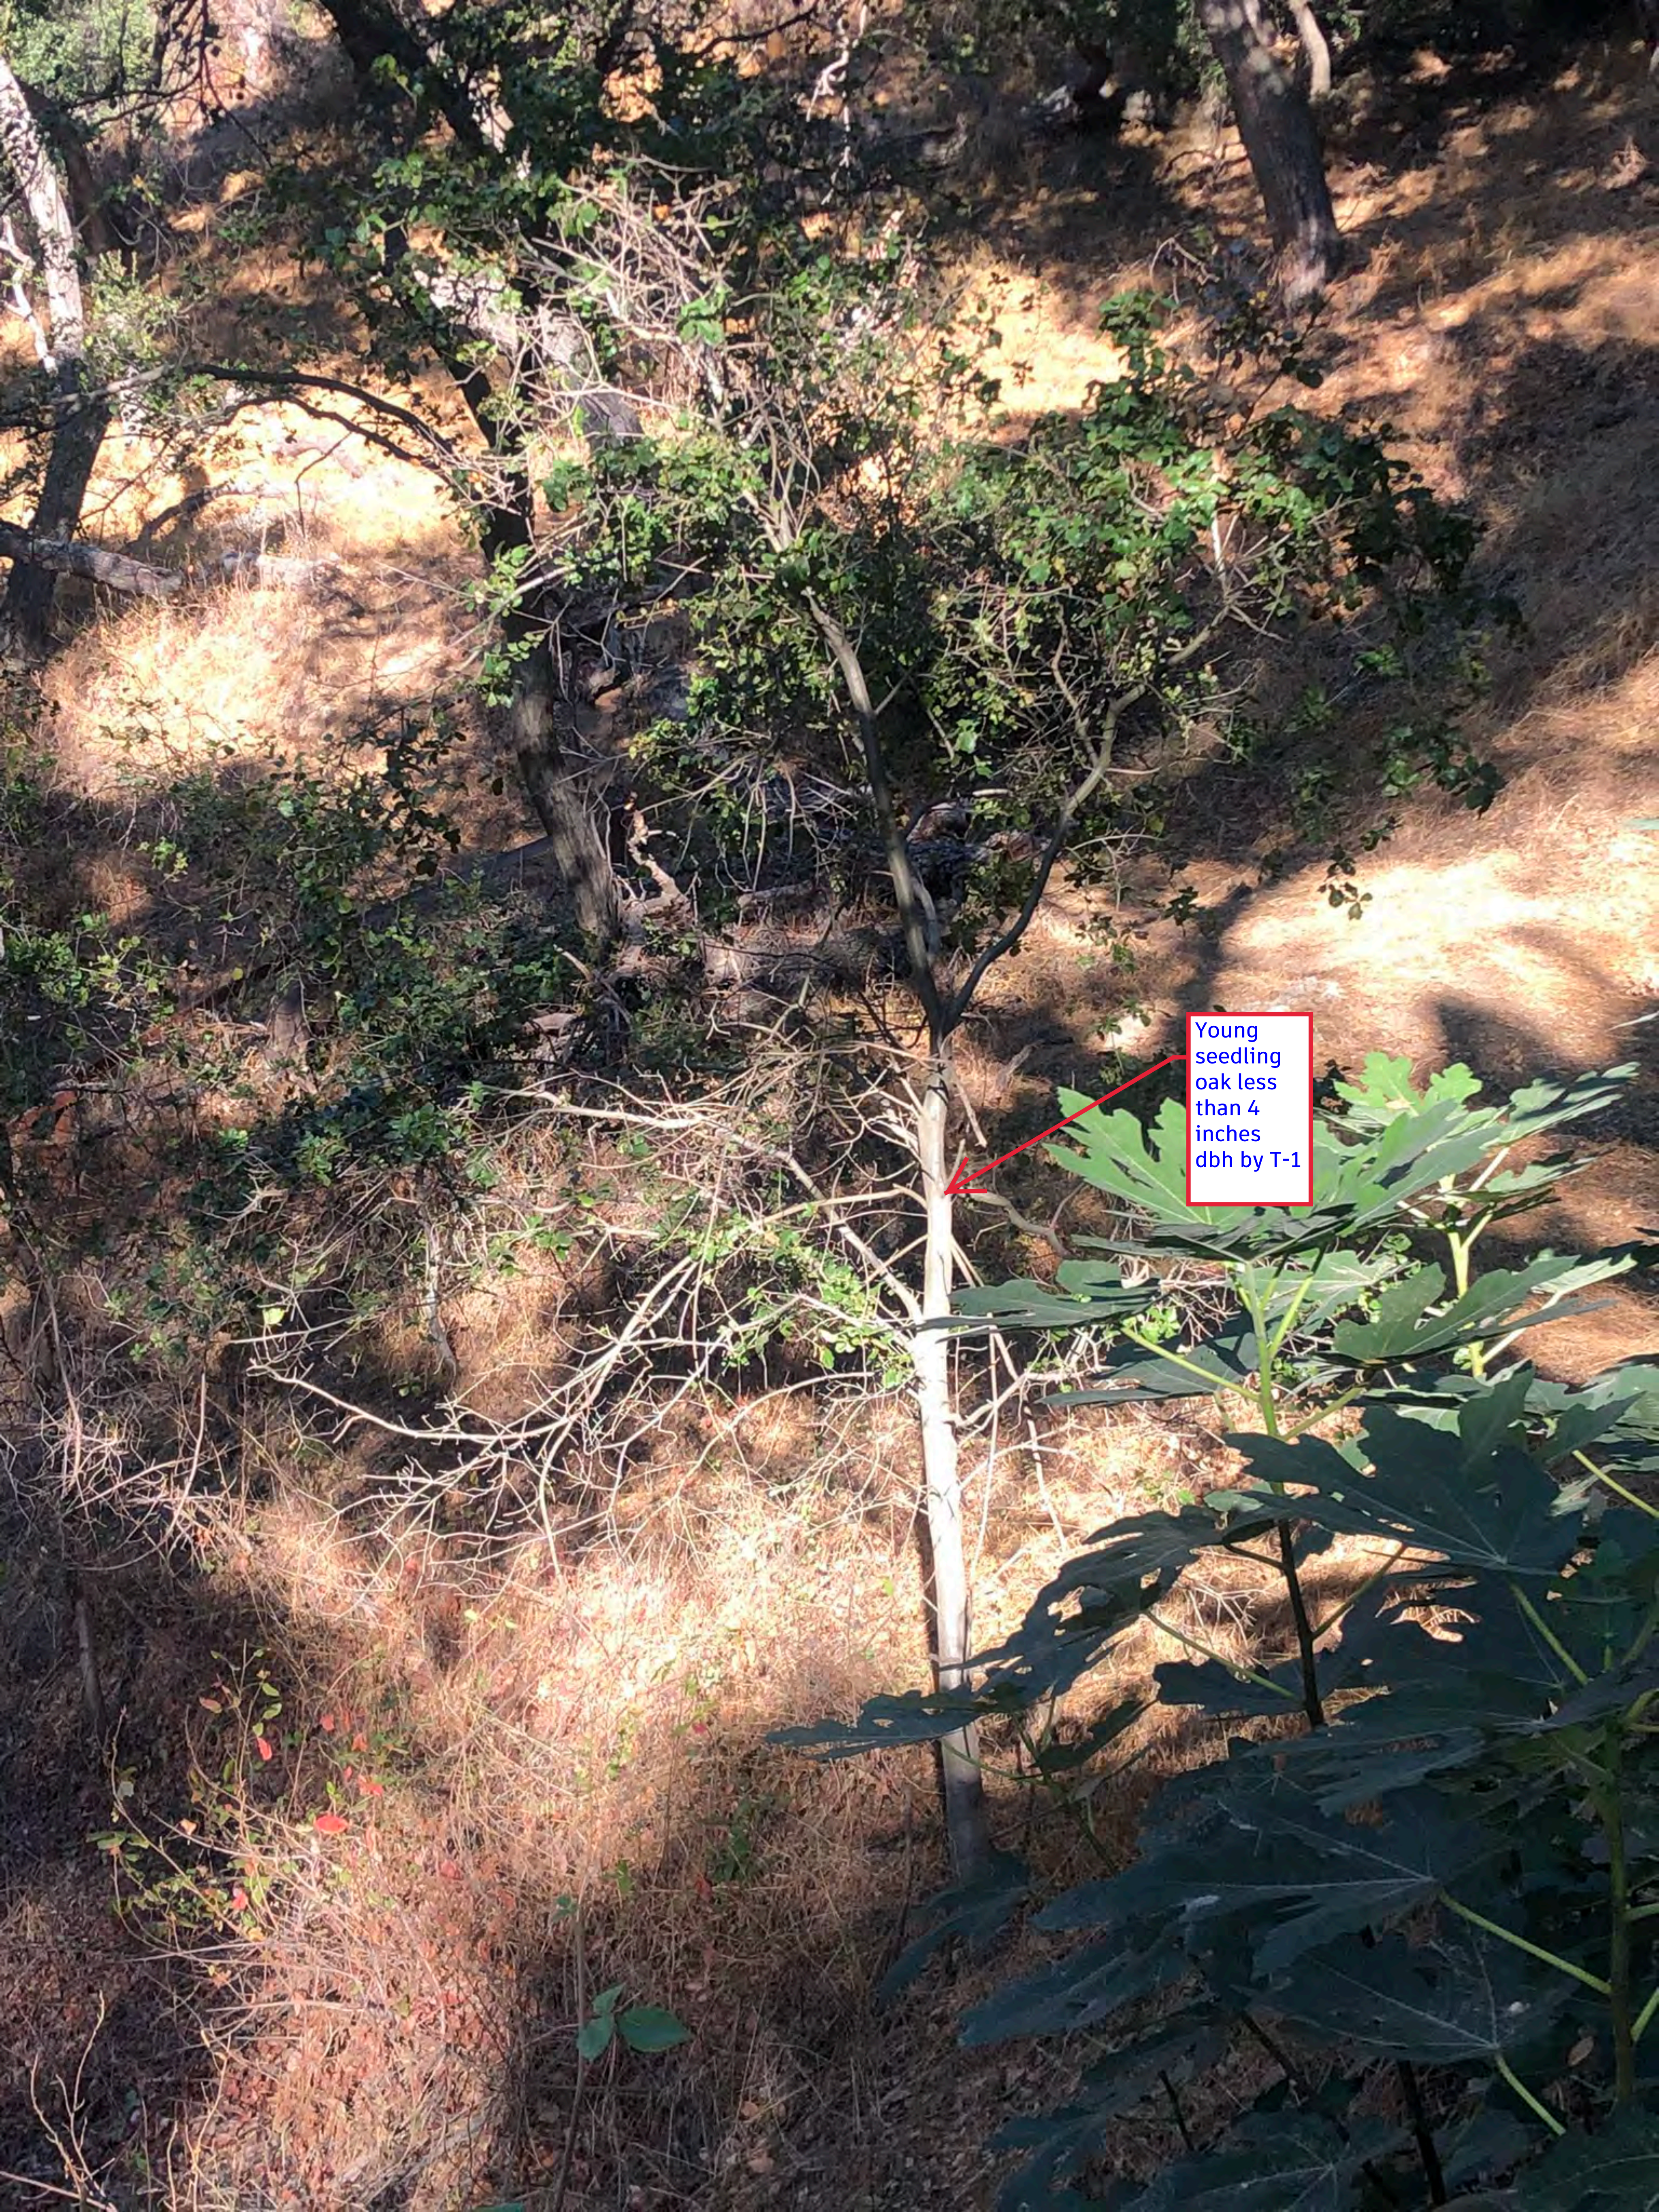
Young  
seedling  
oak less  
than 4  
inches  
dbh by T-1
