REPORT TO THE HEARING OFFICER

PROJECT NUMBER: PRJ2024-000924-(5)

PERMIT NUMBER(S): Oak Tree Permit (“OTP”) No. RPPL2024002516
Zoning Conformance Review No. RPPL2024002515

PROJECT LOCATION: 2980 Crestford Drive, Altadena (Assessor’s Parcel
Number 5829-029-050)

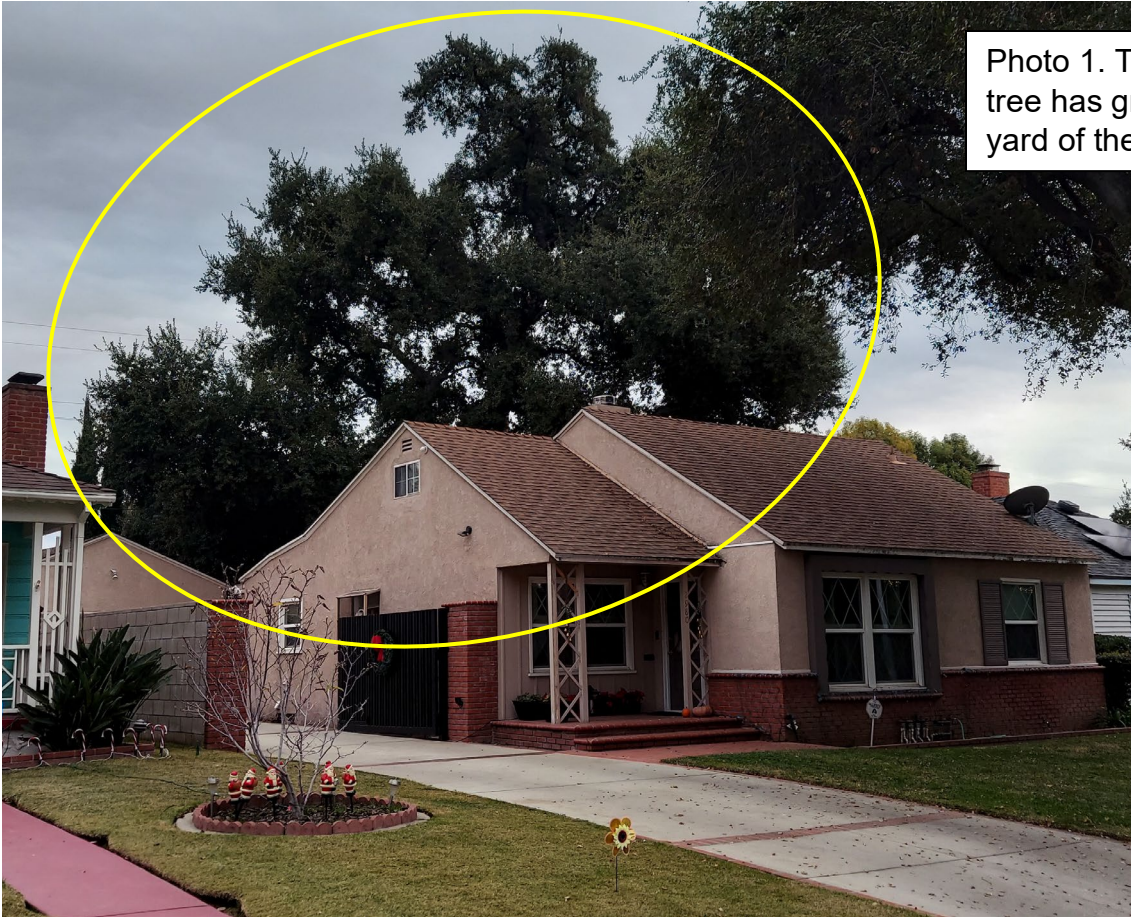
Photo 1. The subject oak tree has grown in the back yard of the Hines Residence.

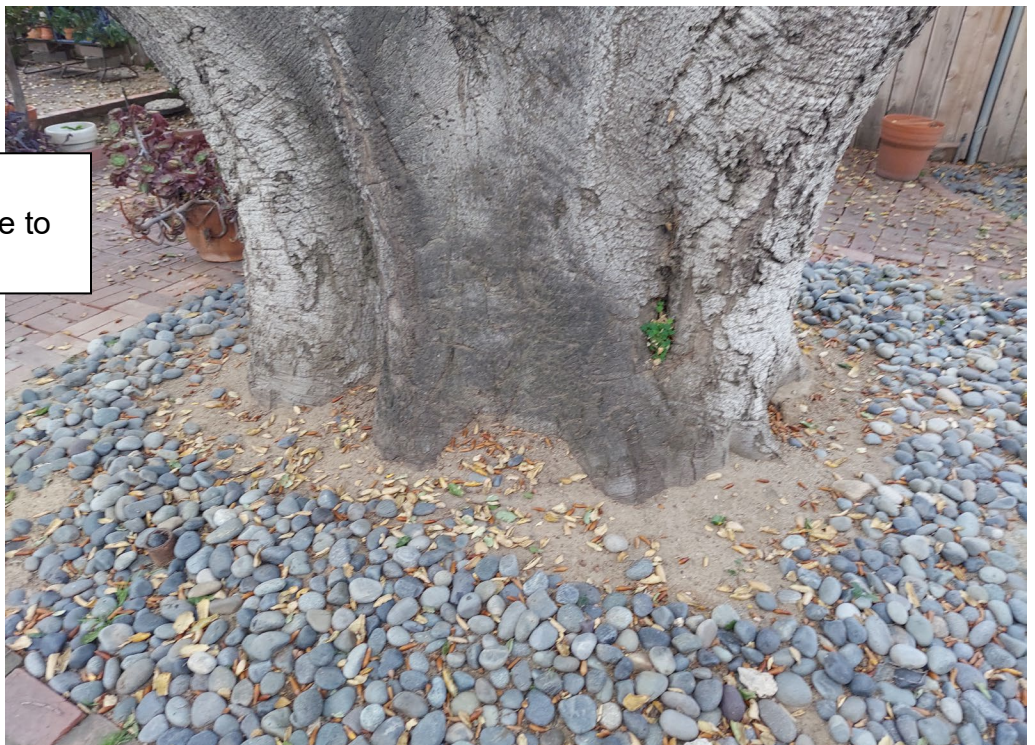
Photo 2. Bare soil and decorative rock are close to the oak's trunk.

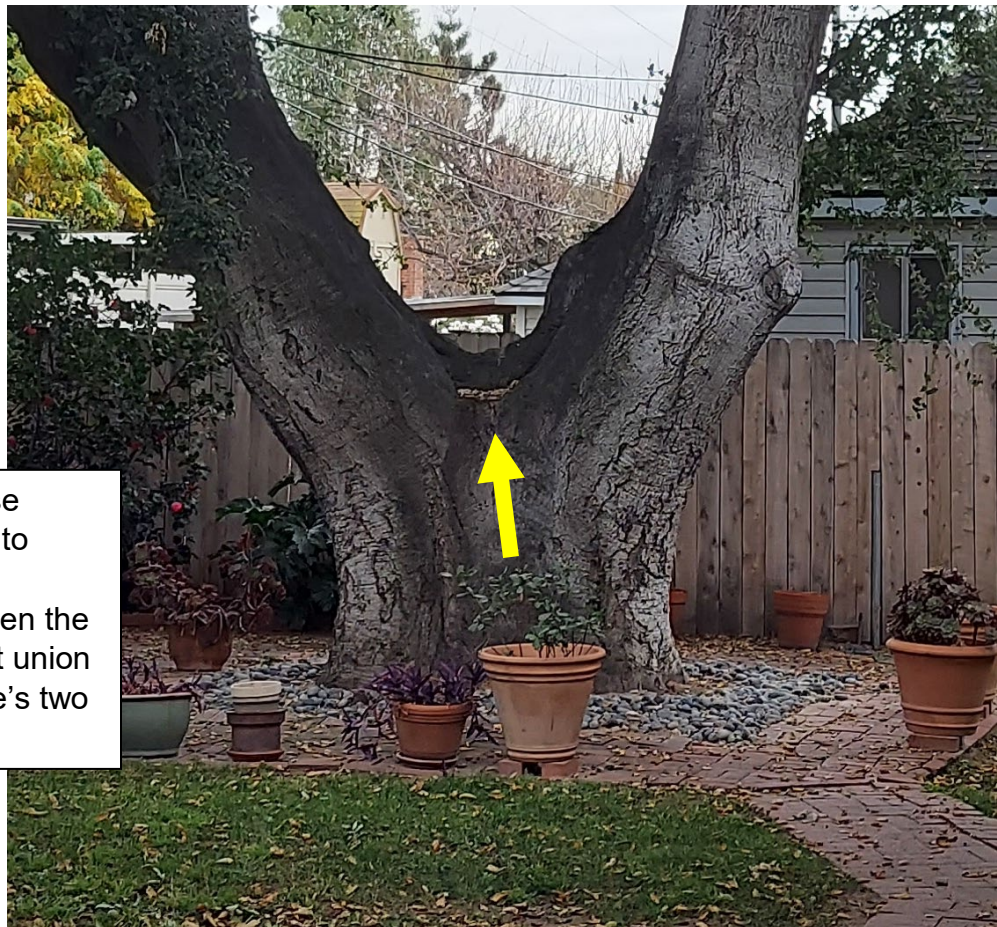
Photo 4. Response wood has formed to strengthen the attachment between the large co-dominant union formed by the tree's two primary limbs.

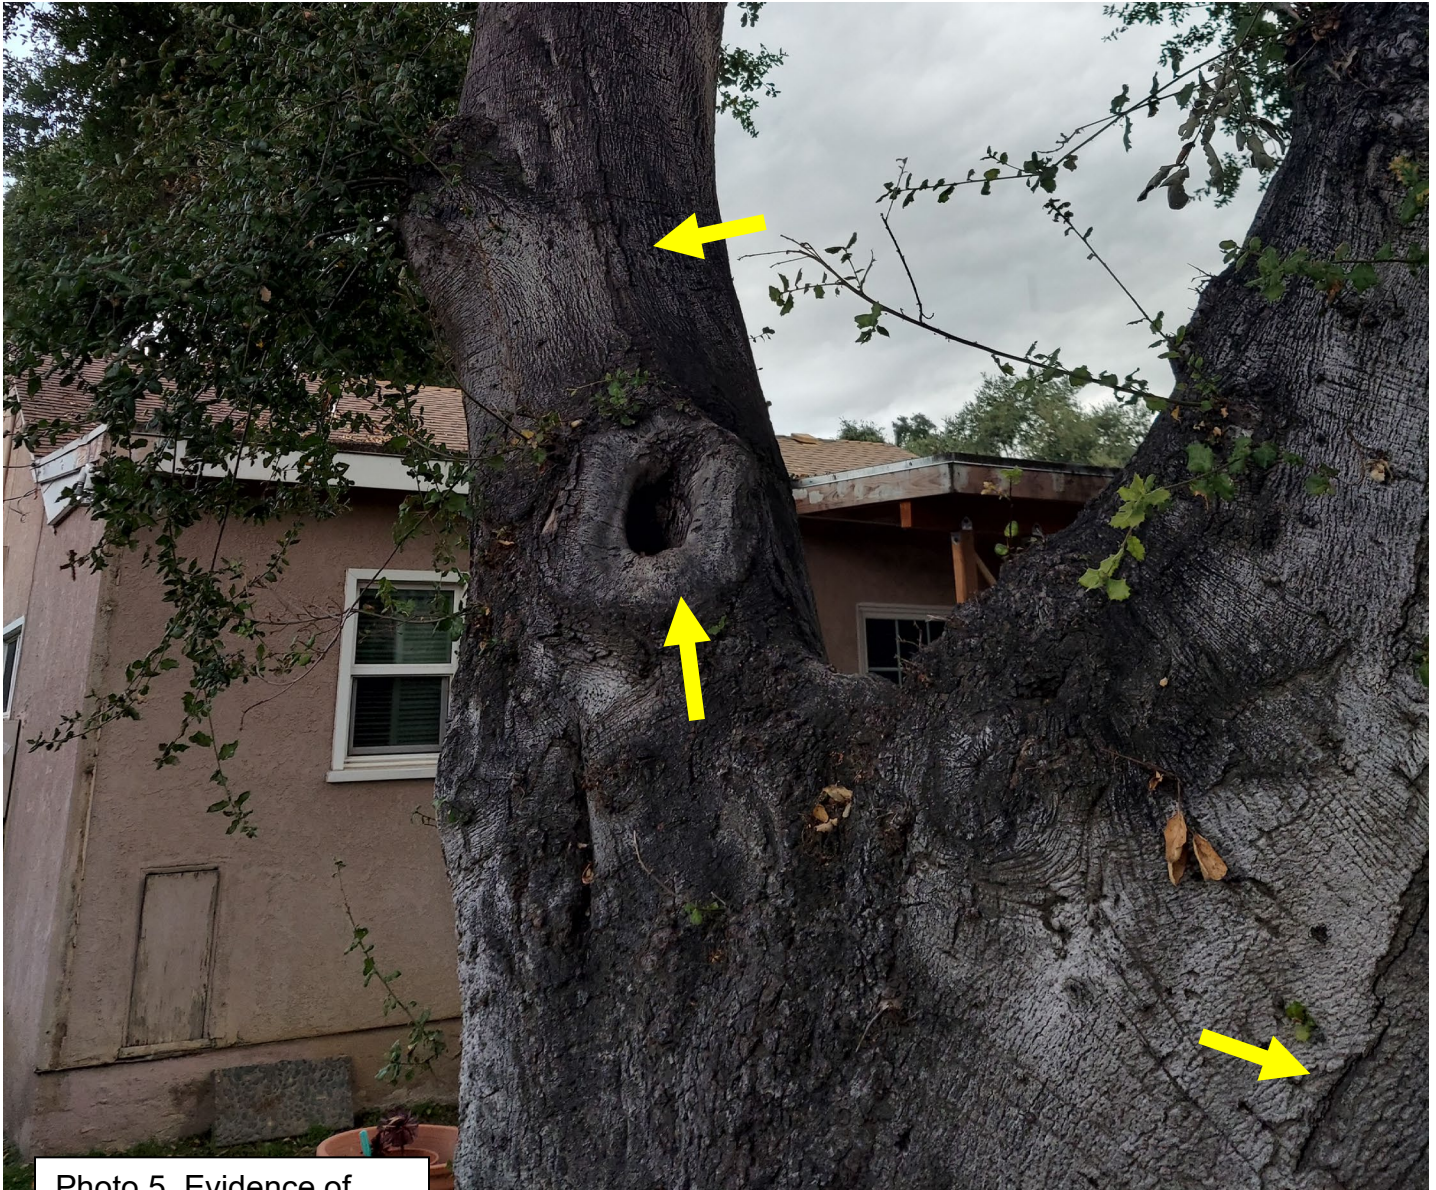
Photo 5. Evidence of vigor was seen where callus tissue has grown and where longitudinal caliper expansion cracks have formed.

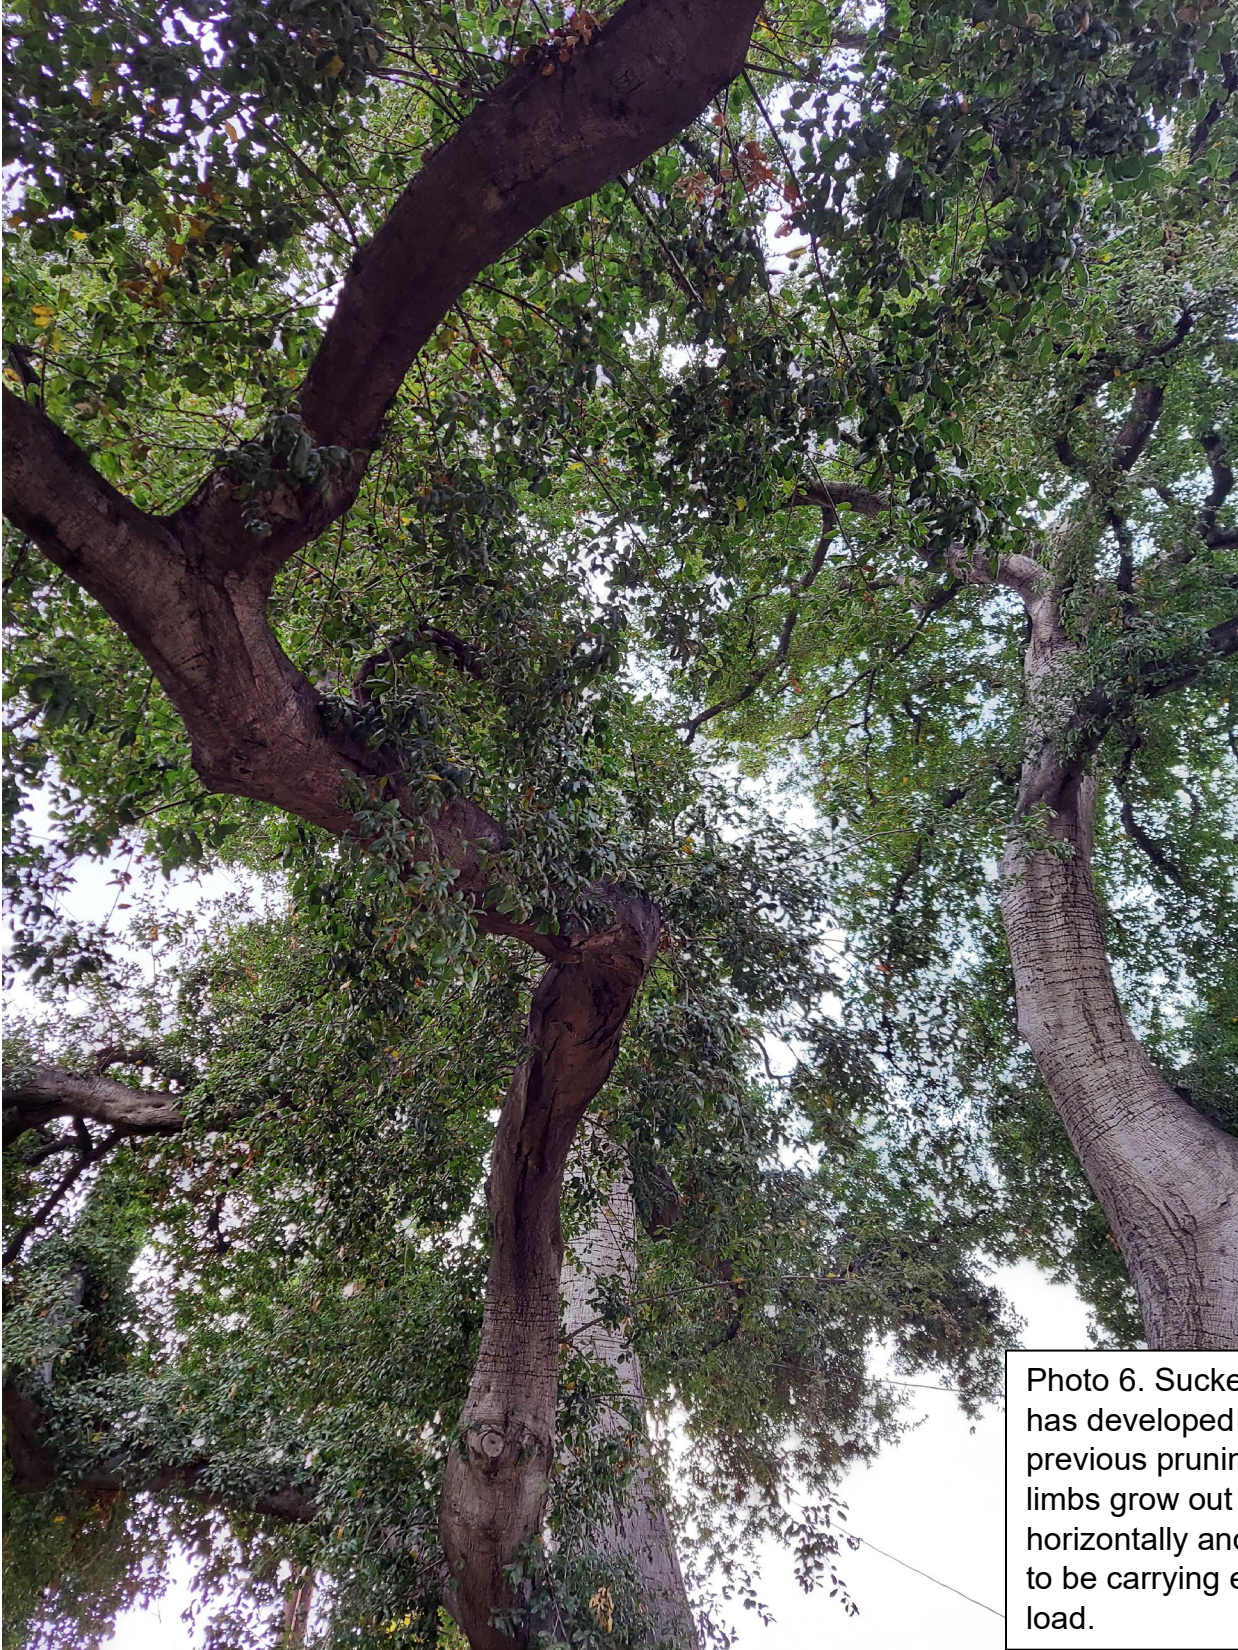
Photo 6. Sucker growth has developed due to previous pruning. Some limbs grow out horizontally and appear to be carrying excessive load.

- Provide end weight reduction on over-extended horizontal limbs during the Summer of 2024. Pruning should be kept to a minimum to achieve desired goals. All pruning work to conform to **ANSI A300** pruning standards.
- Perform a root crown excavation and inspection. Provide further recommendations based on findings.
- Monitor oak yearly and provide further written recommendations based on findings.
