AGENDA

3. Project Name: Woolsey Canyon Grading Project [26-150](#)
Project No.: PRJ2020-001220-(3)
Permit No.: SEA CUP RPPL2021002331, Oak Tree Permit No. RPPL2021002524, Environmental Assessment No. RPPL2023005020
APN: 2017007010, -011, -014, -016, and 018
Address: 24668 Woolsey Canyon Road, West Hills
SEA: Santa Susana Mountains / Simi Hills
USGS Quad: Calabasas
Applicant: Menashe Braonstien
Biologist: Forde Biological Consultants
DRP Planner: Soyeon Choi

Project Name: Woolsey Canyon SEACUP
Project No.: PRJ2020-001220
Permit No.: SEACUP RPPL2021002331
OTP RPPL2021002524
ENV RPPL2023005020
APNs: 2017007010, -011, -014, -016, and 018 (On-site parcels)
2017007001, -003, -004, -006, -012, -013, and 2017-009-902 and 904
(Off-site parcels)
Address: 24668 Woolsey Canyon Road, West Hills, CA 91304
SEA: Santa Susana Mountains / Simi Hills SEA
USGS Quad: Calabasas
Applicant: Menashe Braonstiin
Biologist: Forde Biological Consultants
DRP Project Planner: Soyeon Choi
DRP Biologist: Michael Cady

24668 Woolsey Canyon Road
(APN's-2017-007-010, -011, -014, -016, -018)
Los Angeles County, California

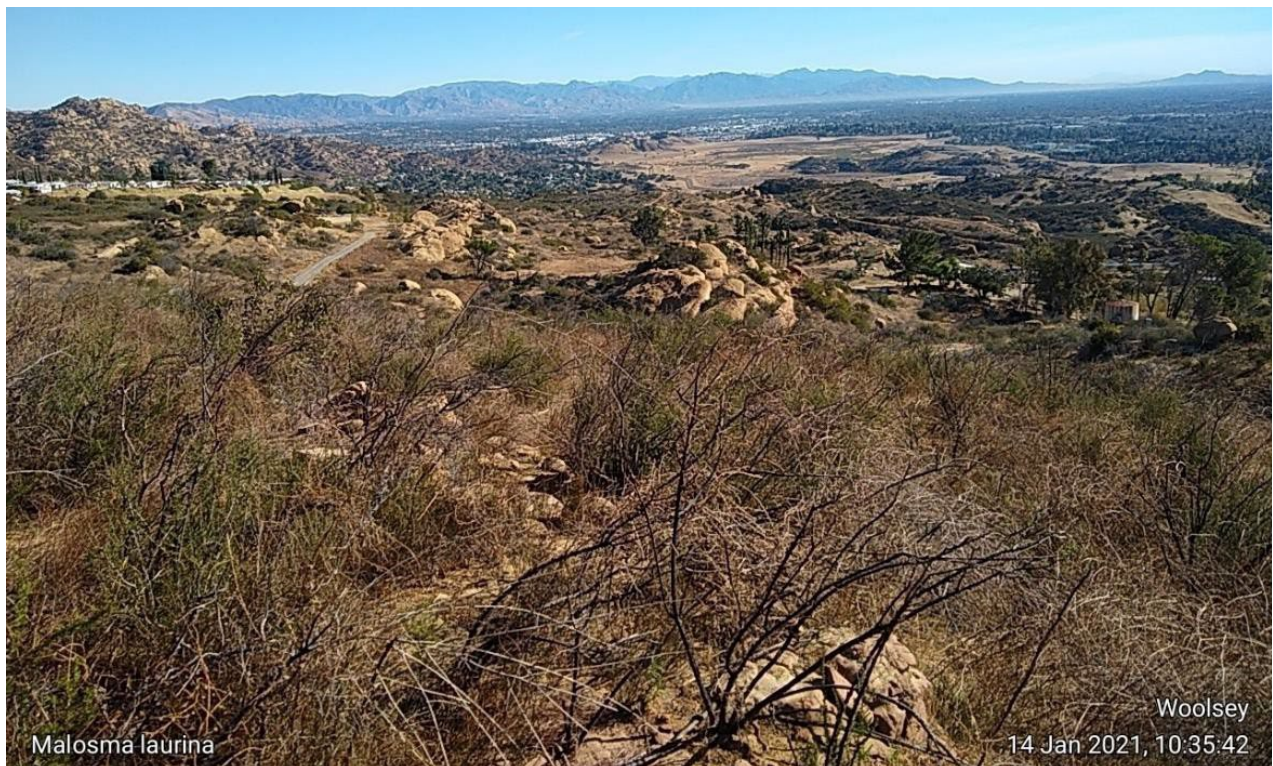
Photograph 3: Chamise chaparral plant community. Facing east

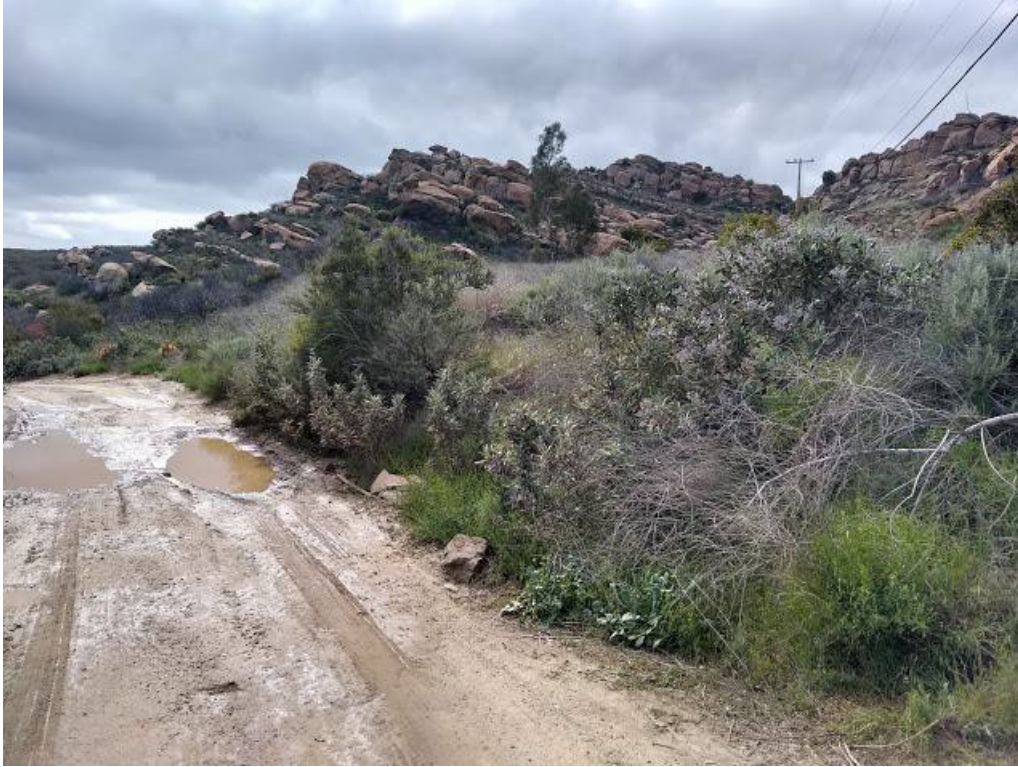
Photograph 4: Thick leaf yerba santa scrub plant community along a dirt road.

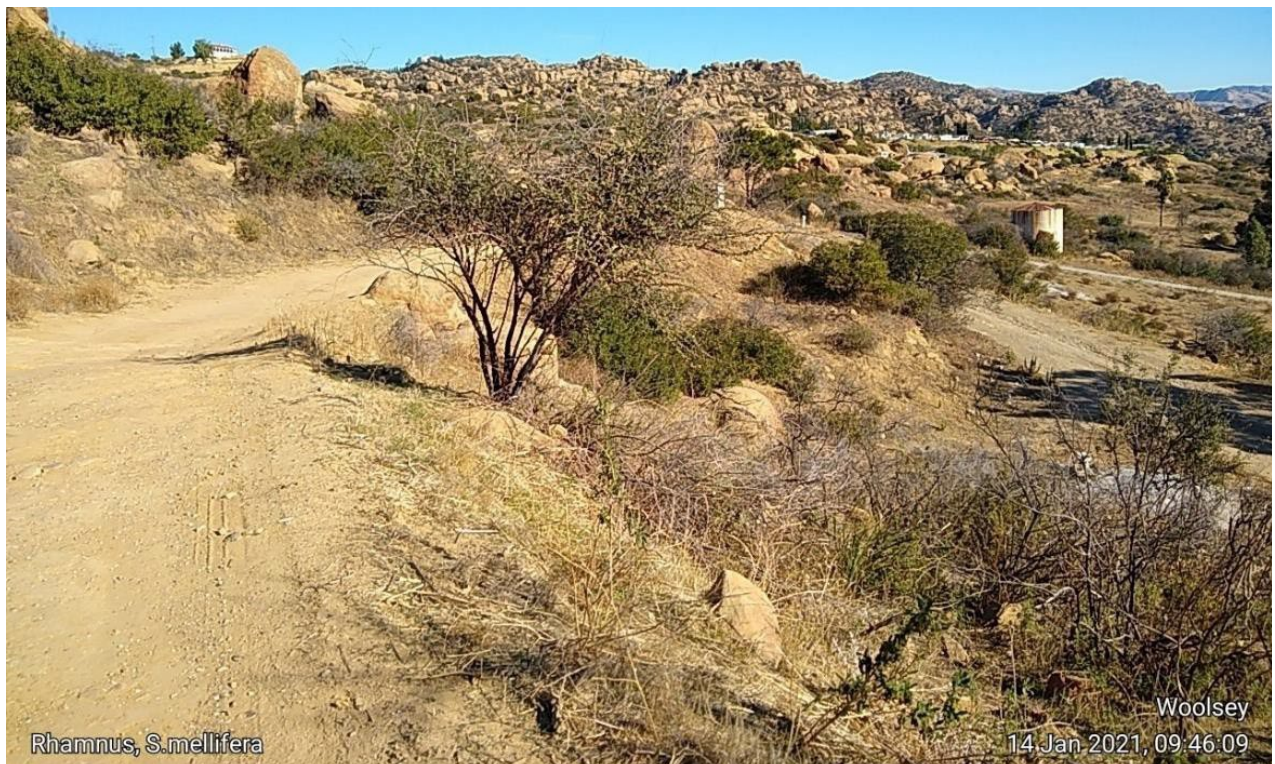
Photograph 5: Laurel sumac scrub along a dirty road. Facing north

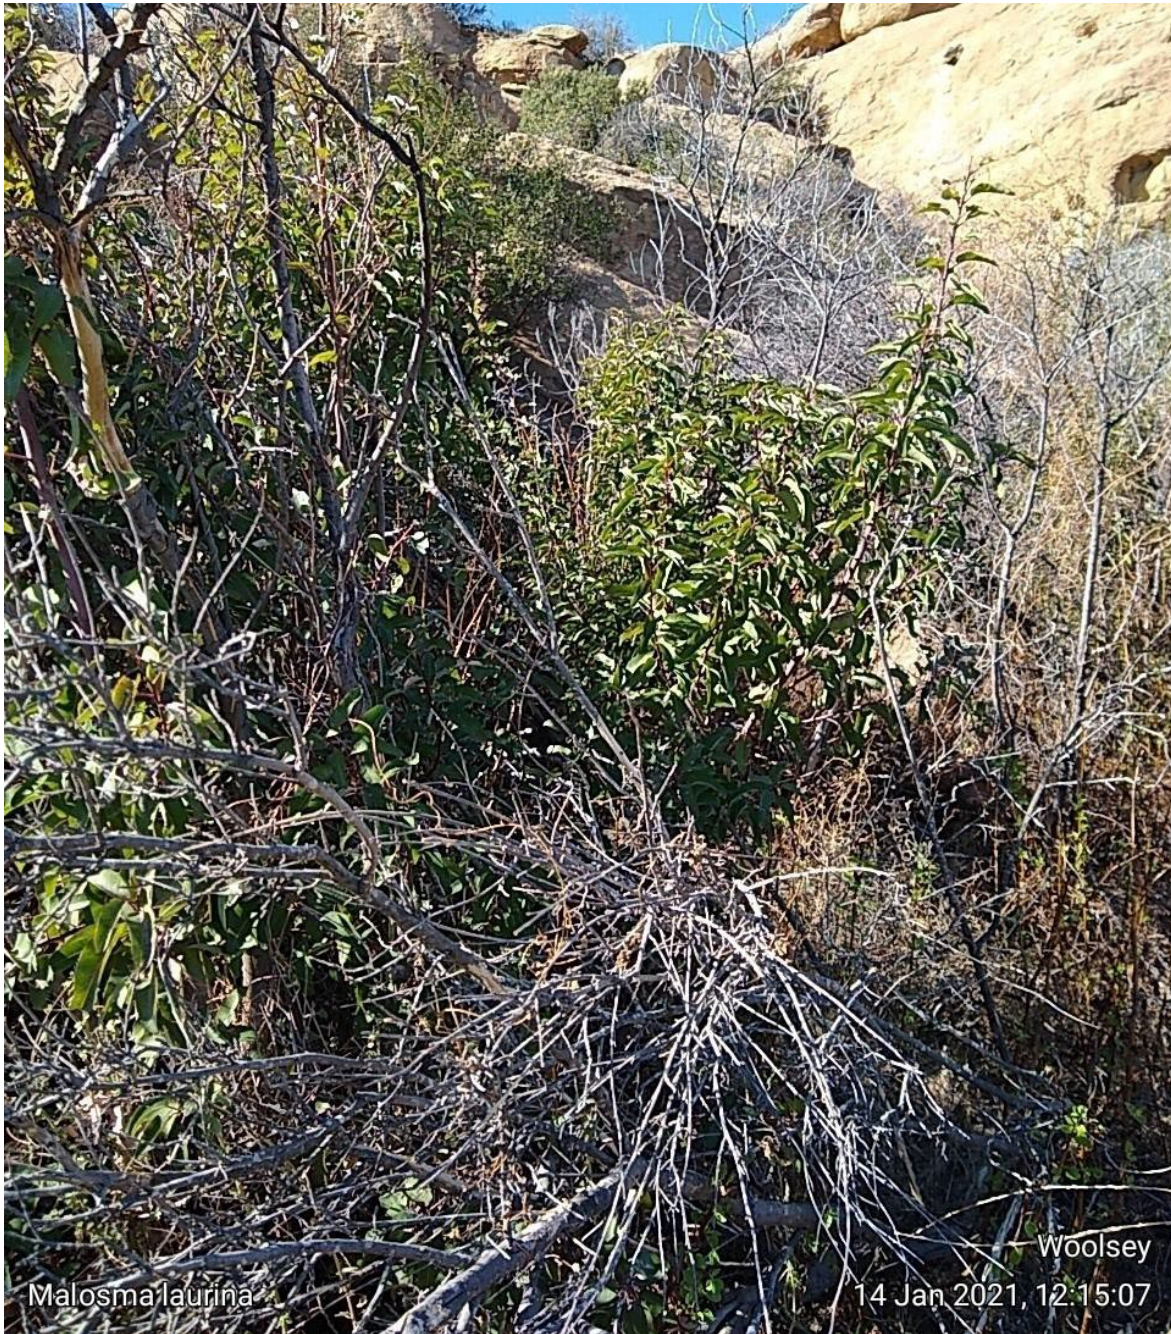
Photograph 6: Laurel sumac scrub plant community. Facing north

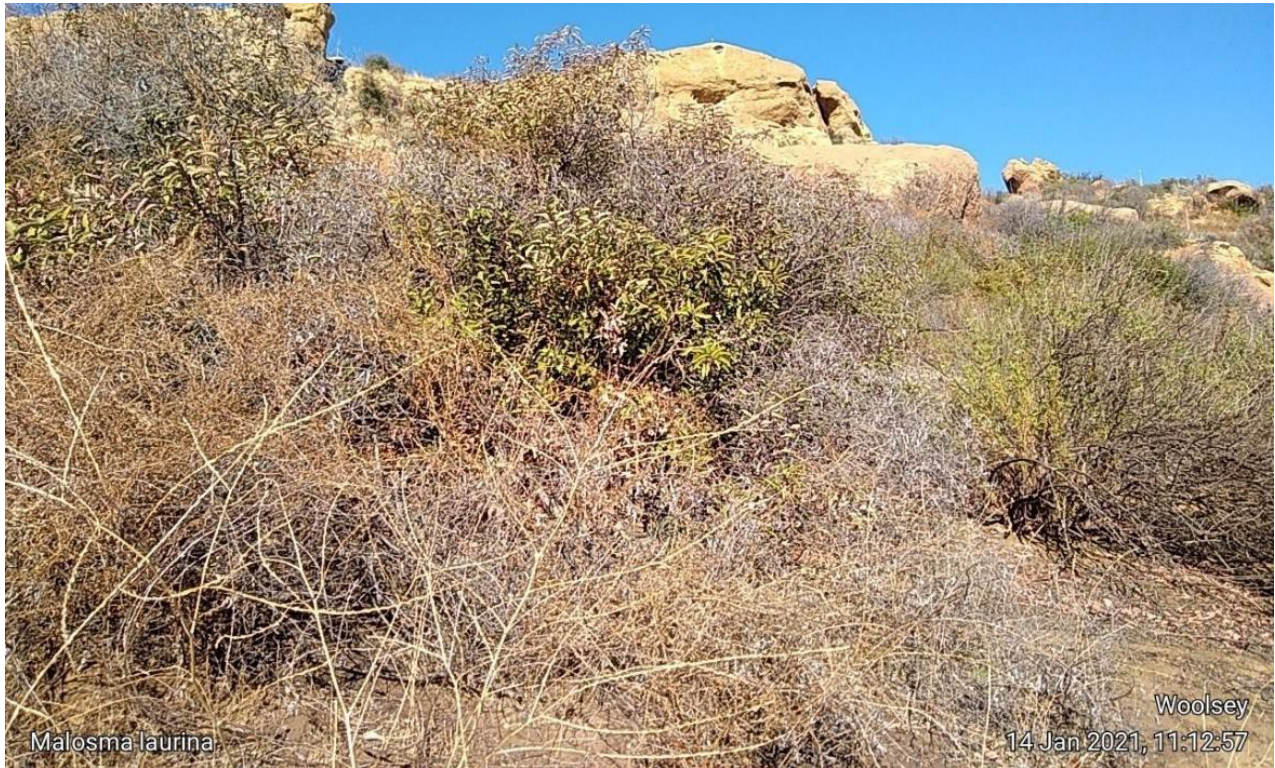
Photograph 7: Laurel sumac scrub plant community. Facing north

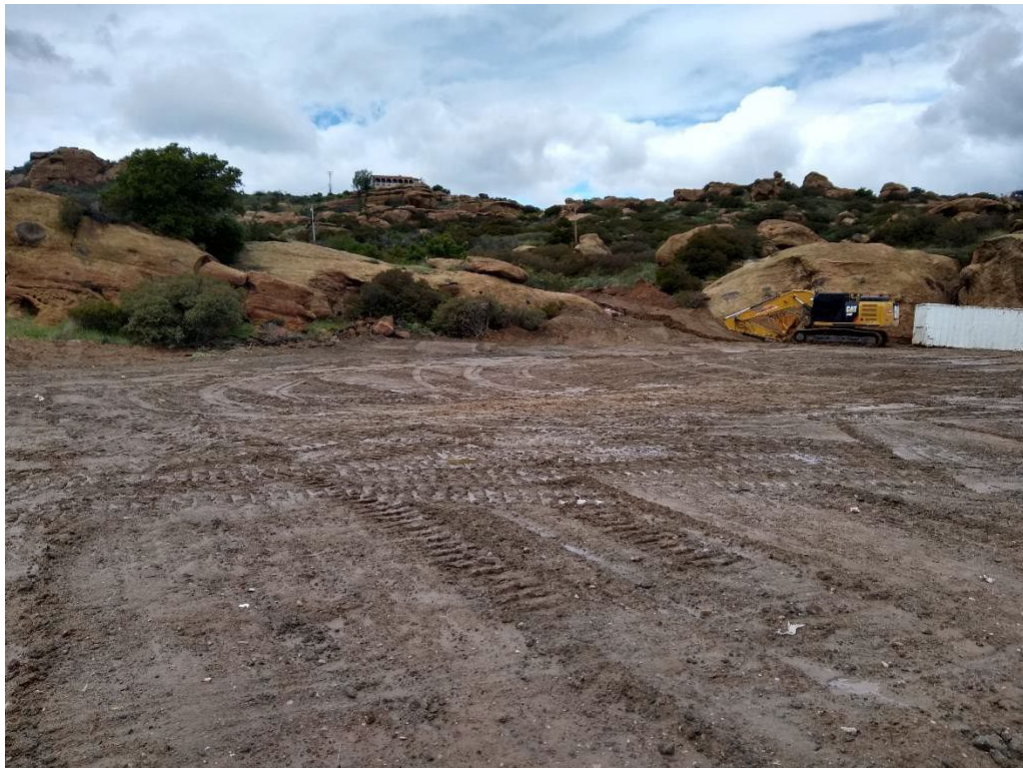
Photograph 8: Disturbed/graded area. Facing east

Based on aerial photography, it appears that significant grading and filling of the property occurred between August 2019 and February 2020. Pepper trees were also planted. The owner was cited for a violation. To determine the extent of the grading and filling, the biologists and GIS technicians conducted an historical analysis to determine conditions before the violation occurred. The analysis included review of aerial photographs dated between 1947 and 2019 and topographic maps dated between 1903 and 2015. The 1947 aerial depicts a road (just south of present-day Woolsey Canyon Road) that cuts through the site east to west. There are also two narrower spur roads, one of them being Knapp Ranch Road. The total disturbance in 1947 was ~1.37 acres (59,677 sq. ft.). The 1952 aerial depicts the same disturbances as in 1947 except that Knapp Ranch Road is wider. Widening of Knapp Ranch Road disturbed an additional ~0.19 acres (8,276 sq. ft.) of the property. The total amount of disturbance by 1952 was ~1.56 acres (67,954 sq. ft.). The 2008 aerial depicts extensive disturbance, which affected an additional ~1.35 acres (58,806 sq. ft.) of property. The total amount of disturbance by 2008 was ~2.91 acres (126,760 sq. ft.). The 2020 aerial photography captured by FBC depicts the area disturbed between August 2019 and February 2020, which affected an additional ~1.36 acres (59,242 sq. ft.) of the property. [The aerial photographs are included as Exhibit C](#).

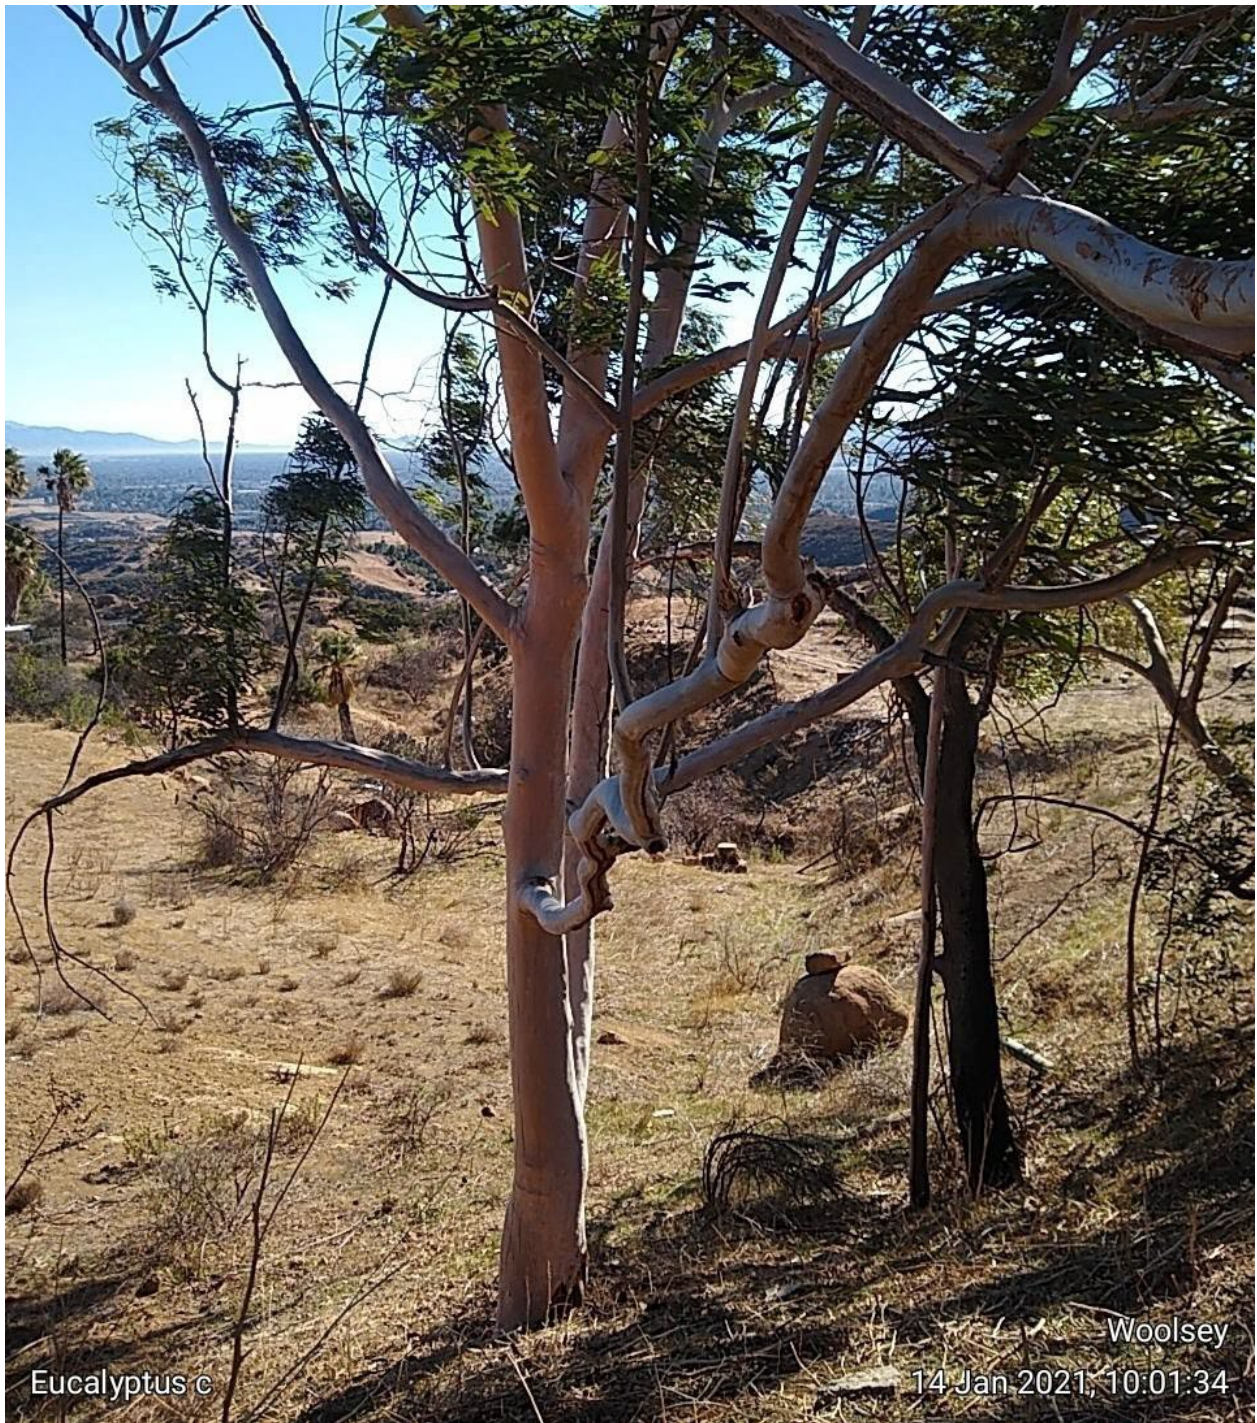
Photograph 9: Eucalyptus tree of heaven on southern-most parcel. Facing east
