## **Hazardous Report Phase 1 and Phase 2**

December 2021 | Phase I Environmental Site Assessment

# Royal Vista Residential Project

for Project Dimensions, Inc.

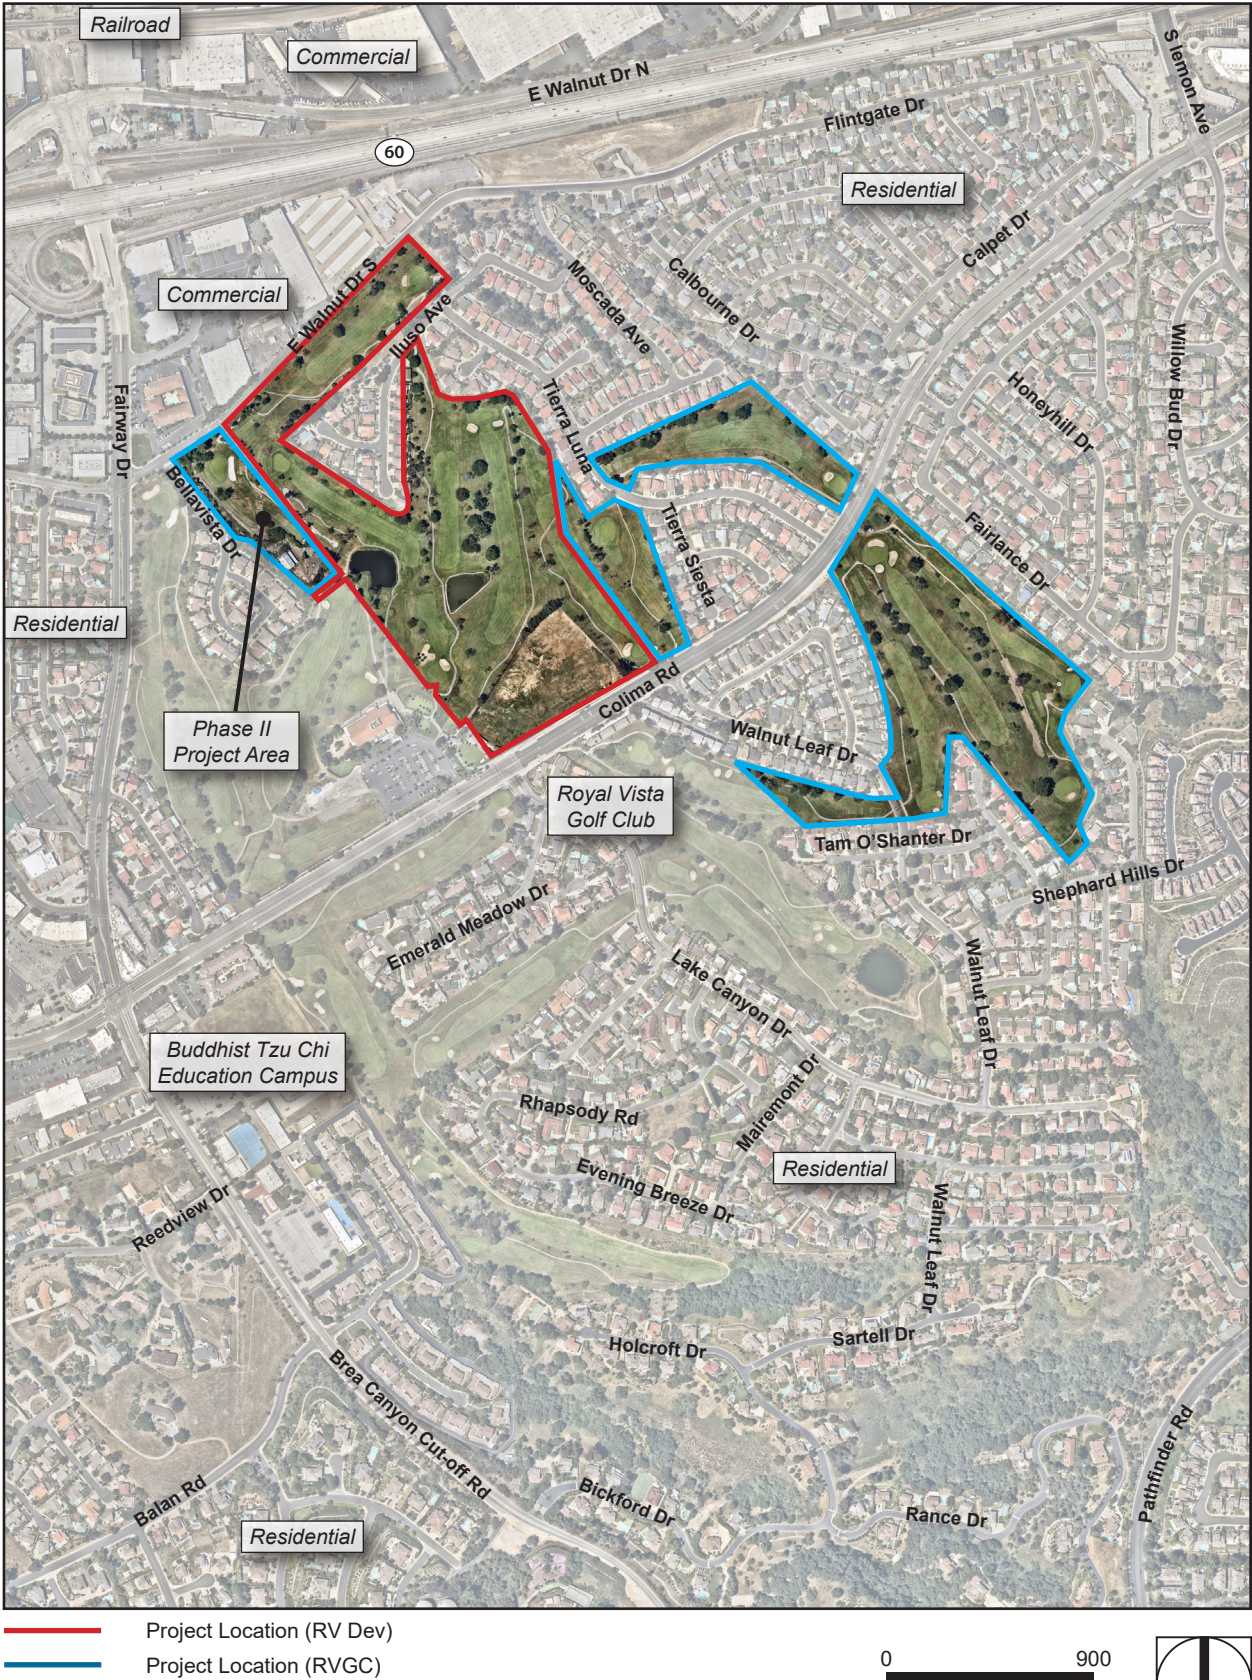
Figure 2 - Aerial Photograph

The project site is approximately 75.63 acres of the 156.44-acre Royal Vista Golf Club. The address for the golf club is 20055 Colima Road, Rowland Heights, CA. Figure 2 is an aerial photograph showing the current site conditions and the outlines of the six separate parcels that make up the project site. The Royal Vista Golf Club contains 27 holes, a club building that hosts large events, a parking lot, a lighted driving range, two practice putting greens, and a chipping area. Within the 75.63 acres of the project site the only identified structures are associated with the maintenance facility for the golf course which was investigated for possible releases in a Phase II completed in 2021 (PlaceWorks 2021).

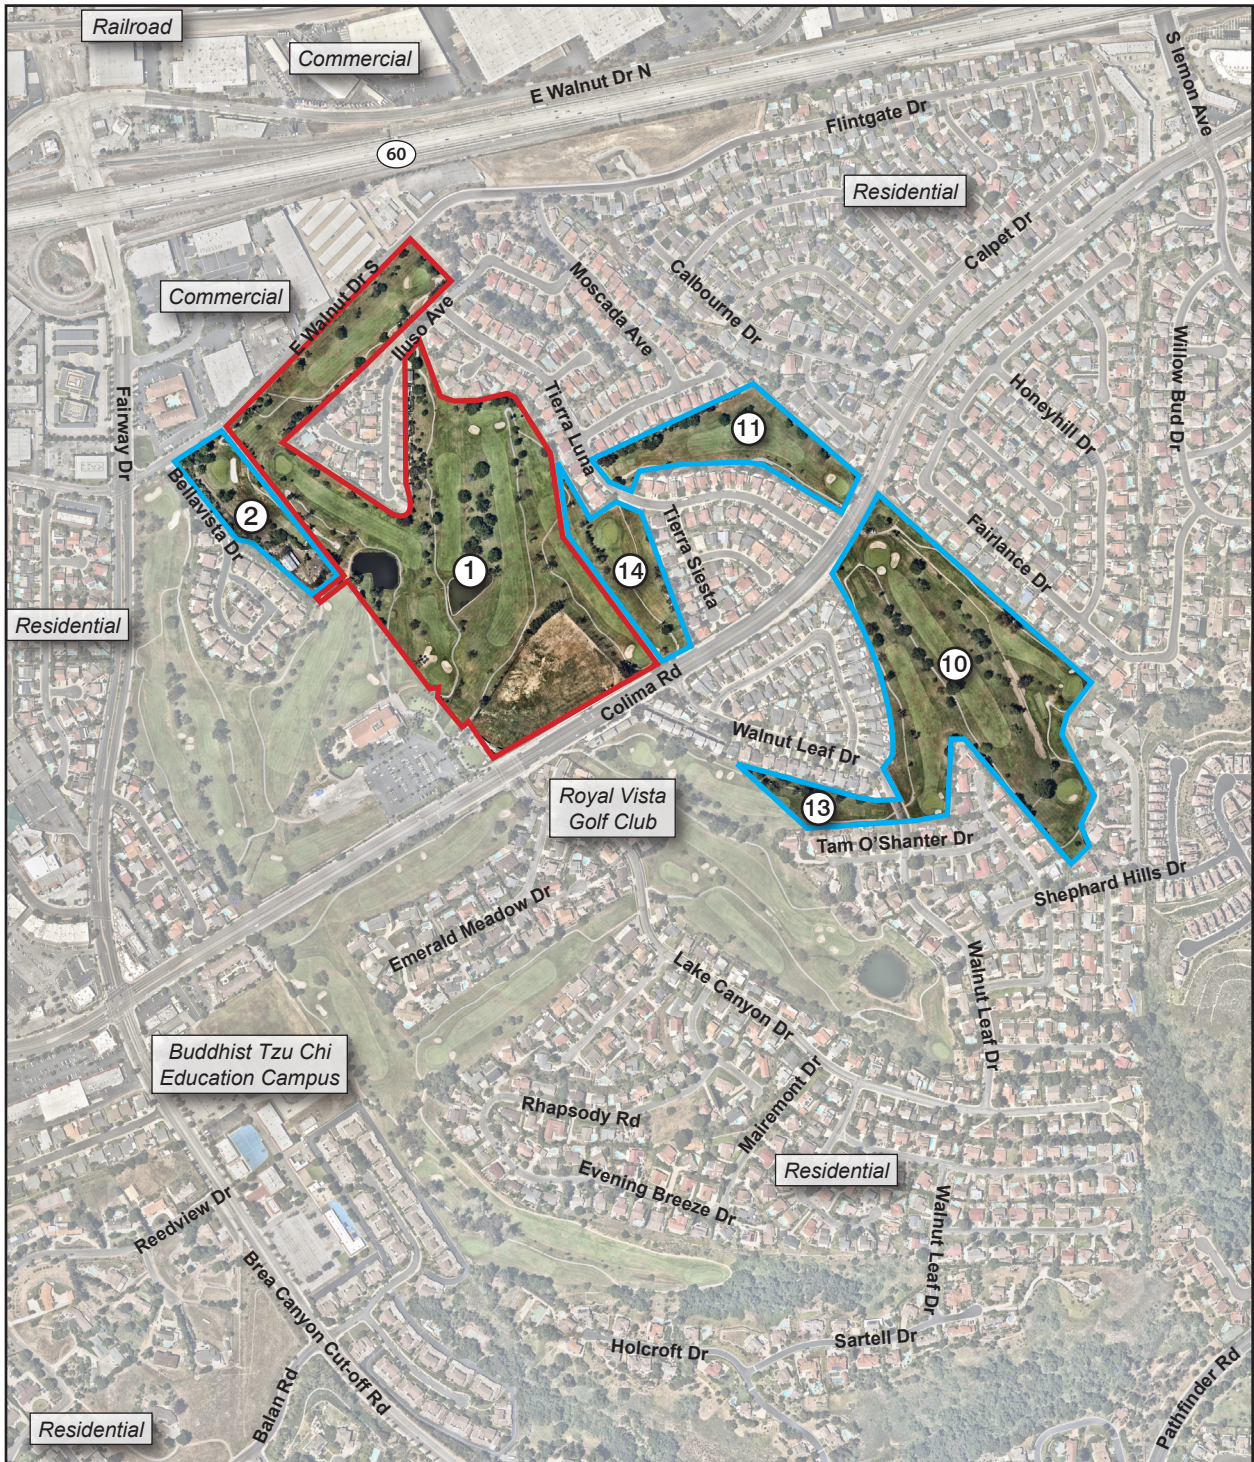
Figure 3 - APN Numbers

Figure 1 depicts the regional location of the project site, Figure 2 is an aerial photograph that shows the local vicinity of the project site, and Figure 3 is an aerial photograph showing the current conditions of the project site and APN numbers.

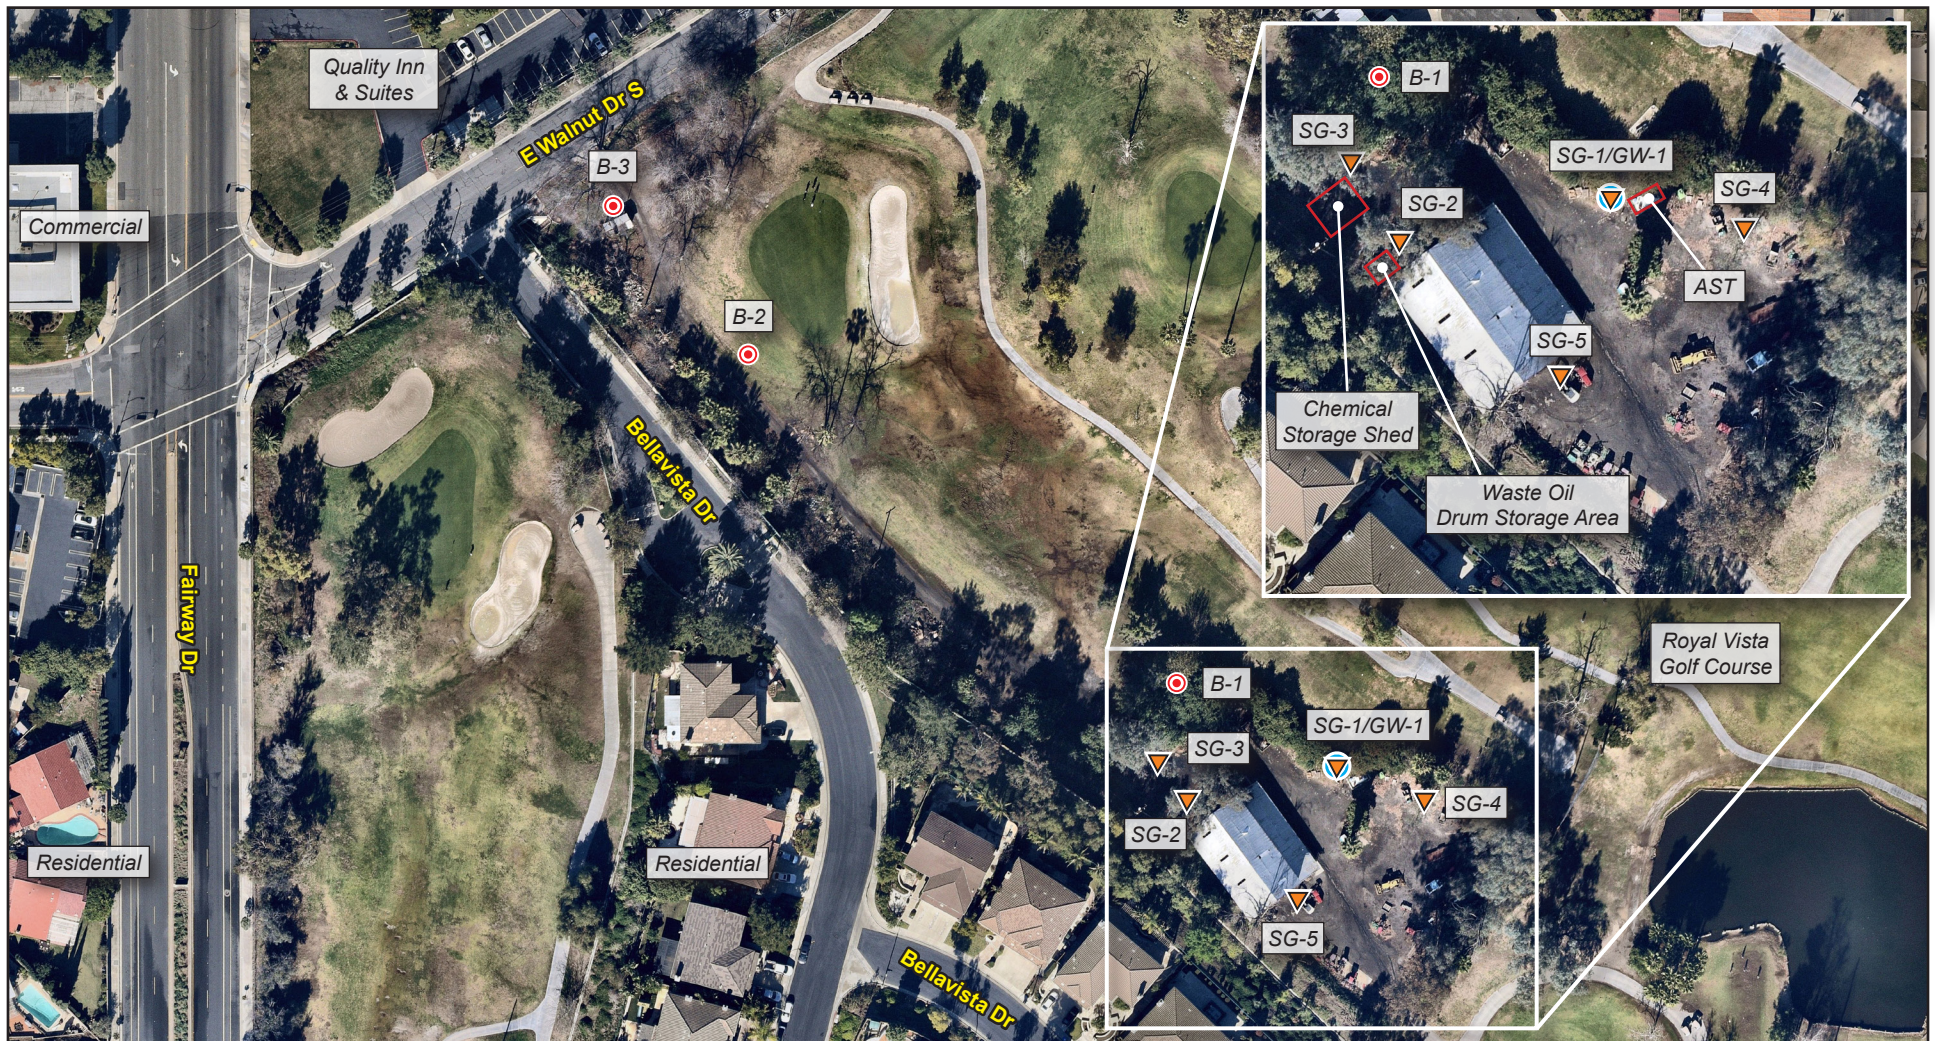
Figure 3 - Sample Locations

▼ SG-X Soil Gas Sample (5)    ● B-X Soil Sample (3)    ⊕ GW-X Ground Water Sample (1)

The 2021 Phase II evaluated the above listed RECs from the 2020 Phase I ESA and determined based on soil and soil gas sampling, that they are not RECs based on the laboratory results. The Phase II ESA recommended no further assessment.
