# Oak Tree Survey Report

## Hope Gardens Sequoia Building Project

**September 2020 (Updated December 2022)**

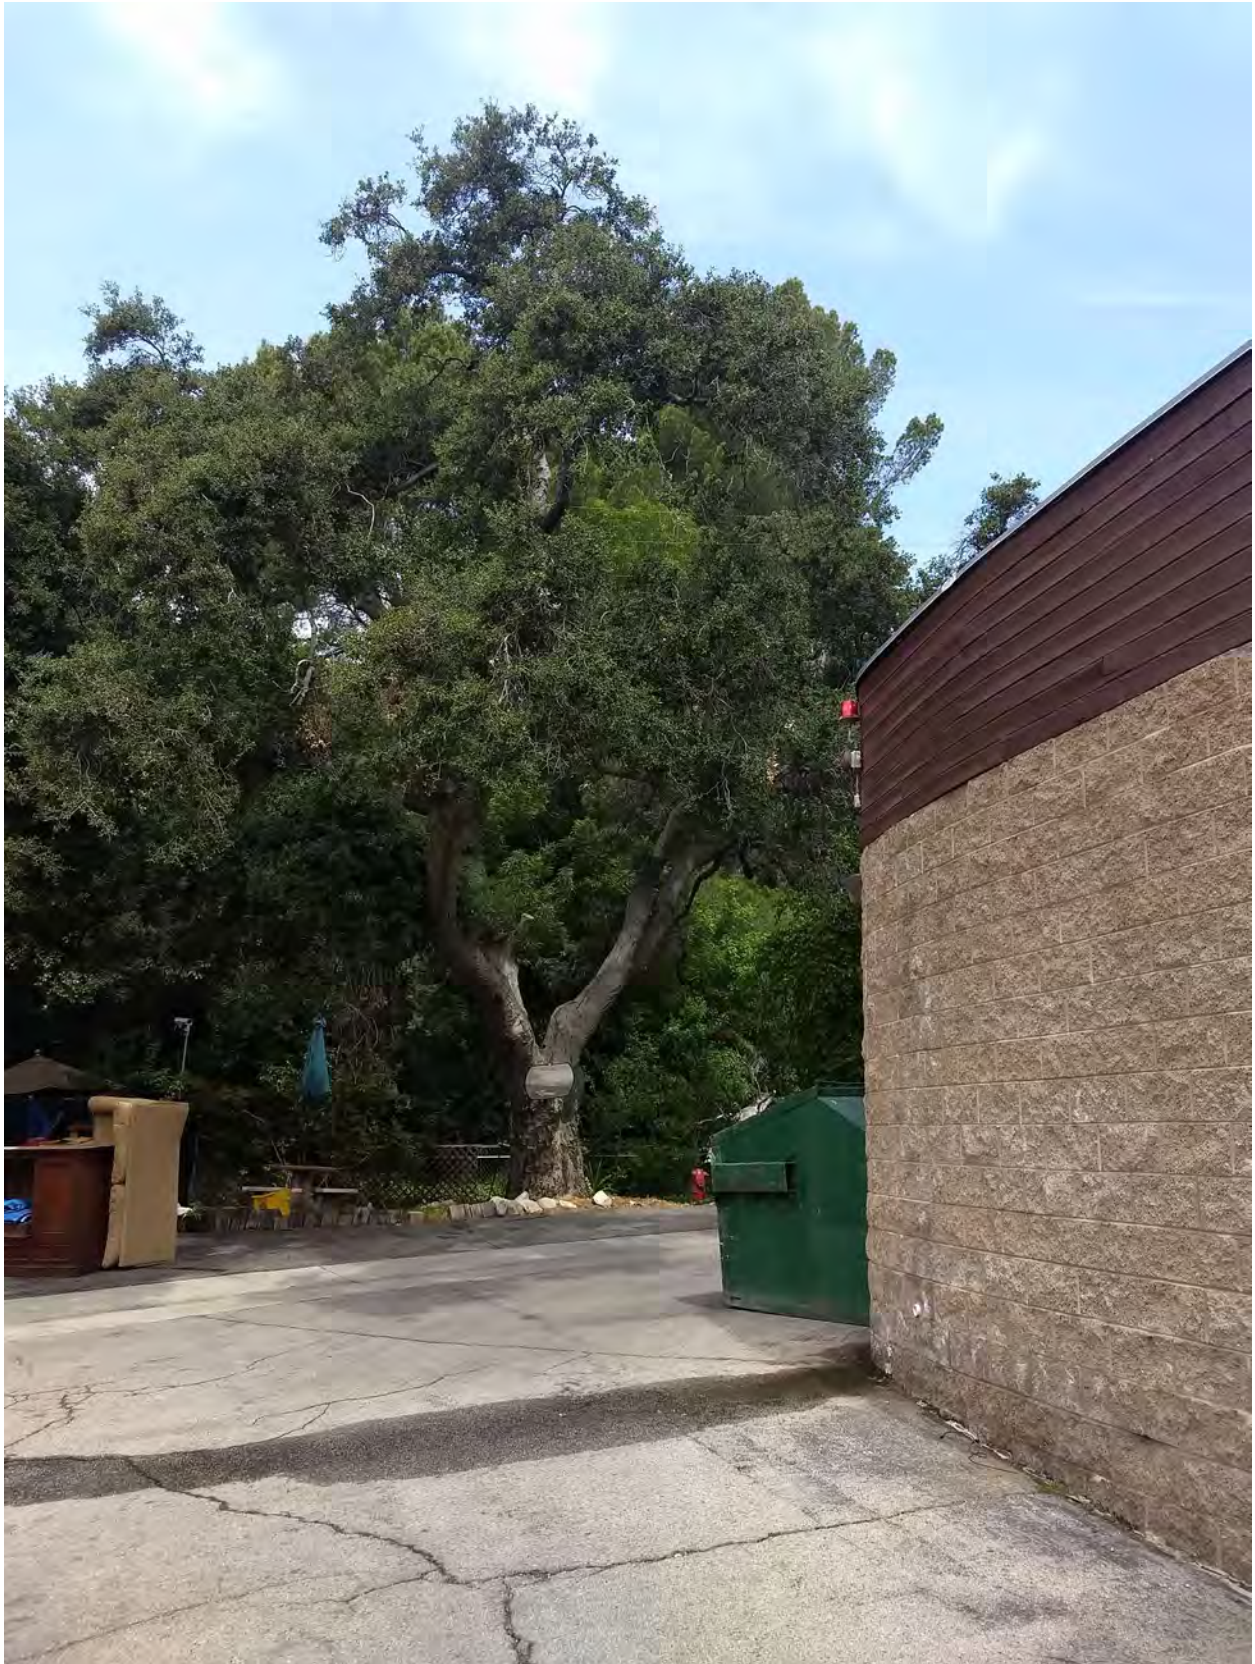
# Oak #11

Of the 4 oaks that will be removed, 3 of them (#11, #13, and #16) are in good health (4, or 5 health rating). Oak #15 is dead/dying (health rating of 1) and we recommend it be removed to avoid any future conflicts. Heritage Oak #26 will not be impacted by the project because it is off the project site and not in jeopardy from project activities.

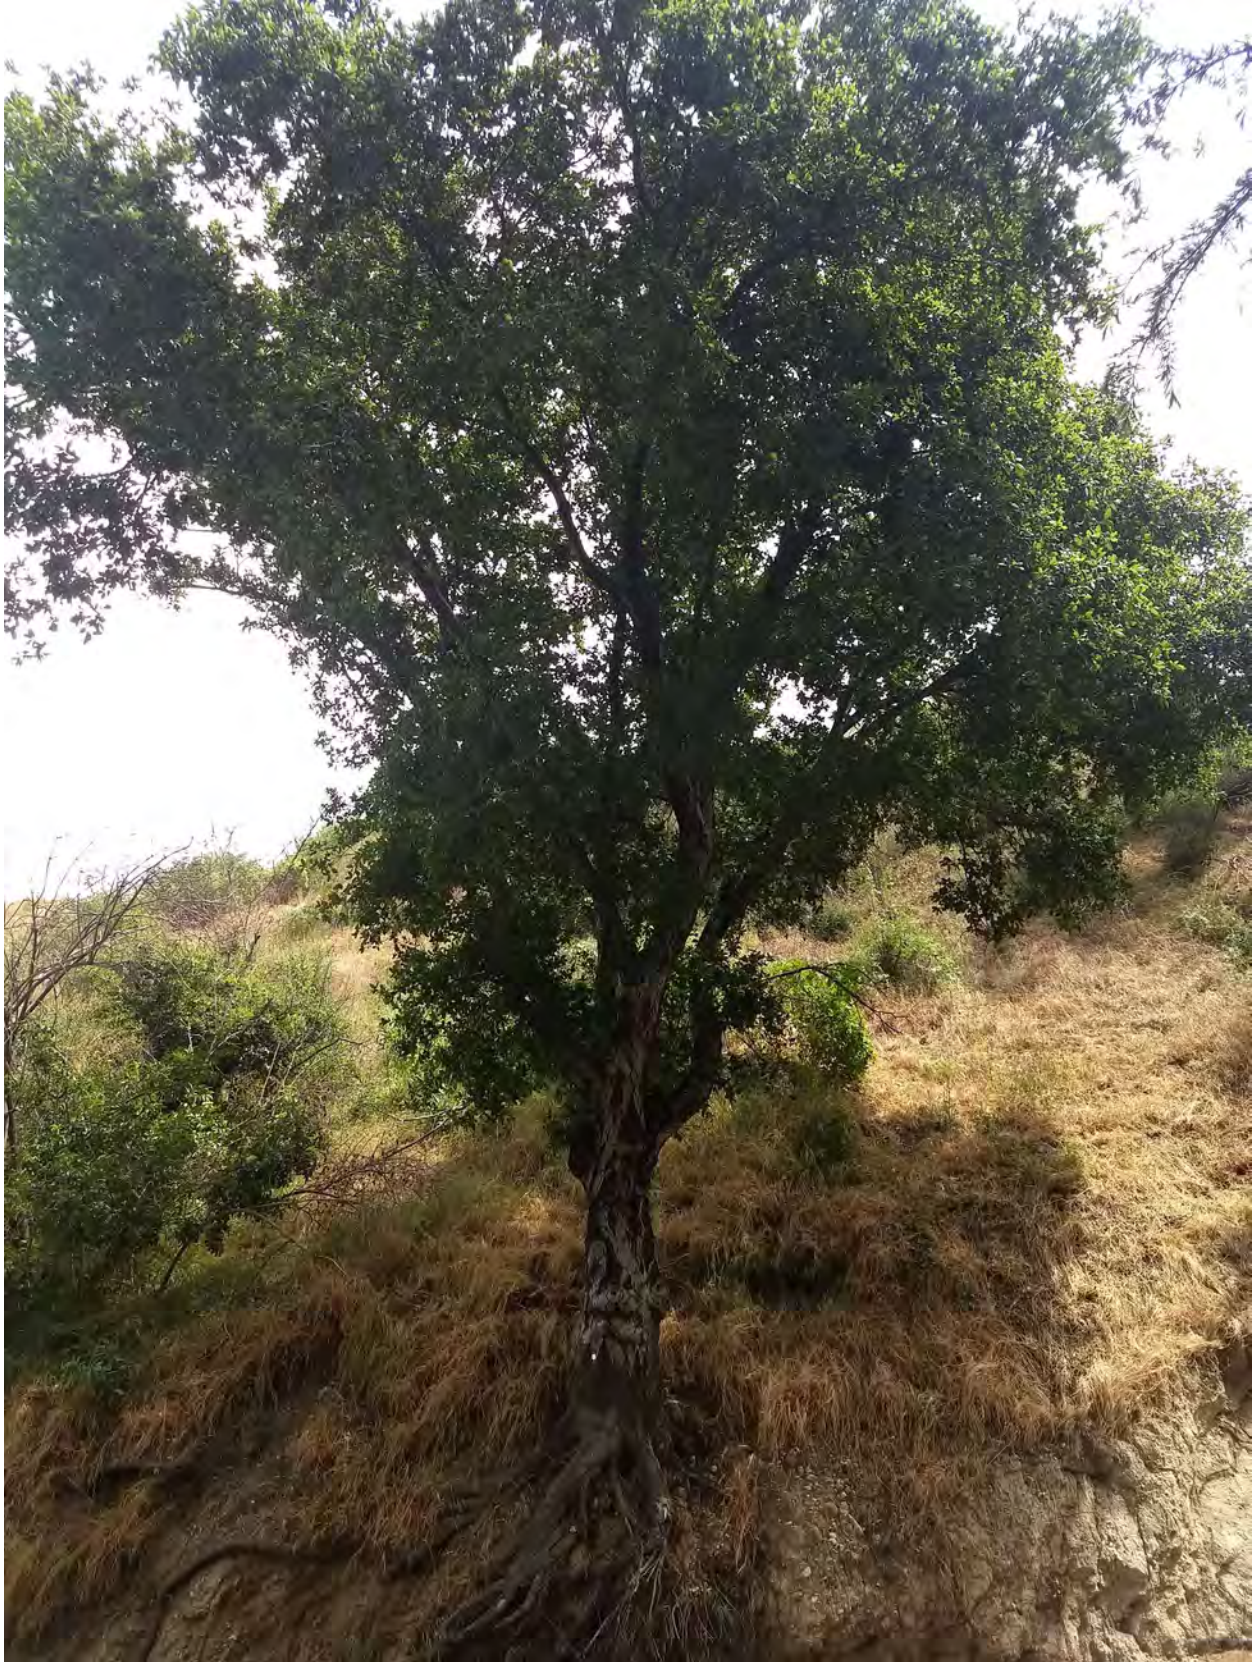
Oak #54

54	Coast	25	15	15								5					3	on road edge on cliff, exposed roots up to 6 ft
55	Coast	30	21	20								4		HR			4	
56	Coast	45	28,25,13	25	20	25	35	40	20	12	20	4				Dead, thinning	4	burned, included bark
57	Coast	30	22	22	3	5	10	12	20	20	20	3		HR		dead, thinning	3	burned, root rot and heart rot visible
