Richard W. Veyna
ASSOCIATES
Horticultural Consultants

February 21, 2024

Ping Wei
2907 Rio Lempa Dr.
Hacienda Heights, CA 91745

On 2/16/24 we inspected the property at the above address. The lot slopes down from south to north. We surveyed the property for the presence of Coast Live Oaks (*Quercus agrifolia*). We found four trees, one of which had been reduced to two feet in height, and three others which had not been pruned at all.

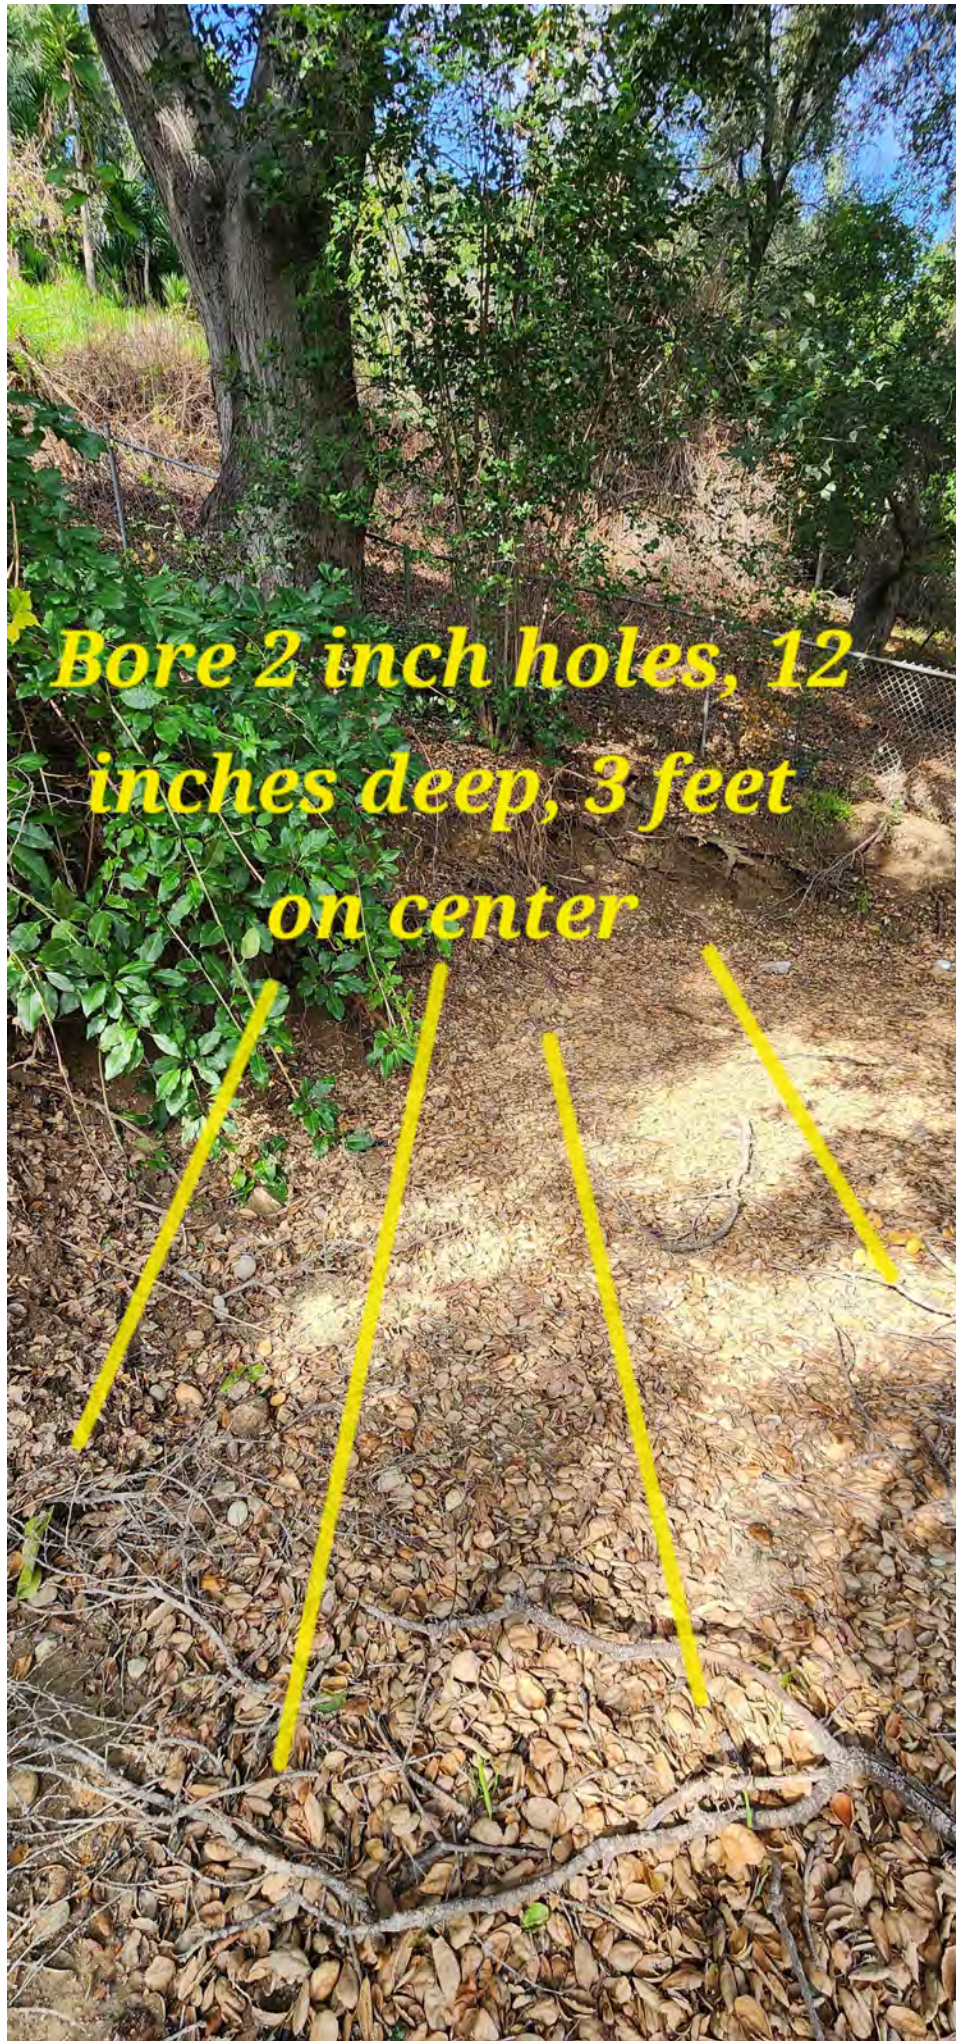
Which tree is this? A site plan for the bore holes would be helpful. What does "3 feet on center" mean? How many bore holes? I'm not going to assume 4 holes just because there are 4 yellow lines.

Bore 2 inch holes, 12 inches deep, 3 feet on center
