Entrada South Oak Tree Report

**OAK TREE REPORT
ENTRADA SOUTH, VTTM 53295
THE OLD ROAD AND MAGIC MOUNTAIN PARKWAY
UNINCORPORATED LOS ANGELES COUNTY**

**DECEMBER 22, 2021
AMENDED: MARCH 31, 2023**

**Re: Oak Tree Report Amendment - Entrada South, VTTM 53295
Unincorporated Los Angeles County
Oak Tree Permit No.: ROAK-200700018**

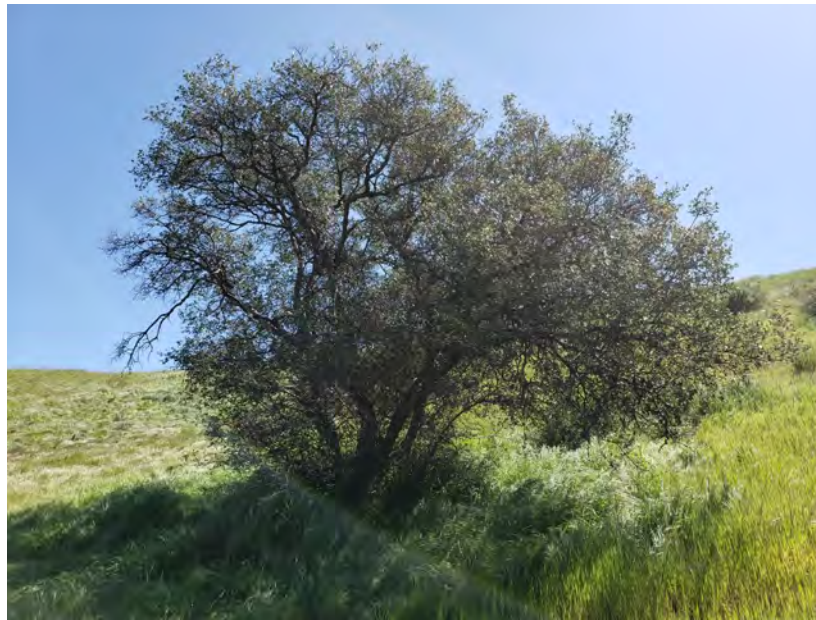
Tree No.156

156	<i>Quercus berberidifolia</i>	9 @ 3.5'		25	23	12	10	20																	C-	C-	F	C-	old tag 158, HOB, significant dieback on south and east, recovery growth noted on north and west
