BIOTA REPORT FOR THE DUGGAN PROPERTY EXPLORATORY WATER WELLS AND PIPELINE, 302 E. CARLISLE ROAD, THOUSAND OAKS, CALIFORNIA

Biota Report for the Duggan Property Water Pipeline, 302 E. Carlisle Road, Thousand Oaks, California

(APNs 4472-002-006, 4472-002-011, 4472-003-043, 4472-003-044, and 4472-003-048)

30 September 2023, Updated 25 October 2024, 23 January, and 23 March 2025

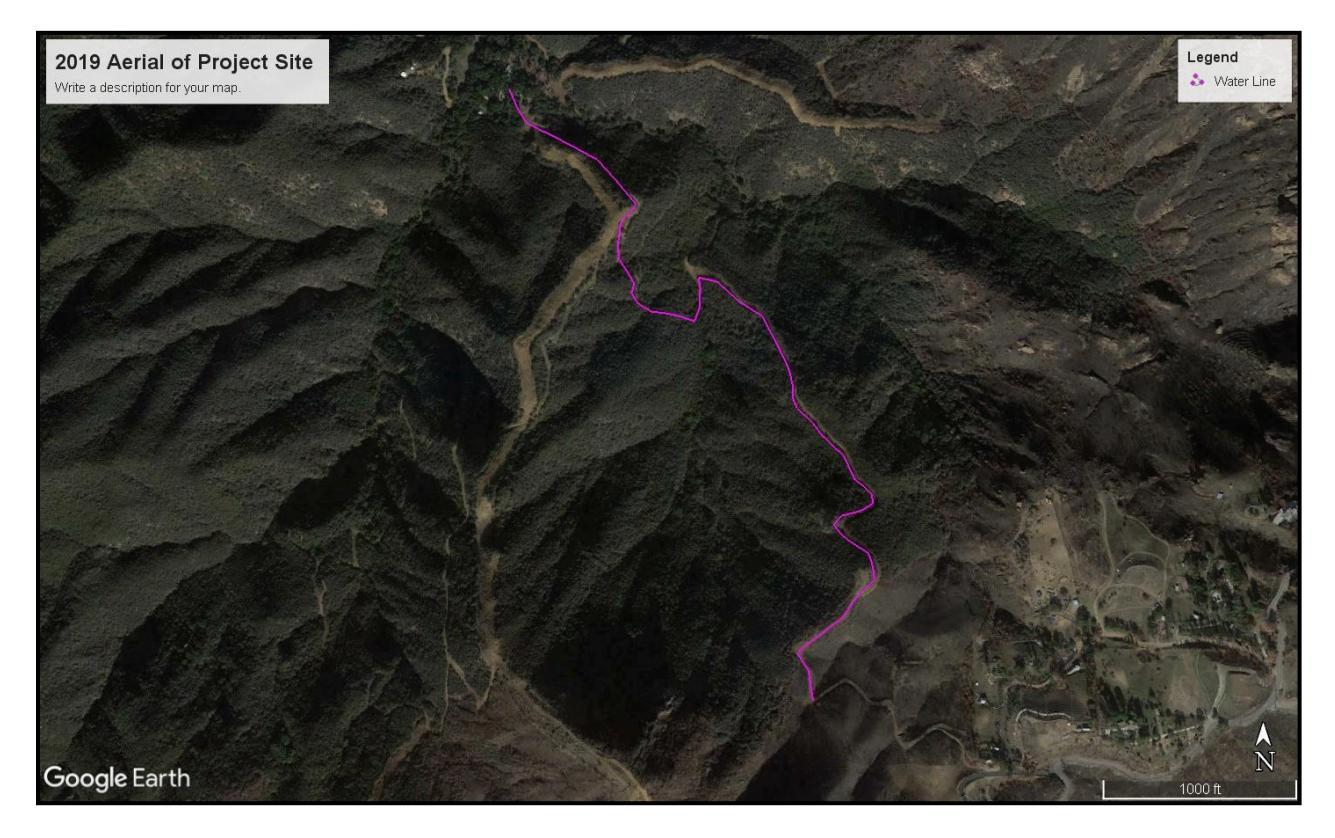
Figure 4. Project Site Burned Area

The Woolsey Fire burned the eastern portions of parcels 043, 044, 006, 011, and all of parcel 015 in late 2018, which is visible on the aerial photograph dated 3 January 2019 that is the base for Figure 4, Project Site Burned Area, showing the general alignment of the proposed water line, which would follow a fire road from the top of the ridge and connect with a firebreak road near the bottom of the canyon.

The ranch roads on the steep slopes also served as a firebreak and contained the spread of the Woolsey Fire along the north/northwestern edge of the road just northwest of the proposed well site, with a small portion (southernmost) of the site burned on 9 November 2018. No other portions of the proposed water line were burned in the Woolsey Fire.

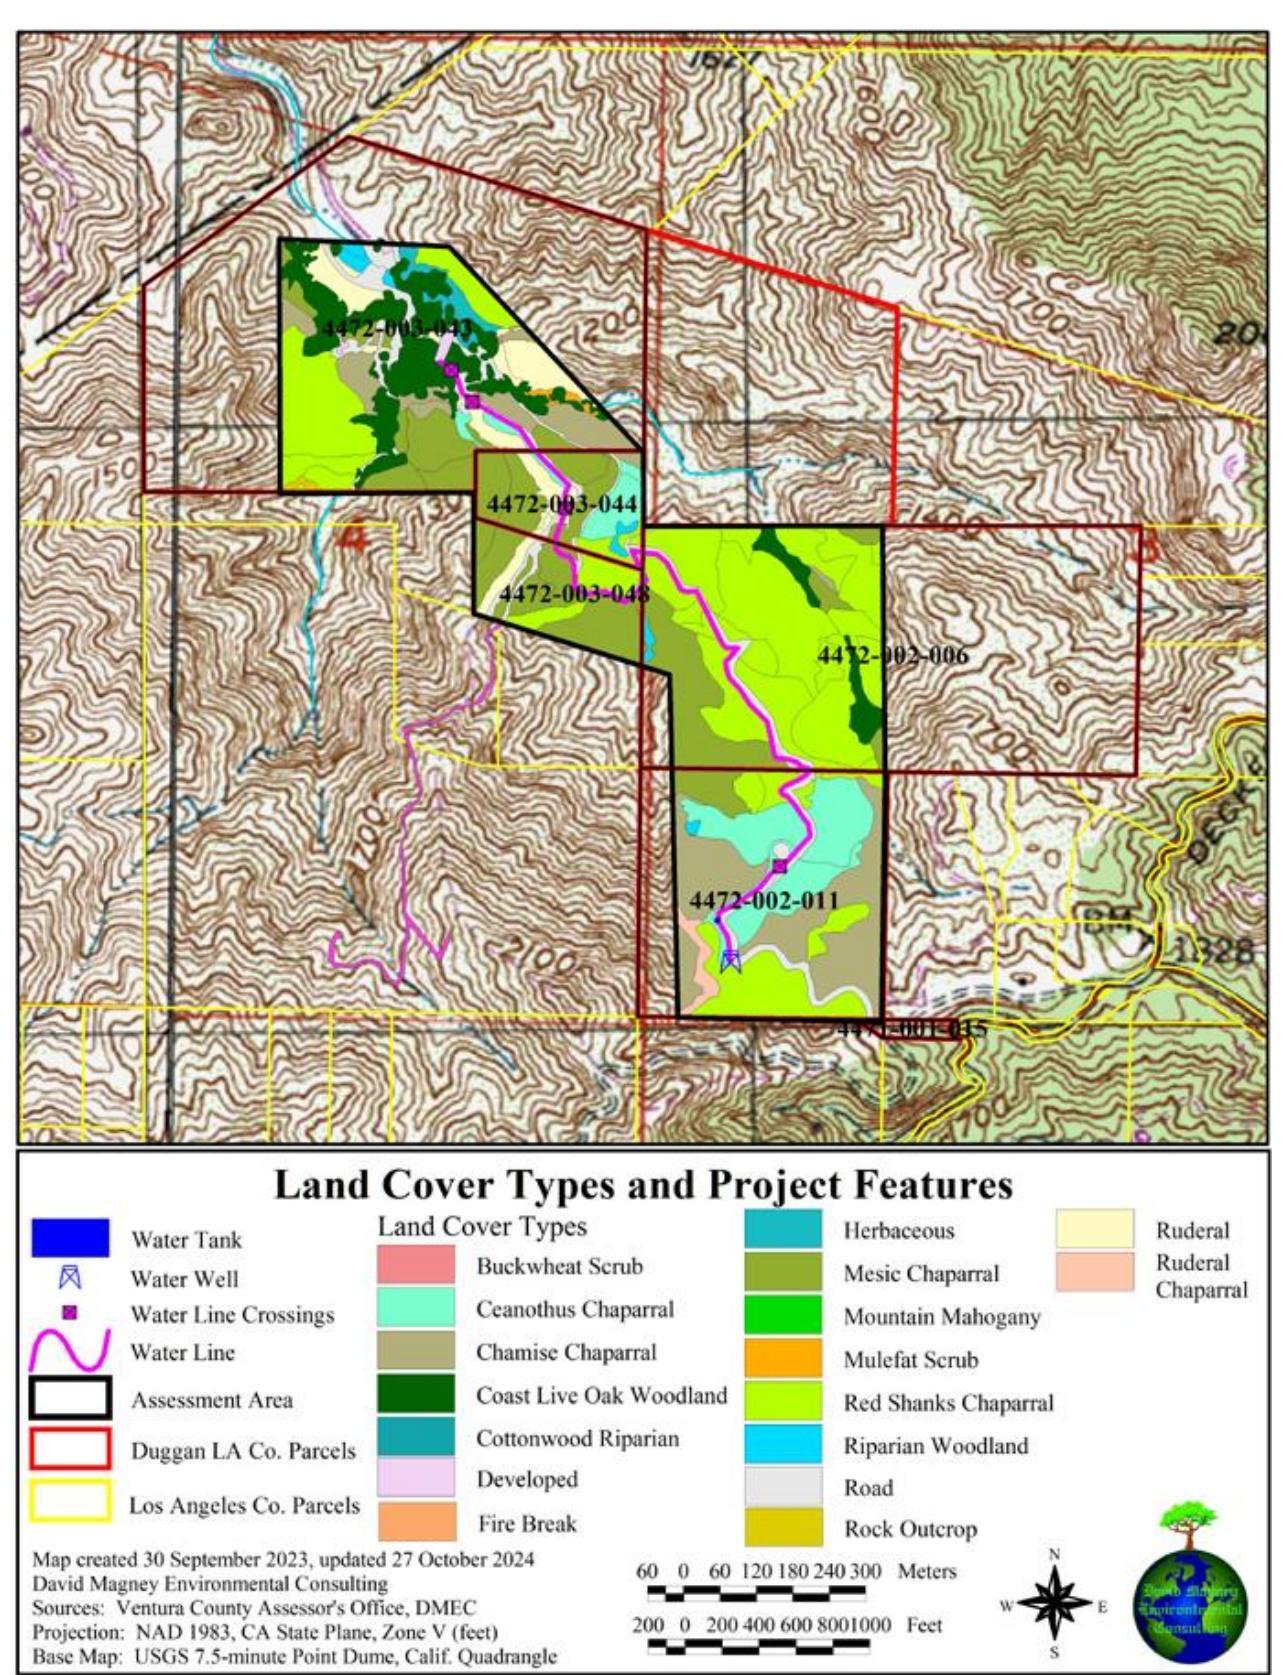
The proposed project involves installing a 5,000-gallon water tank and put at the new water well at the top of the ridge to the south and constructing a water line, mostly above ground, to an existing water storage tank to supply Ms. Duggan's residential needs for her home at 302 E. Carlisle Road. The parcel on which the water well would is located is approximately 41.126 acres in size. The total footprint of the proposed water tank is approximately 322 square feet, located entirely within the previously disturbed ranch road.
