Revised Draft SEIR Appendix 5.5h Hasley Canyon Creek CLOMR

FEMA Application - Conditional Letter of Map Revision

Hasley Canyon Creek Soil Cement Bank Protection Valencia Commerce Center TPM No. 18108 ESTU No. 2023000284

January 2025

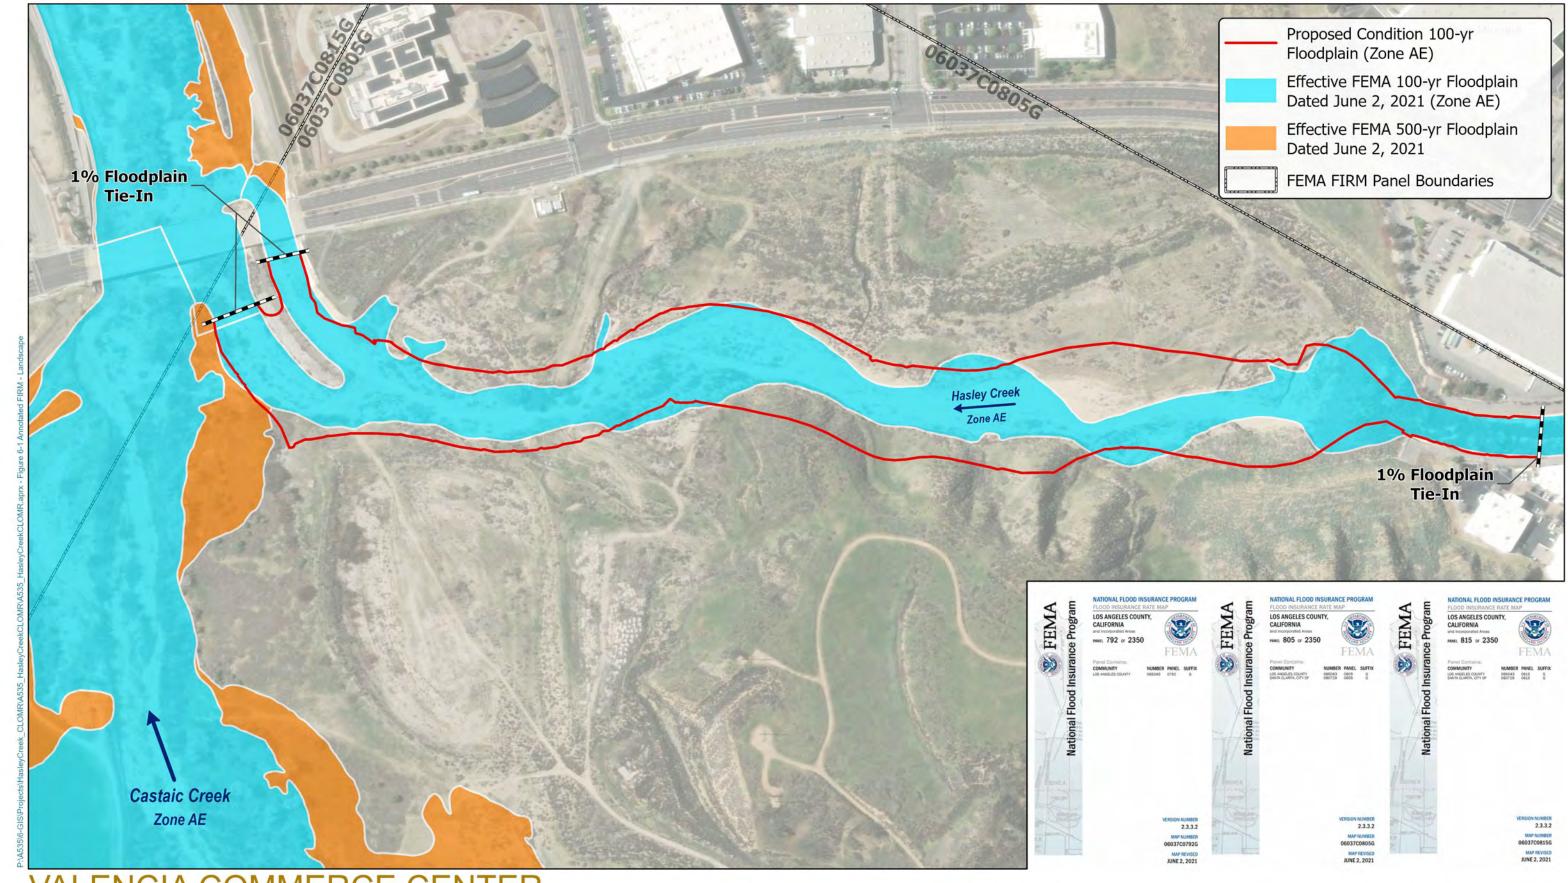
ANNOTATED FIRM

Based on the present application and enclosed analyses, we are requesting that FEMA provide a Conditional Letter of Map Revision for the proposed Soil Cement Bank Protection Project on Hasley Canyon Creek, affecting FIRM Panel 06037C0805G. The proposed condition 100-year floodplain and base flood elevations are shown on the Annotated FIRM in **Figure 6-1**.

The comparison analysis shows that the floodplain extents for the study reach tie-in to the FEMA Zone AE floodplain for 100-yr Base Flood Elevations (BFEs) within 0.5-ft or less. The upstream and downstream tie-in locations are at HEC-RAS river stations 4396 and 1061, respectively. These abide by FEMA guidelines for flood hazard analysis.

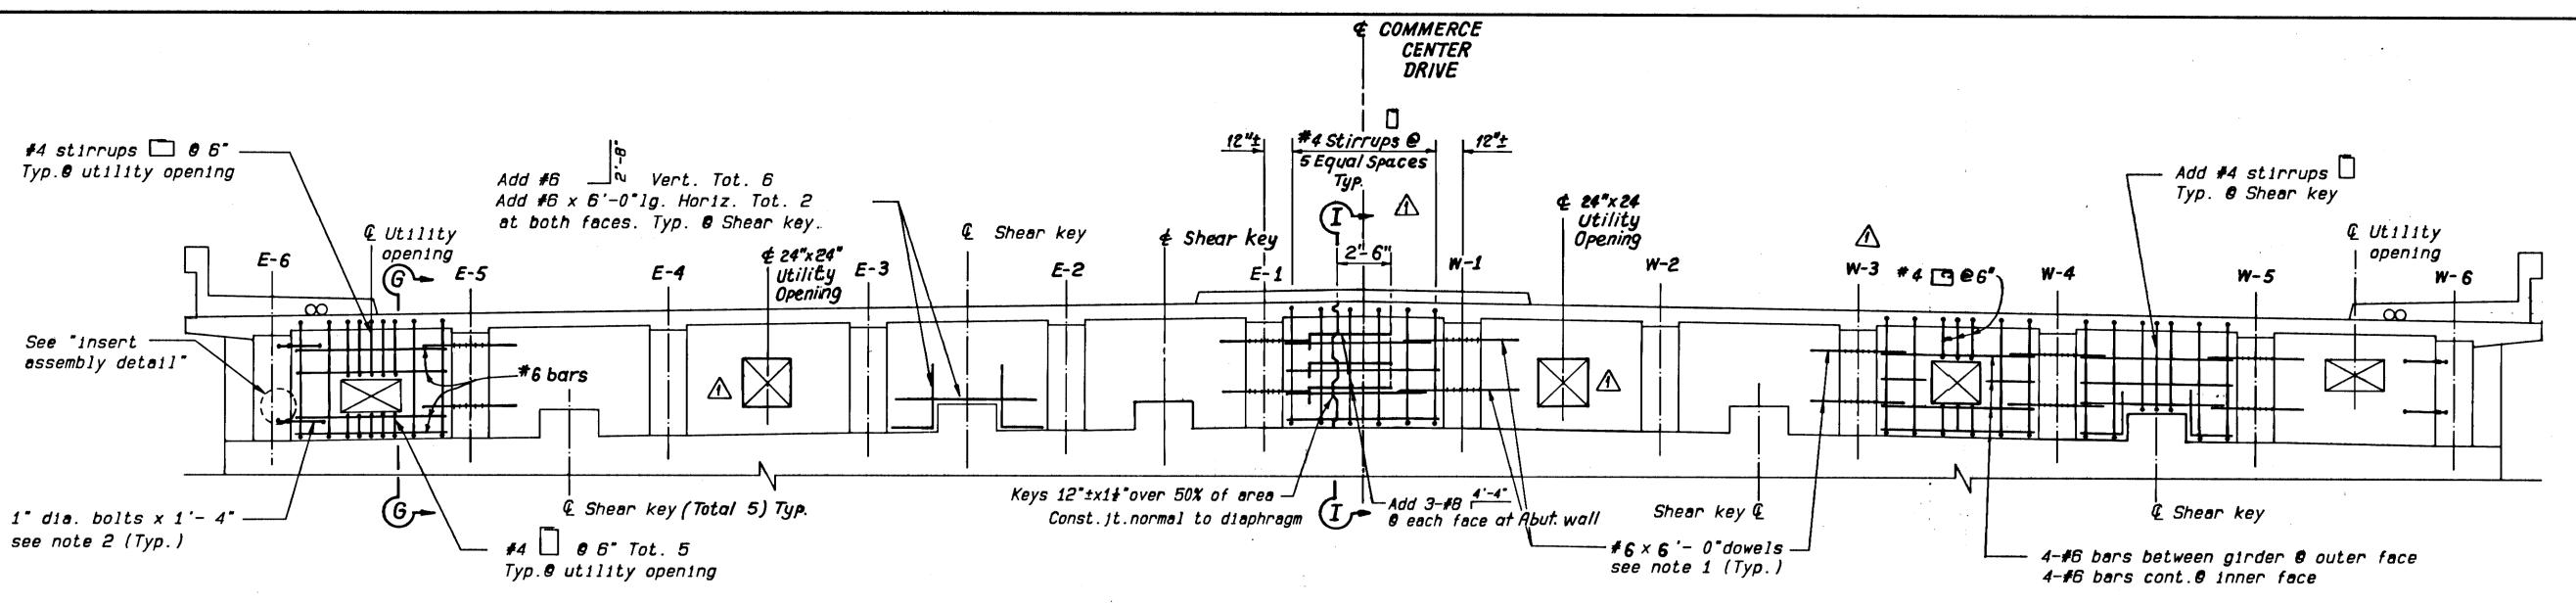
NORMAL SECTION - END DIAPHRAGM AT ABUT. 1 & 8 Scale: 1/4"= 1'- 0"

thin unreinforced concrete under girders.
